Asbestos Management Survey

College Road Depot, B44 0AY

Report No	D-05899	Report Issue Date	22 October 2020
Client Name & Address	Asset Management & Maintenance Division Mole Street Centre Mole Street Sparkbrook Birmingham B11 1XA	Site Address	College Road Depot, 599-603 College Road, Kingstanding, Birmingham, B44 0AY
Order Placed By	John Flaherty	Instruction Date	17 January 2020
Order Number	RHM01 JRRR A00	Project Reference	-
Survey Date(s)	22 September 2020	Lead Surveyor	Nazir Korimbocus

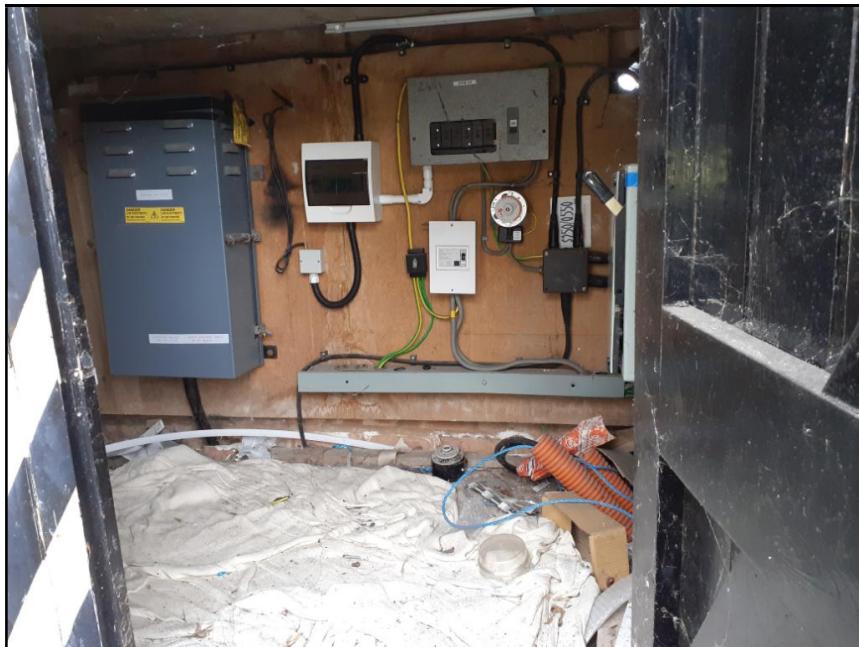
Description Electrical distribution equipment .

Score
Asbestos Type	Presumed Asbestos	-
Product Type		-
Extent of Damage		-
Surface Treatment		-
Estimated Amount		
Accessibility		
Risk Score		12

Recommendation	Inspection Required
Notes	Electrical distribution equipment is live and could not be inspected for safety reasons.

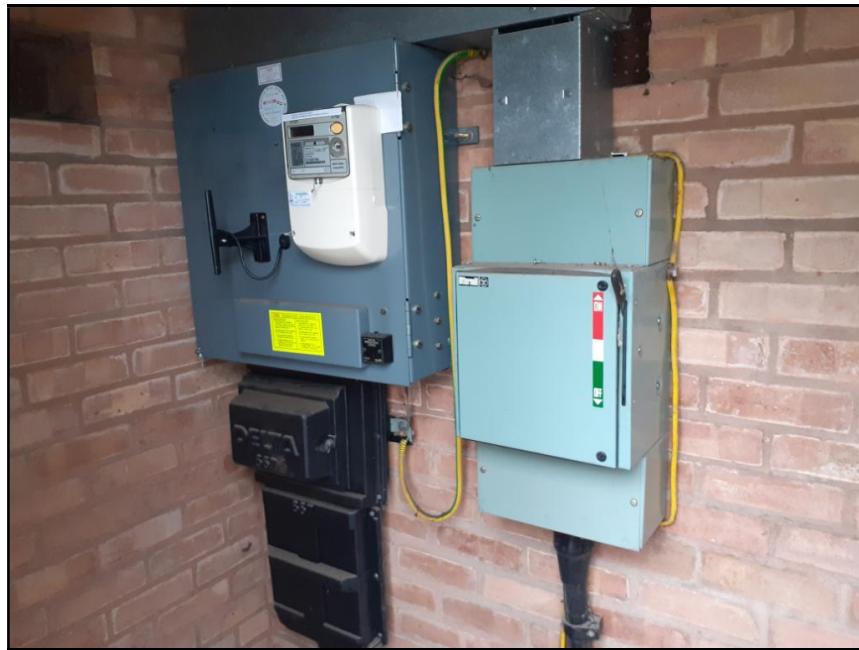
Description Electrical distribution equipment .

Score
Asbestos Type	Presumed Asbestos	-
Product Type		-
Extent of Damage		-
Surface Treatment		-
Estimated Amount		
Accessibility		
Risk Score		12

Recommendation	Inspection Required
Notes	Electrical distribution equipment is live and could not be inspected for safety reasons.

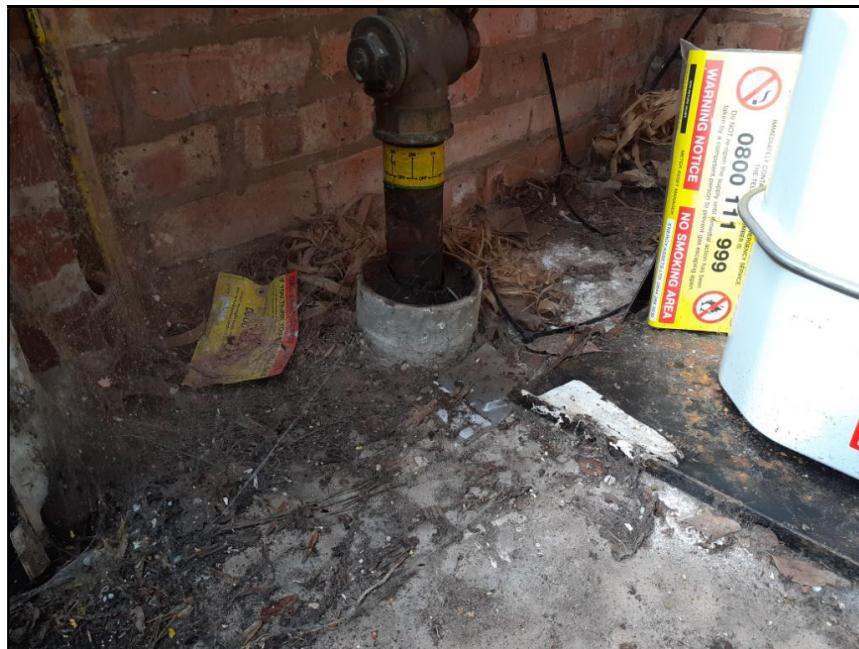
Description Pipe sleeve.

Score
Asbestos Type	AMOSITE, CHRYSOTILE	2
Product Type	Cement Products	1
Extent of Damage	Low Damage	1
Surface Treatment	Unsealed cement / Enclosed lagging or spray / Encapsulated board	1
Estimated Amount	1 Item	
Accessibility	Easily Disturbed	
Risk Score		5

Recommendation	Encapsulate, Repair and Manage
Notes	Pipe sleeve to gas meter store by main entrance.

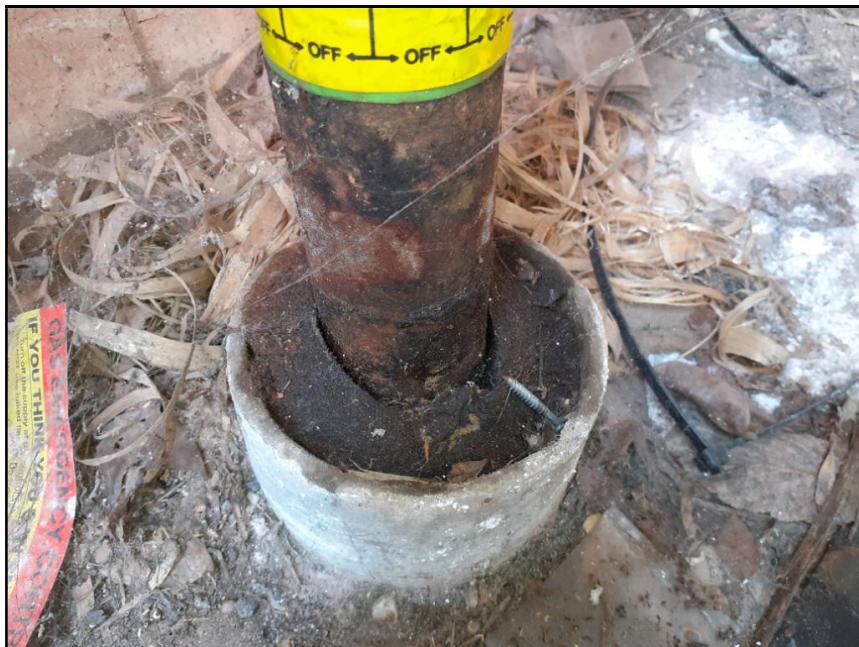
Description Putty within pipe sleeve .

Score
Asbestos Type	NO ASBESTOS DETECTED	-
Product Type	Putty	-
Extent of Damage	Low Damage	-
Surface Treatment	Composite, reinforced or bonded	-
Estimated Amount	Unknown	
Accessibility	Easily Disturbed	
Risk Score		0

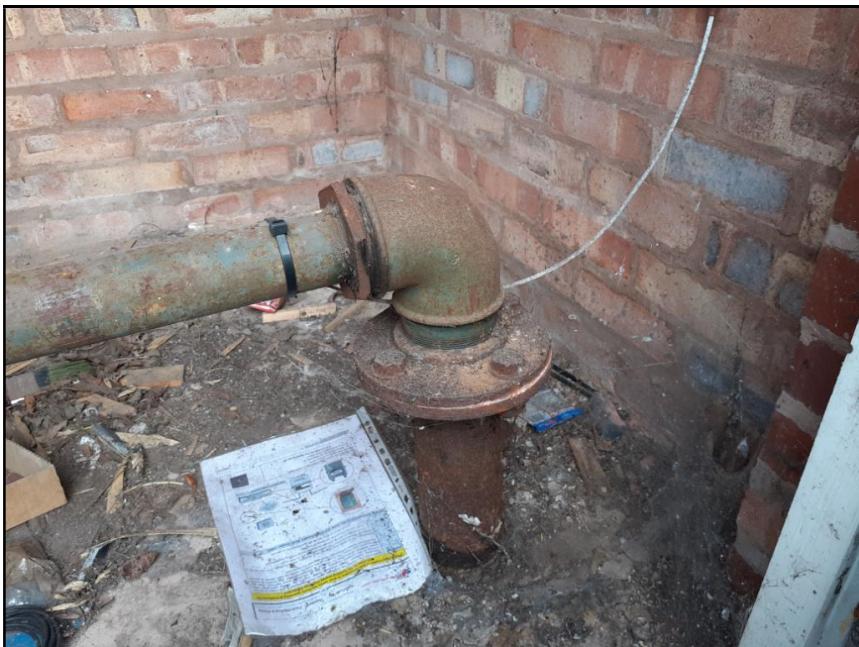
Description Gasket.

Score
Asbestos Type	CHRYSOTILE	1
Product Type	Gaskets	1
Extent of Damage	Low Damage	1
Surface Treatment	Composite, reinforced or bonded	0
Estimated Amount	1 Item	
Accessibility	Usually Inaccessible	
Risk Score		3

Recommendation	Manage & Re-inspect
Notes	Gasket to flange in gas cupboard near to main entrance.

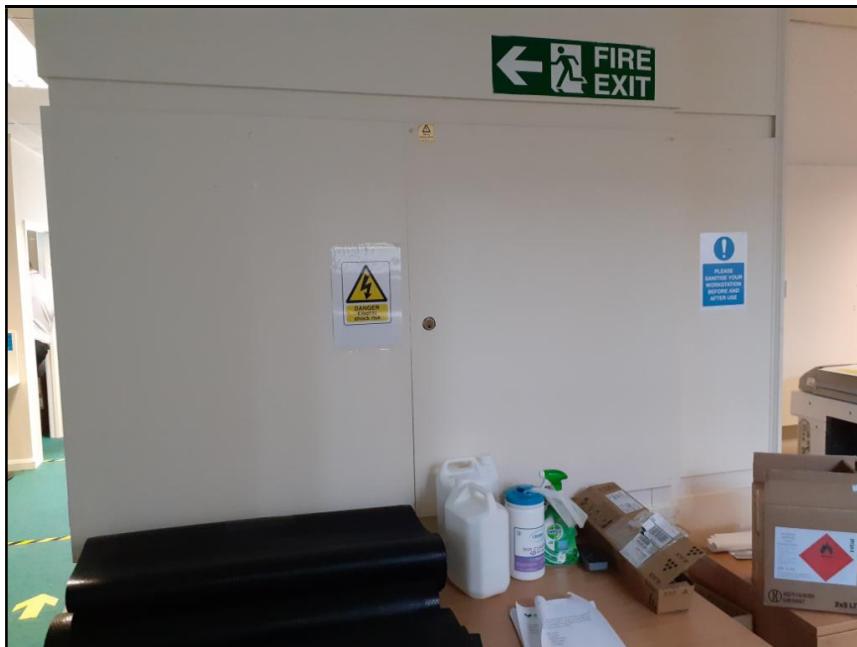
Description Electrical distribution equipment .

Score
Asbestos Type	Presumed Asbestos	-
Product Type		-
Extent of Damage		-
Surface Treatment		-
Estimated Amount		
Accessibility		
Risk Score		12

Recommendation	Inspection Required
Notes	Electrical distribution equipment cannot be inspected for safety reasons as they are live.

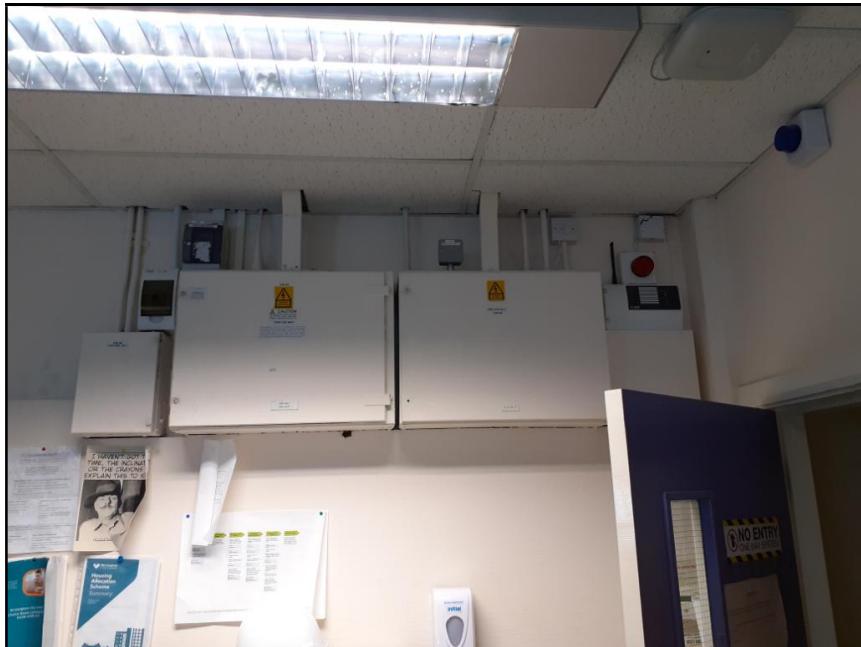
Description Electrical distribution equipment .

Score
Asbestos Type	Presumed Asbestos	-
Product Type		-
Extent of Damage		-
Surface Treatment		-
Estimated Amount		
Accessibility		
Risk Score		12

Recommendation	Inspection Required
Notes	Electrical distribution equipment cannot be inspected for safety reasons as they are live.

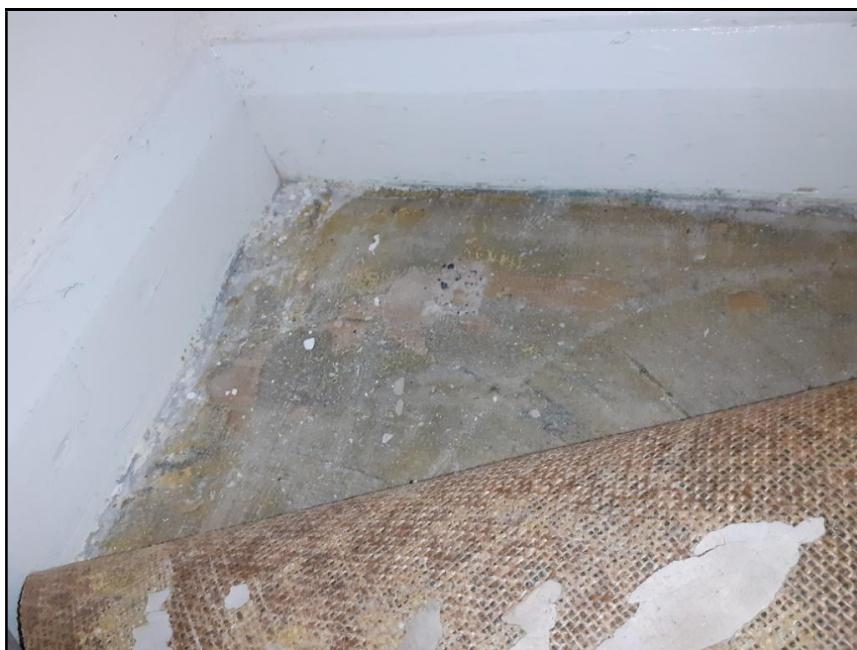
Description Floor tiles and adhesive .

Score
Asbestos Type	CHRYSTAL (CHRYSTAL IN TILE AND ADHESIVE)	1
Product Type	Floor Tiles & Adhesive	1
Extent of Damage	Low Damage	1
Surface Treatment	Composite, reinforced or bonded	0
Estimated Amount	Unknown	
Accessibility	Usually Inaccessible	
Risk Score		3

Recommendation	Manage & Re-inspect
Notes	Floor tiles and adhesive found beneath the screed. Found to the floor area near the disabled toilet and corner office.

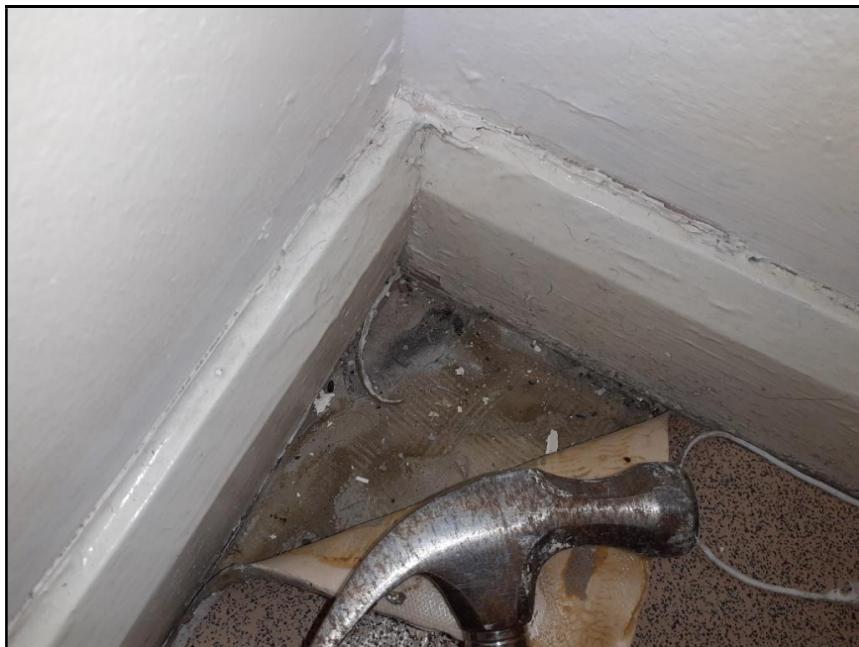
Description Floor beneath vinyl .

Score
Asbestos Type	CHRYSOTILE	1
Product Type	Bitumen Products	1
Extent of Damage	Low Damage	1
Surface Treatment	Composite, reinforced or bonded	0
Estimated Amount	8 m ²	
Accessibility	Usually Inaccessible	
Risk Score		3

Recommendation	Manage & Re-inspect
Notes	Multiple layers of screed and bituminous adhesive.

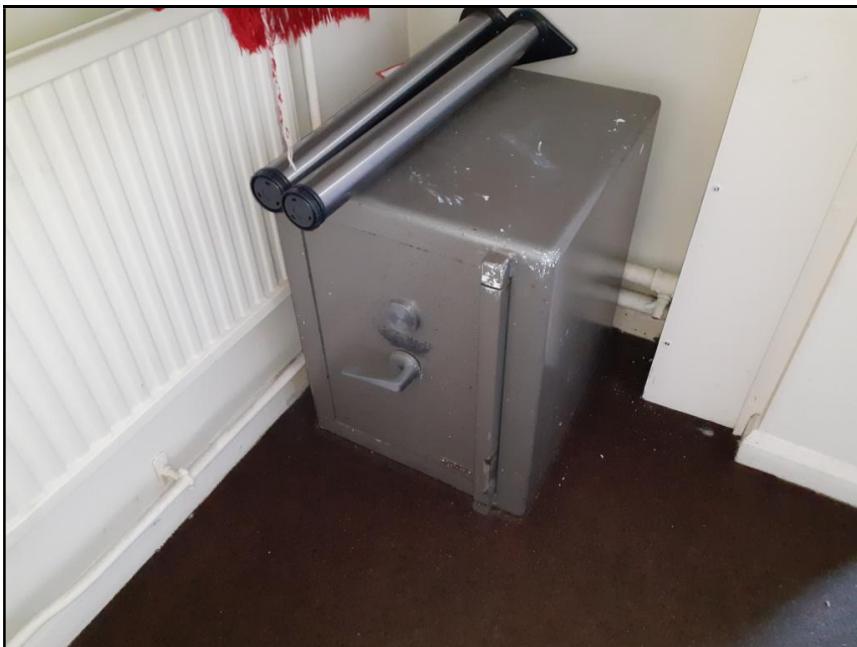
Description Safe.

Score
Asbestos Type	Presumed Asbestos	-
Product Type		-
Extent of Damage		-
Surface Treatment		-
Estimated Amount		
Accessibility		
Risk Score		12

Recommendation	Inspection Required
Notes	Unable to inspect due to damage limitation. Safe linings have been found to contain asbestos materials.

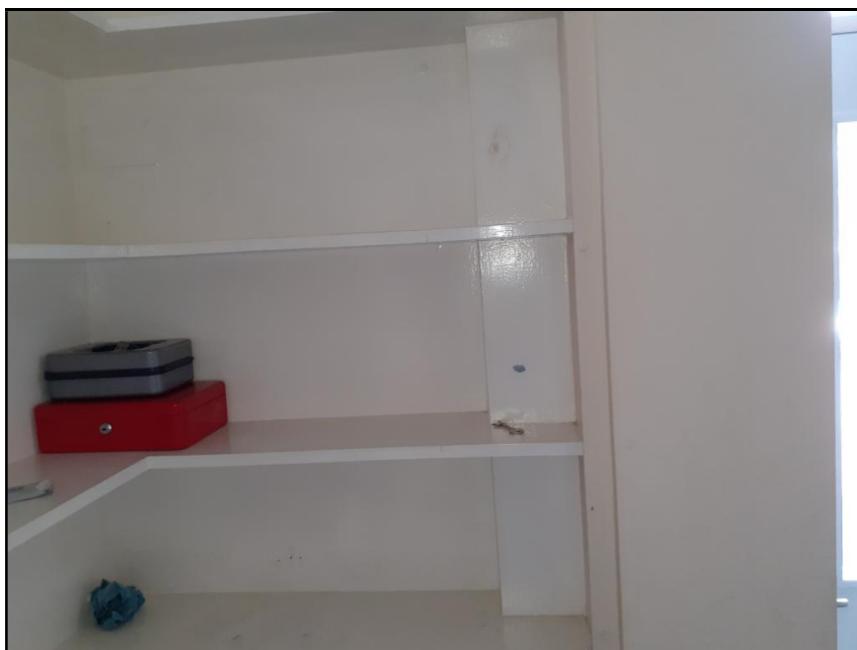
Description Boxing within shelving unit.

Score
Asbestos Type	AMOSITE, CHRYSOTILE	2
Product Type	Board	2
Extent of Damage	Low Damage	1
Surface Treatment	Unsealed cement / Enclosed lagging or spray / Encapsulated board	1
Estimated Amount	1 L/M	
Accessibility	Easily Disturbed	
Risk Score		6

Recommendation	Manage & Re-inspect
Notes	Low density board boxing within the shelving.

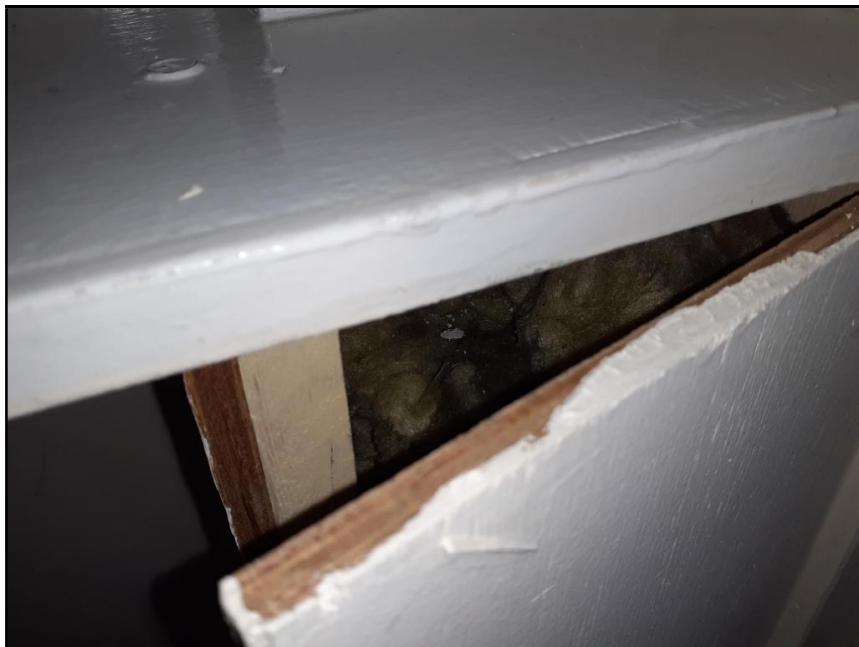
Building	Floor	Location/ Room	Position	Item	Sample No.	Inspection Ref	Risk Score
Main Building	0	003 - Circulation 004	Debris within boxing	Debris	S006	556721	10

Description Debris within boxing.

Score
Asbestos Type	AMOSITE, CHRYSOTILE	2
Product Type	Debris	3
Extent of Damage	High Damage	3
Surface Treatment	Unsealed board or cloth / Encapsulated lagging or spray	2
Estimated Amount	Unknown	
Accessibility	Usually Inaccessible	
Risk Score		10

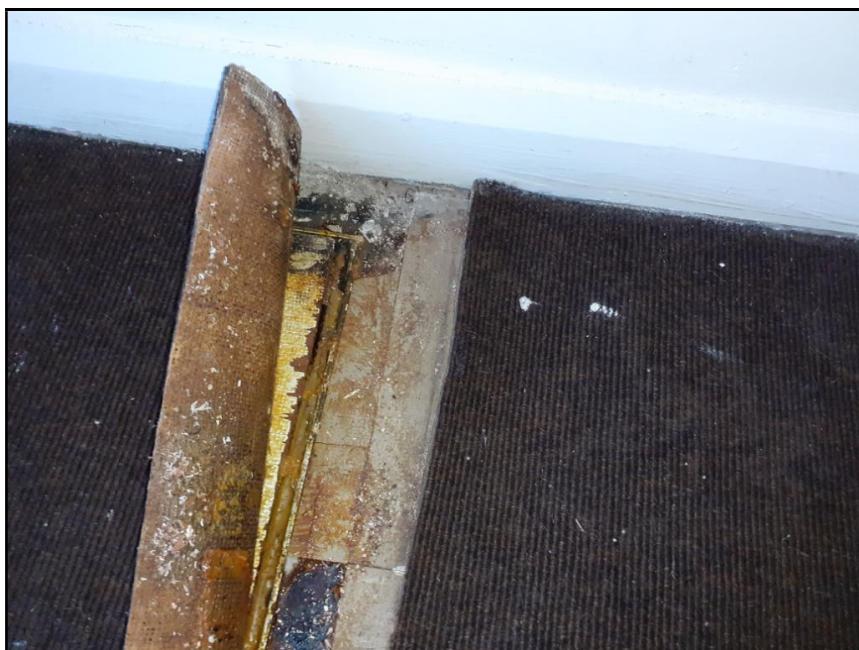
Description Floor tiles and adhesive .

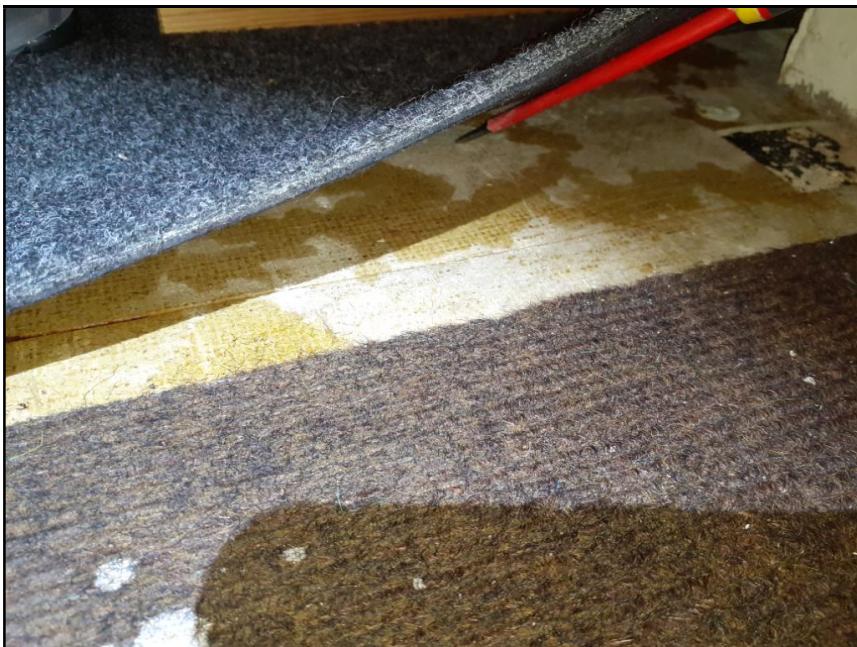
Description Floor tiles and adhesive . Visually consistent with Sample 8.

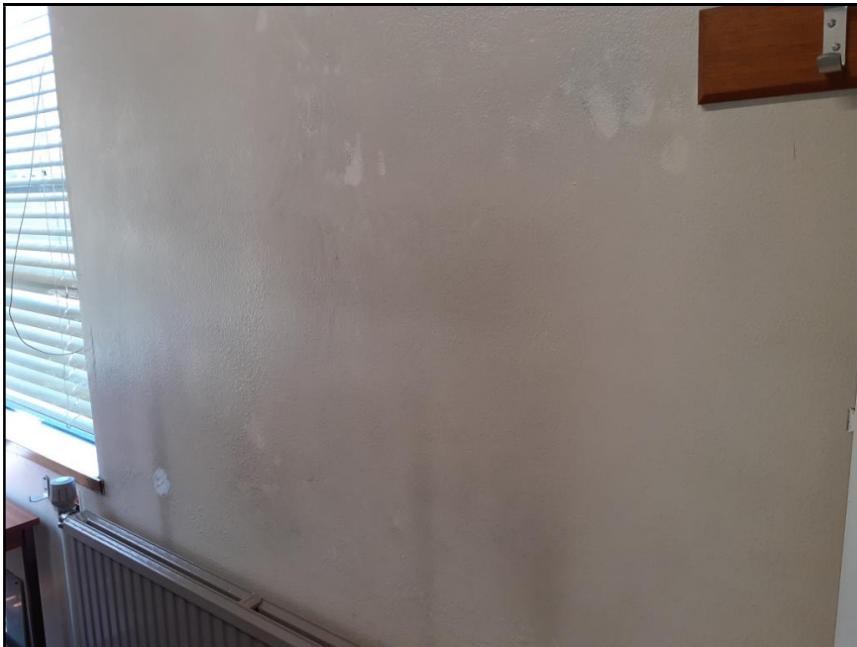
Description Textured coating to walls .

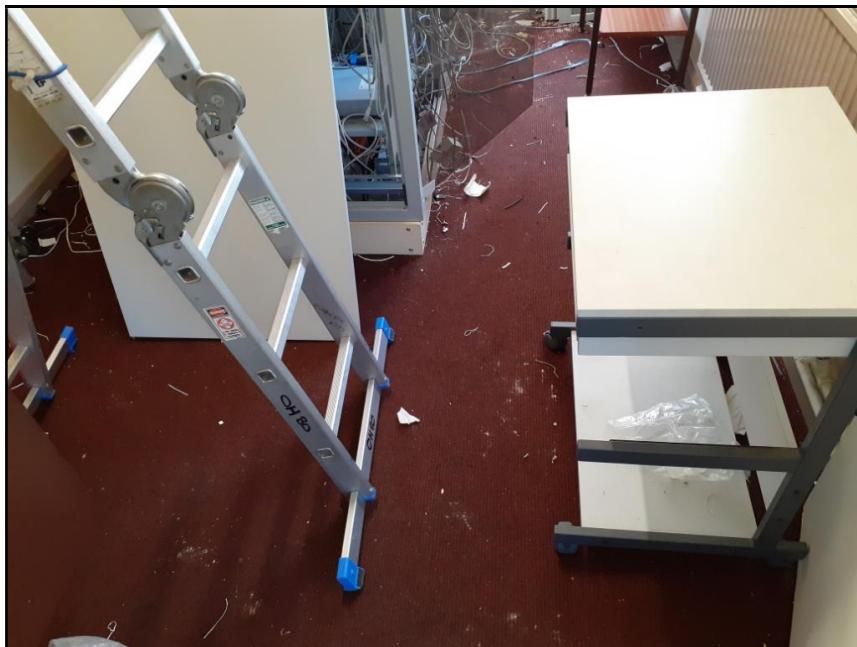
Description Floor tiles and adhesive . Visually consistent with Sample 8.

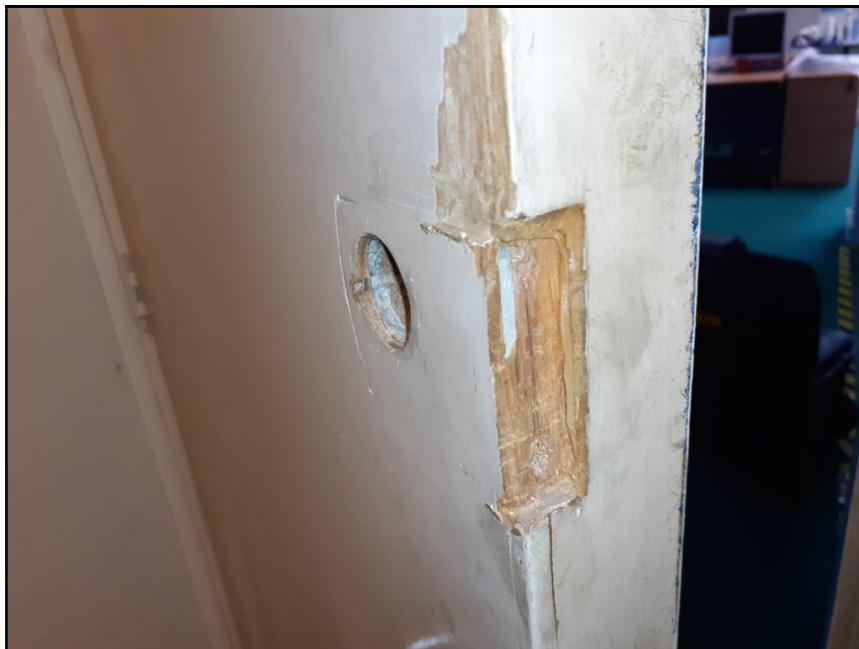
Description Fire door.

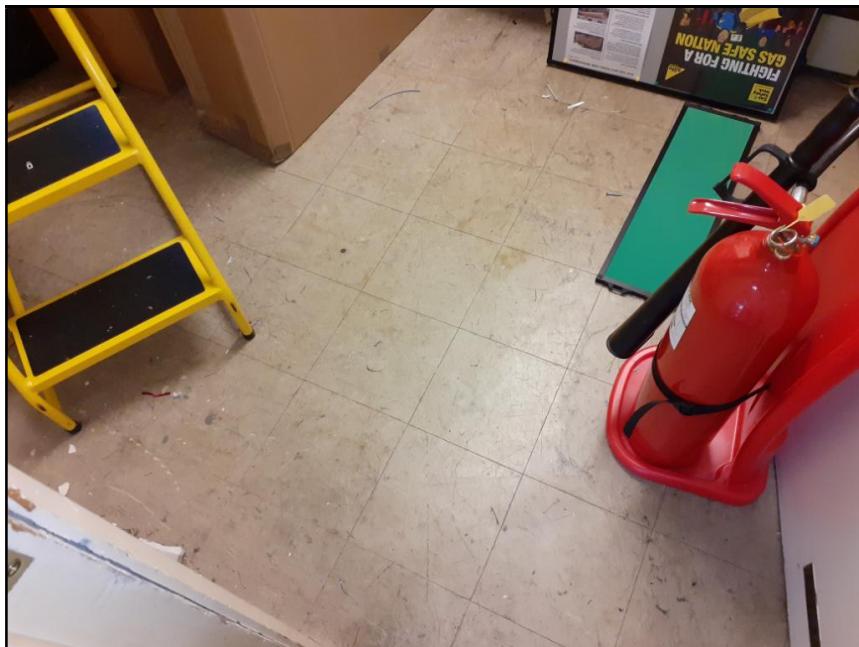
Description Floor tiles and adhesive . Visually consistent with Sample 8.

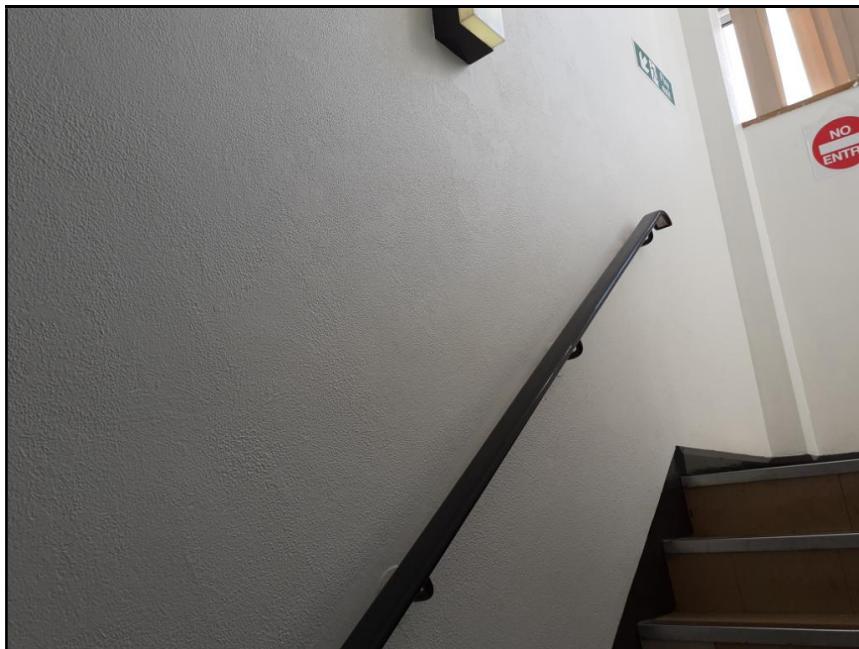
Description Textured coating to walls .

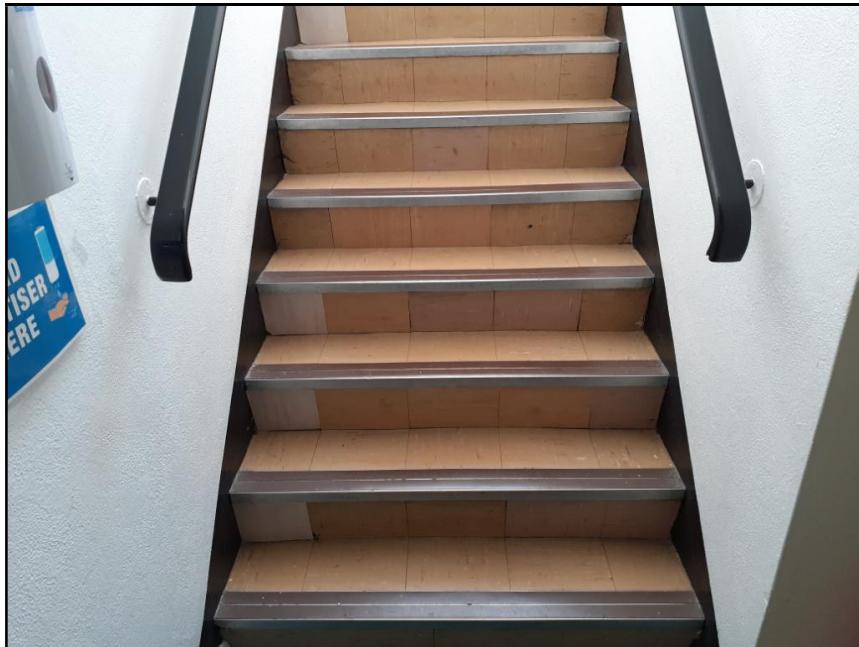
Description Floor tiles and adhesive .

Recommendation	Manage & Re-inspect
Notes

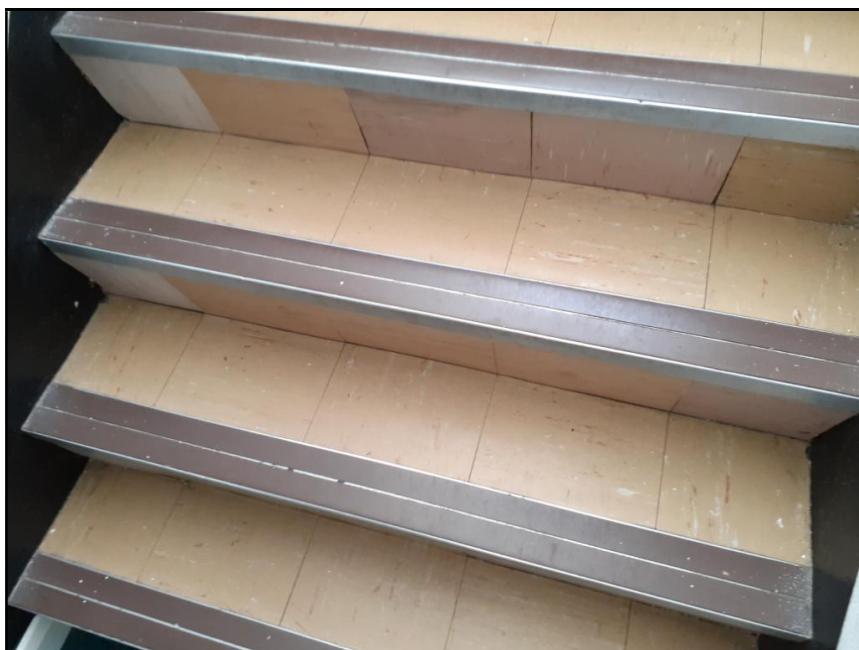
Description Stair nosing strips .

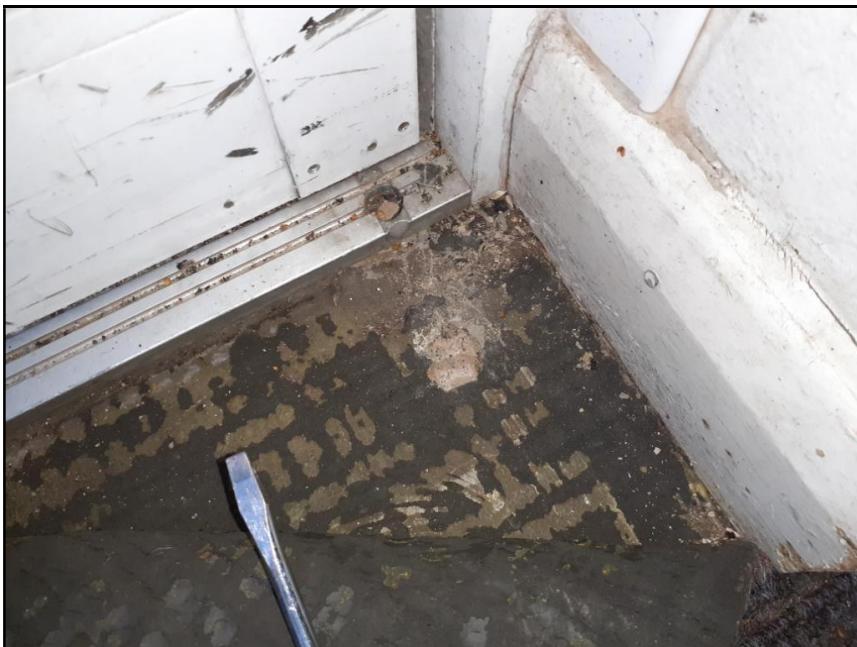
Description Floor beneath carpet . Visually consistent with Sample 4.

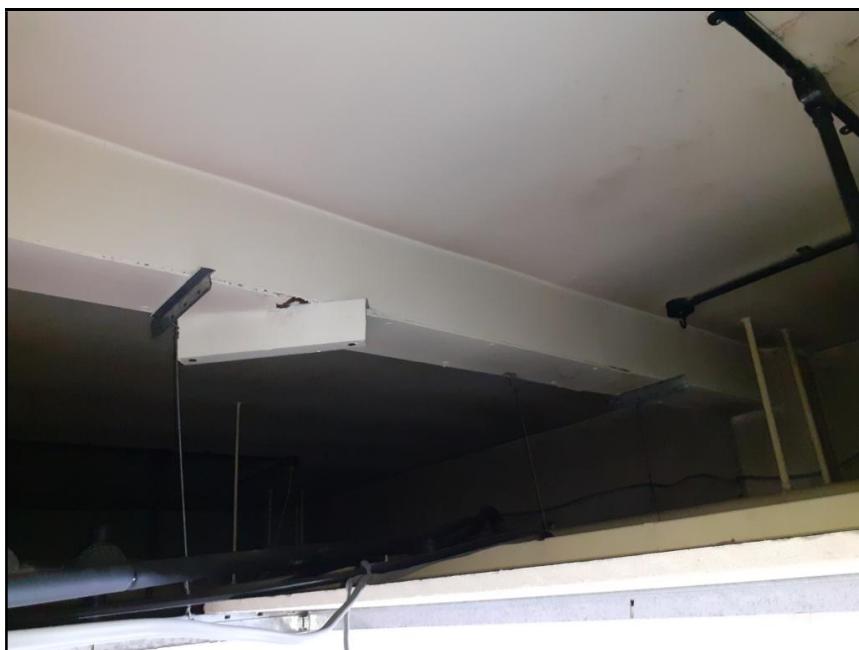
Description Boxing within the ceiling void.

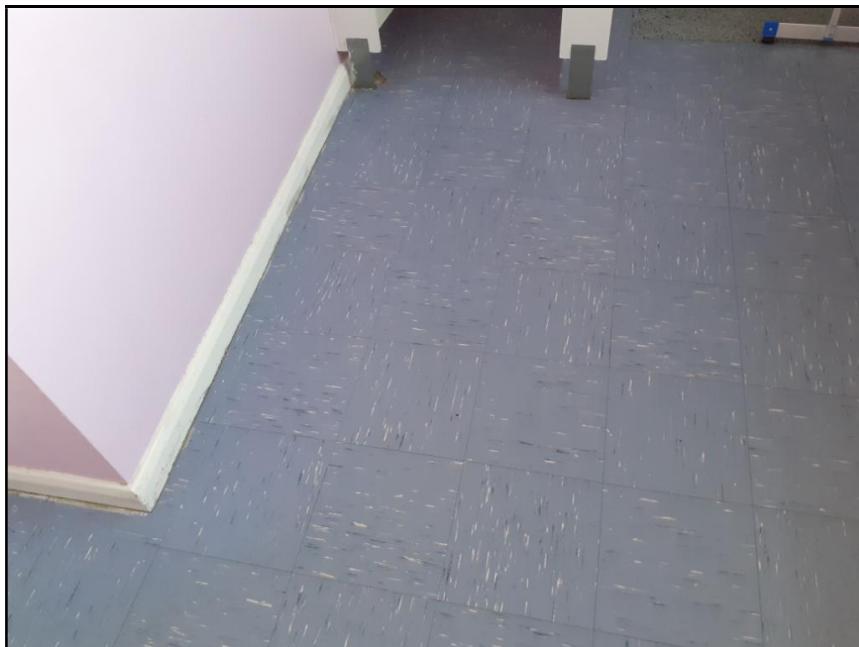
Description Floor tiles and adhesive .

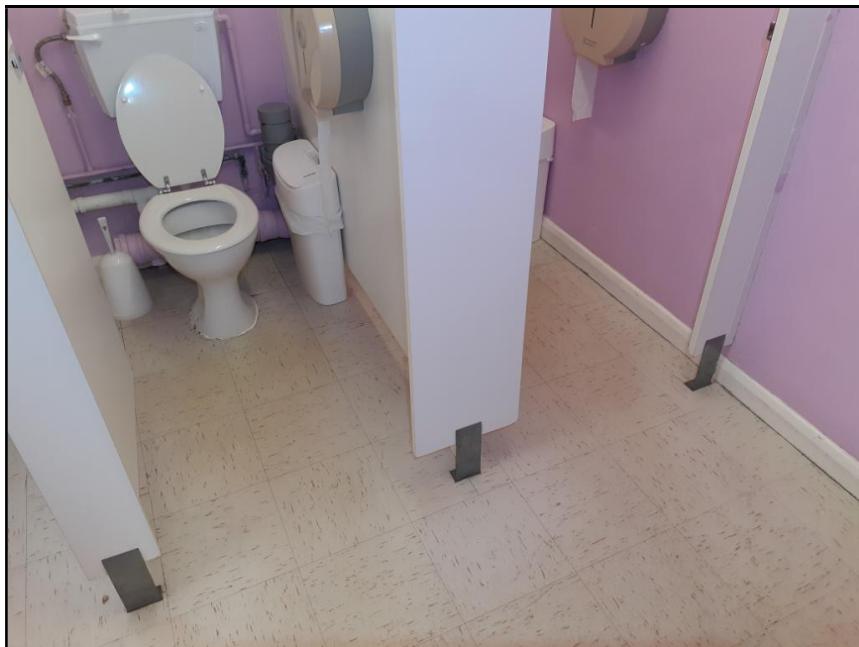
Description Floor tiles and adhesive . Visually consistent with Sample 8.

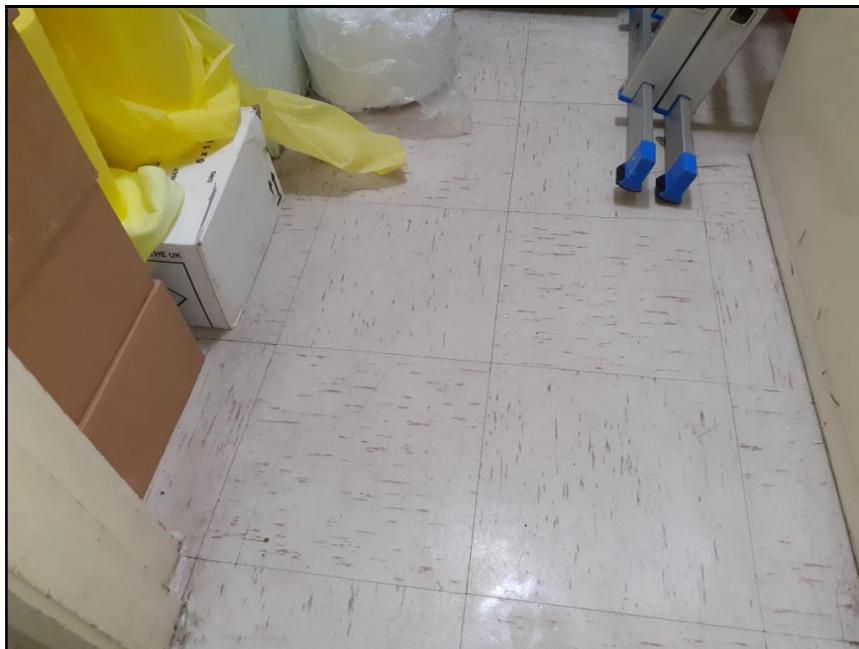
Description Floor tiles and adhesive . Visually consistent with Sample 8.

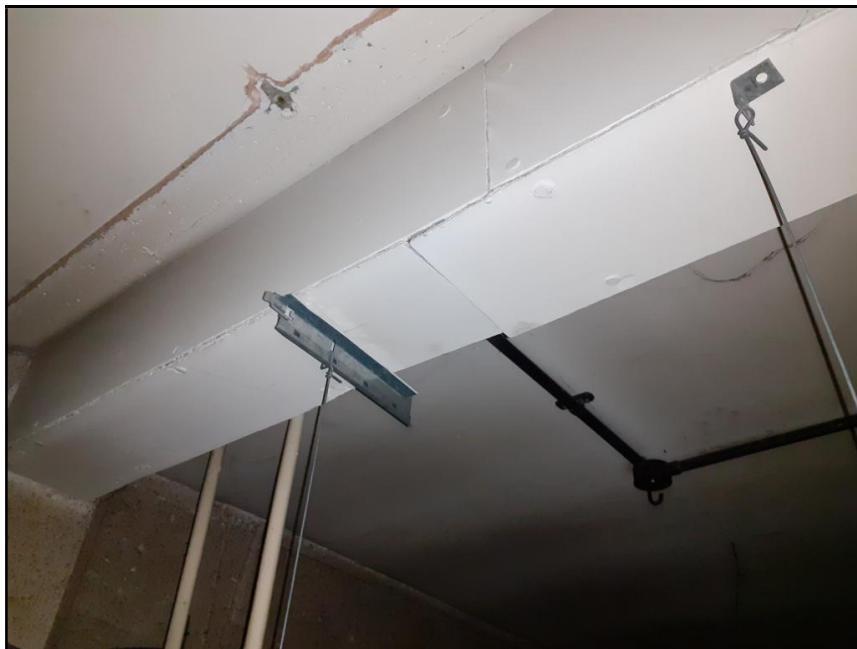
Description Boxing within the ceiling void. . Visually consistent with Sample 13.

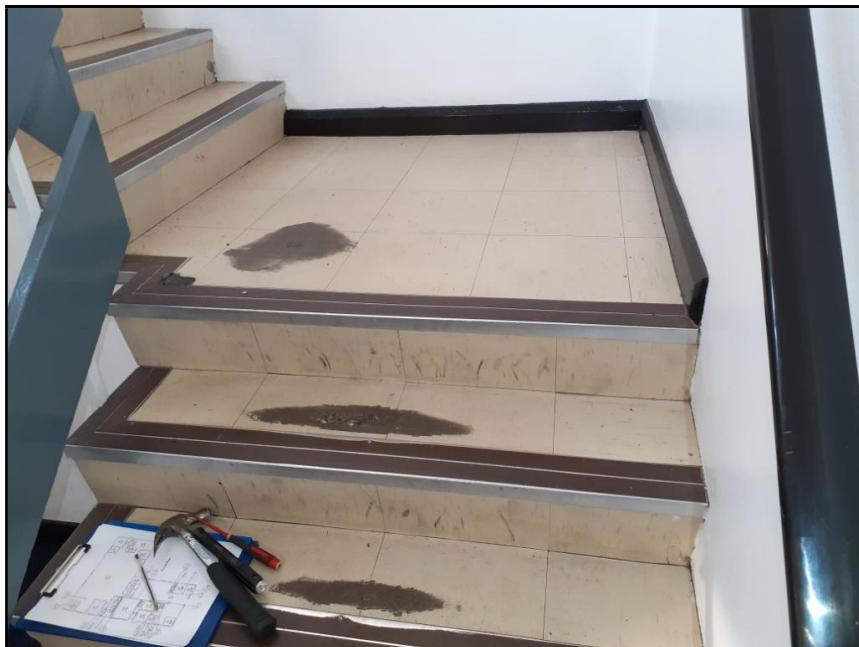
Description Floor tiles and adhesive . Visually consistent with Sample 8.

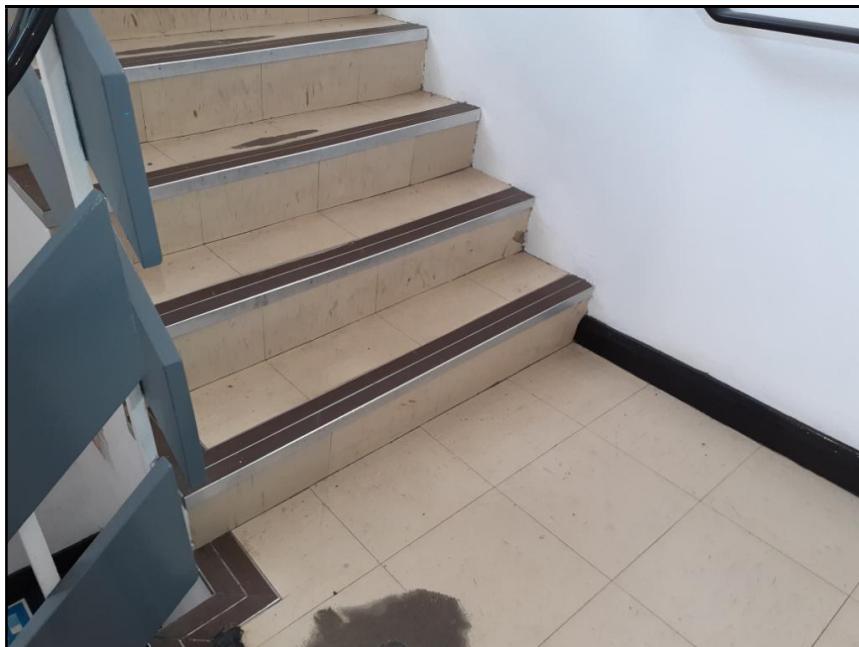
Description Stair nosing strips . Visually consistent with Sample 12.

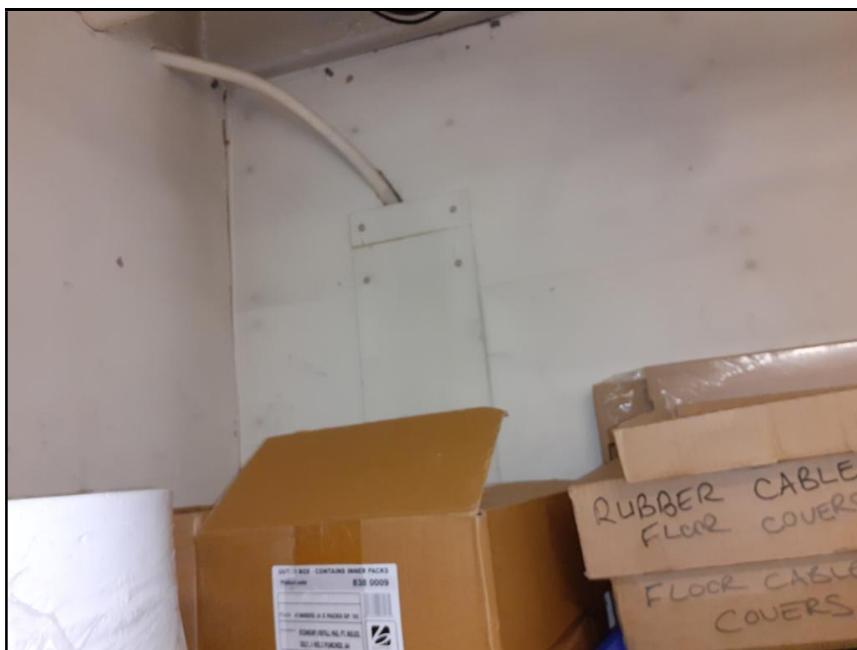
Description Wall void behind wooden boxing.

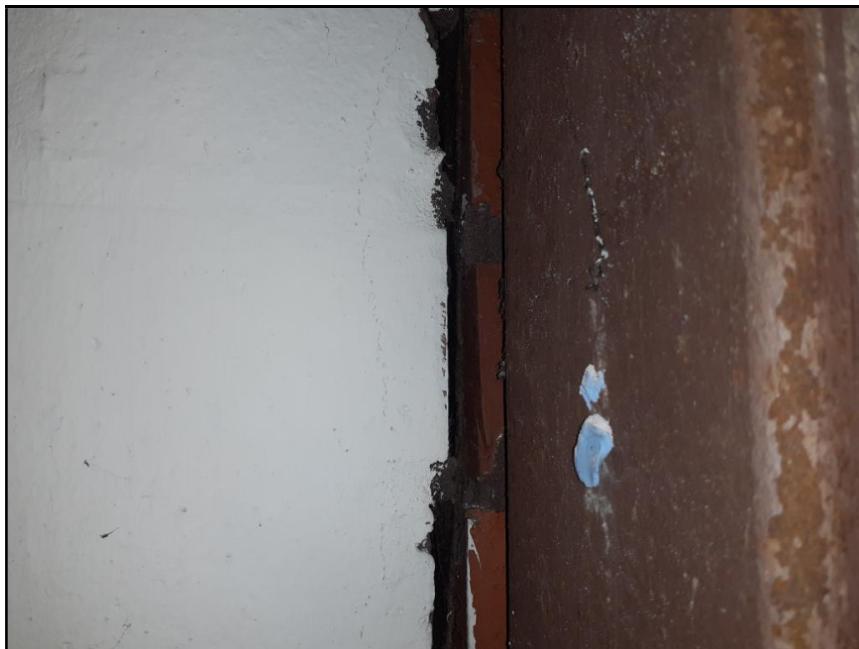
Description Damp proof membrane surrounding windows. .

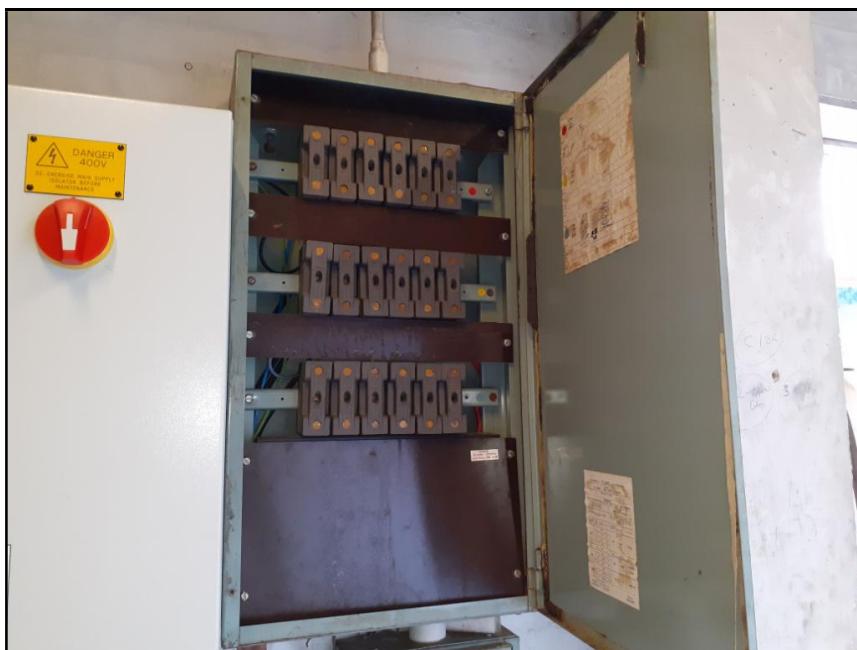
Description Electrical distribution equipment .

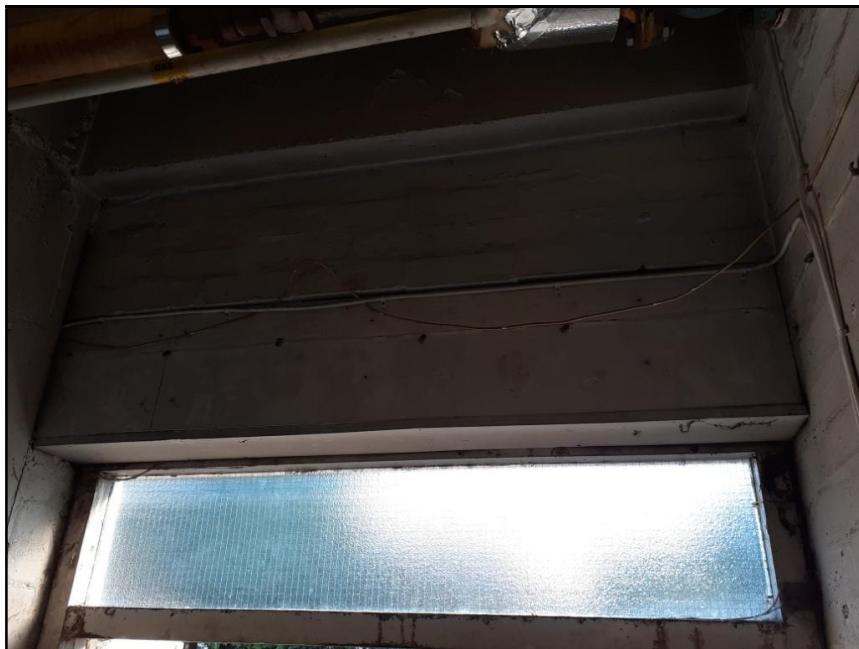
Description Behind boxing .

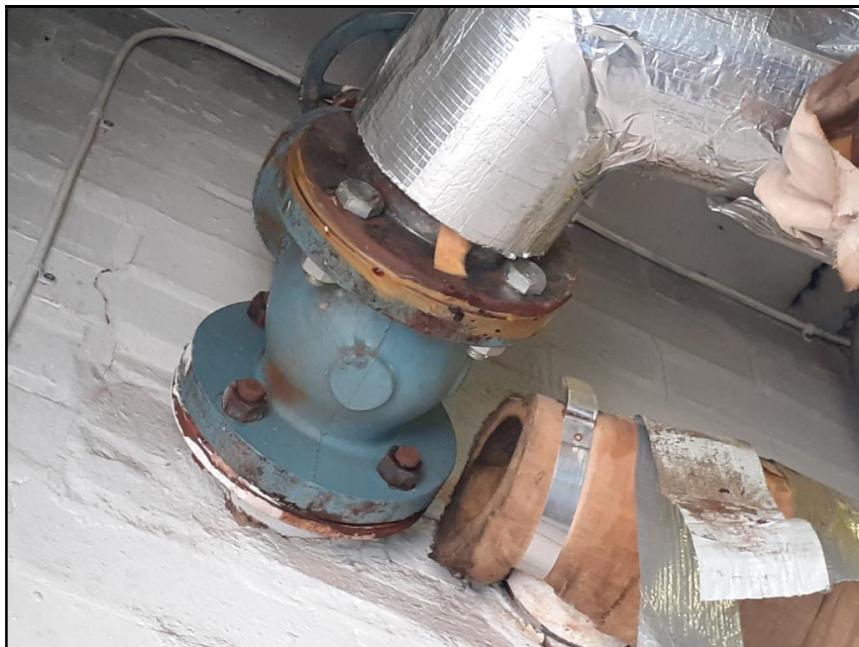
Description Gaskets .

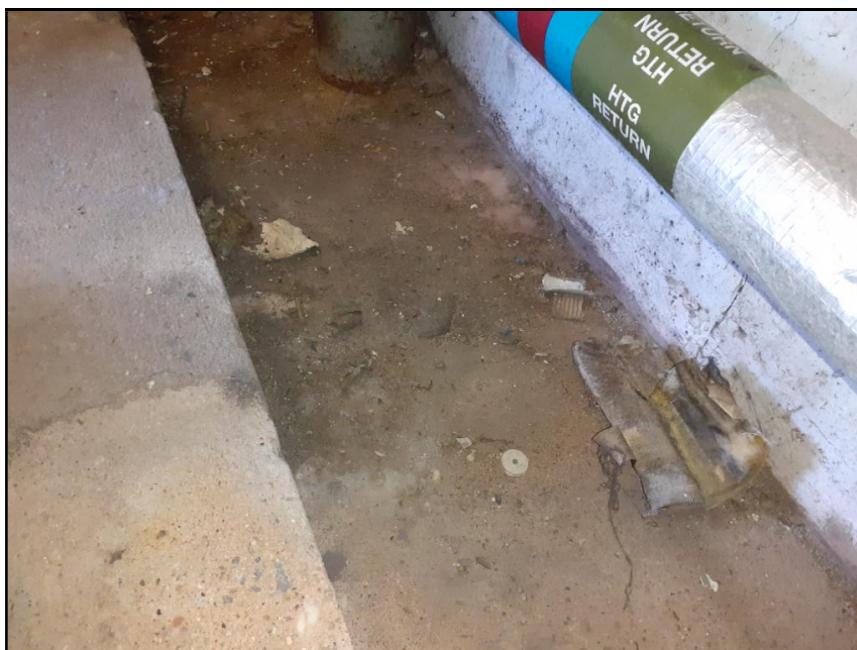
Description Debris to floor .

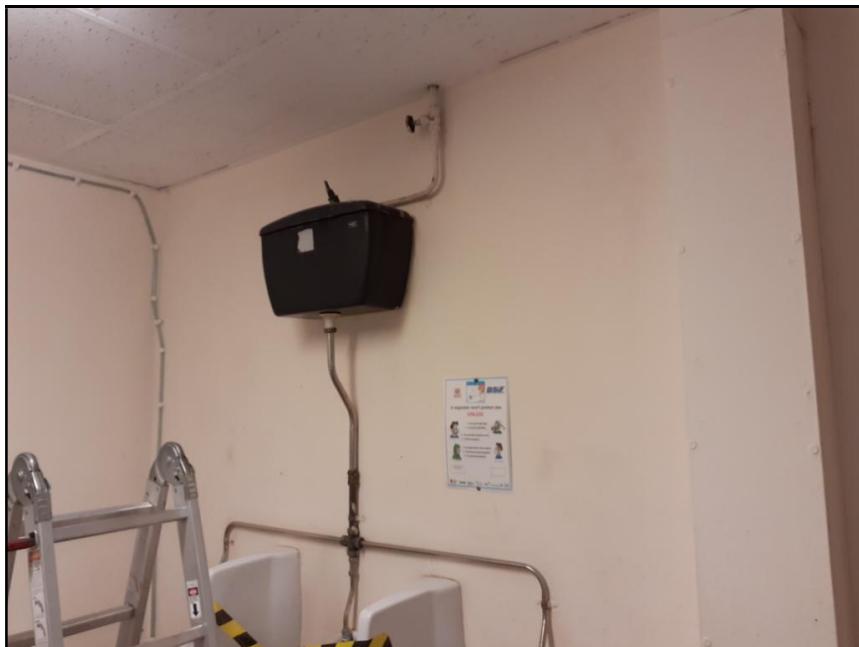
Description Toilet cistern .

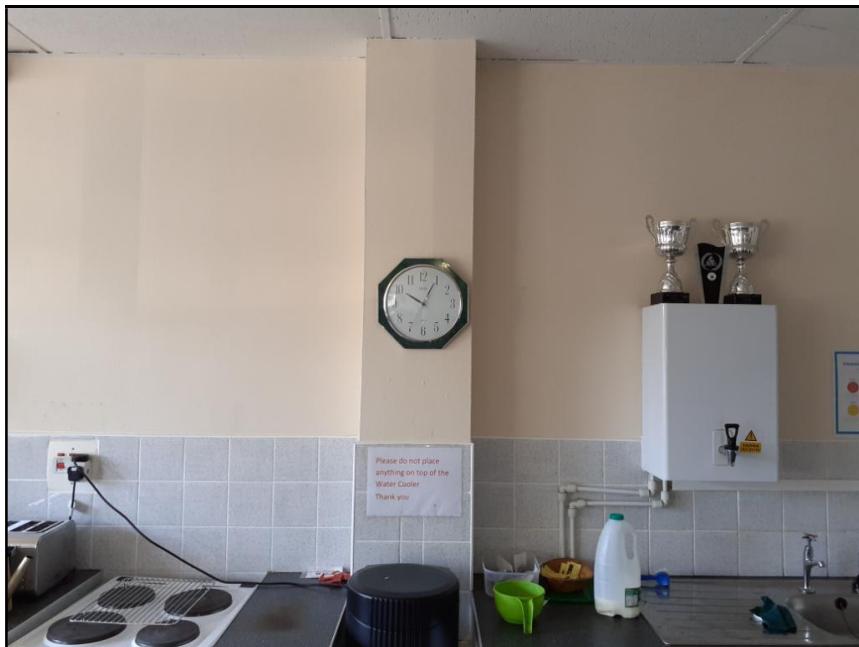
Description Behind boxing .

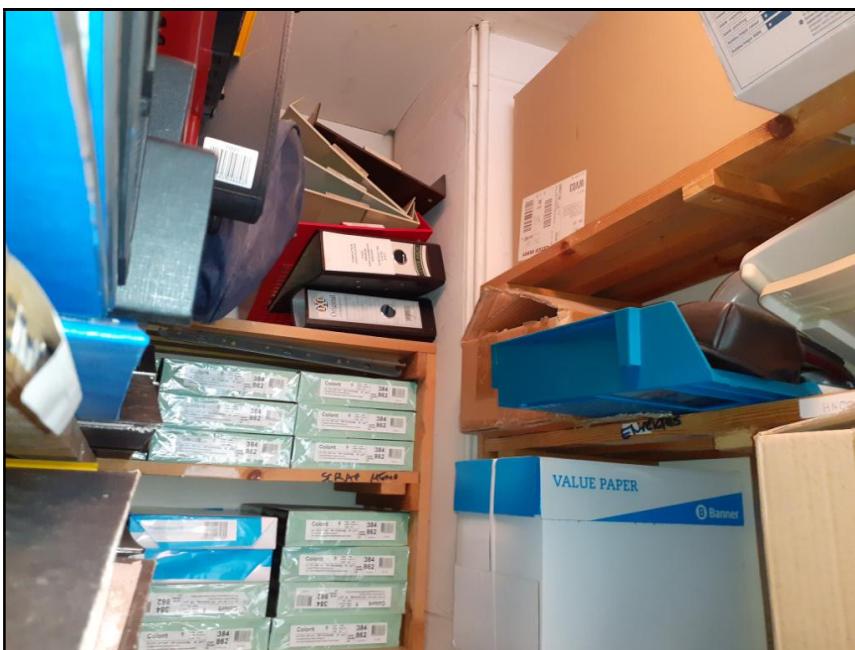
Description Inside boxing .
