Asbestos Management Survey

College Road Depot, B44 0AY

Report No	D-05899	Report Issue Date	22 October 2020
Client Name & Address	Asset Management & Maintenance Division Mole Street Centre Mole Street Sparkbrook Birmingham B11 1XA	Site Address	College Road Depot, 599-603 College Road, Kingstanding, Birmingham, B44 0AY
Order Placed By	John Flaherty	Instruction Date	17 January 2020
Order Number	RHM01 JRRR A00	Project Reference	-
Survey Date(s)	22 September 2020	Lead Surveyor	Nazir Korimbocus

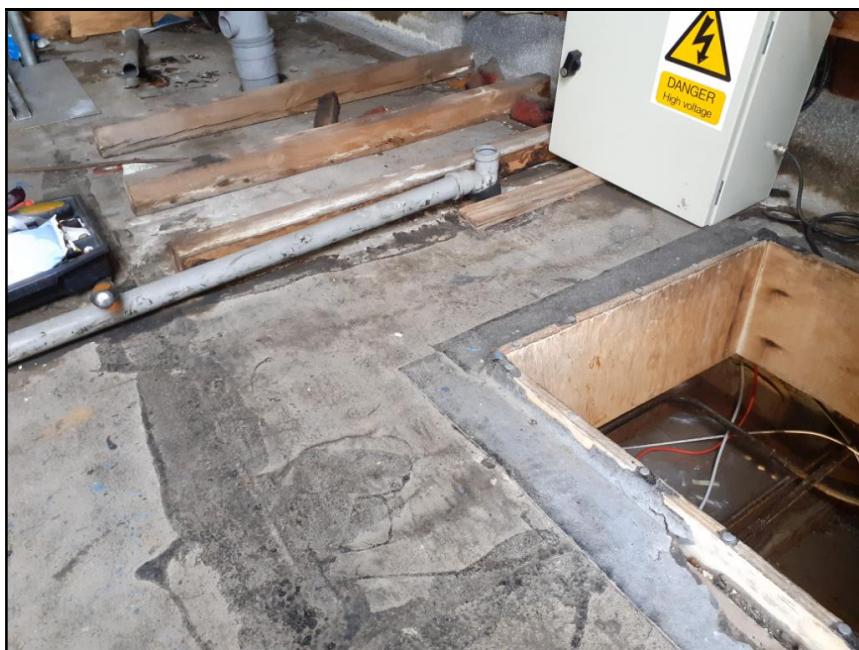
Description Felt membrane to floor and access hatch.

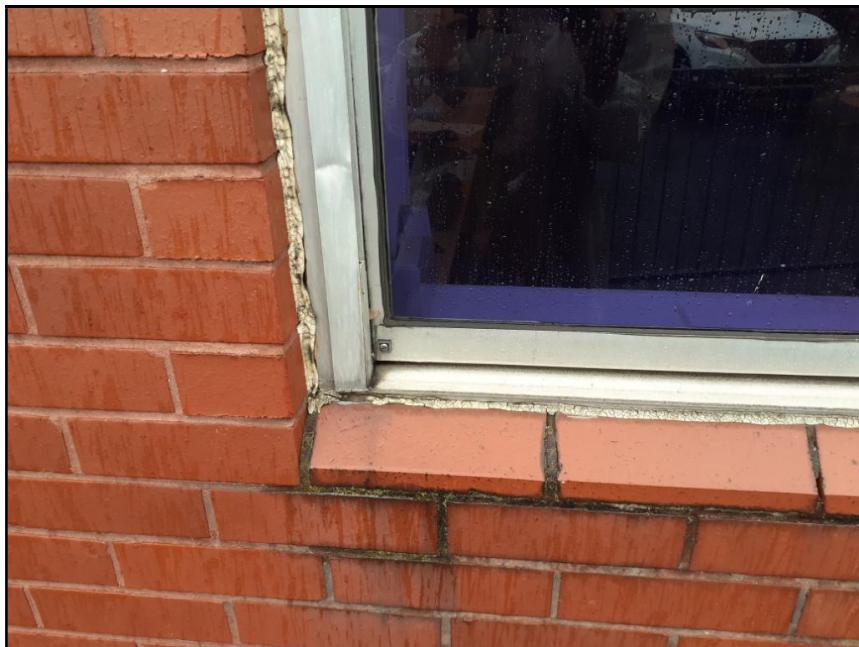
Description Window putty .

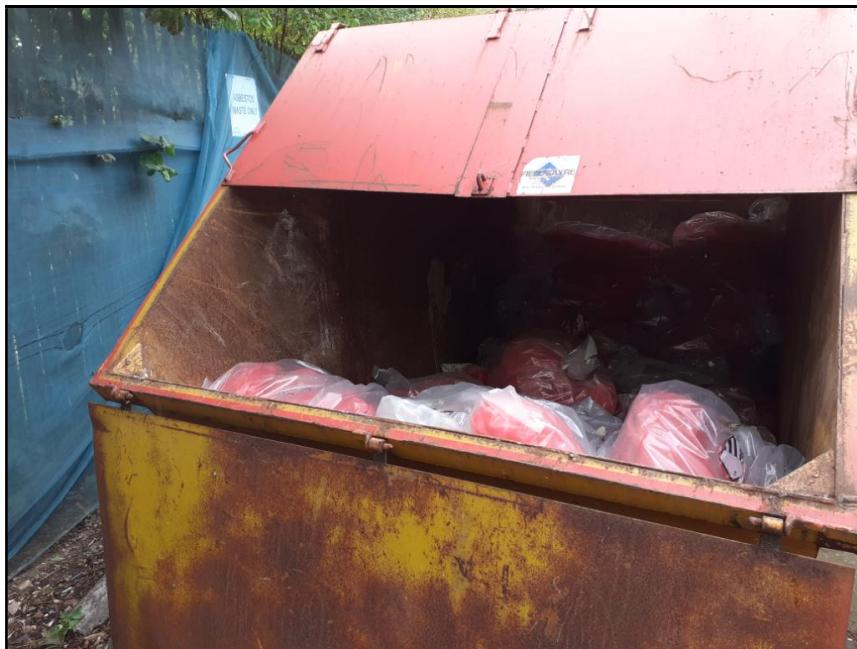
Description Asbestos waste area.

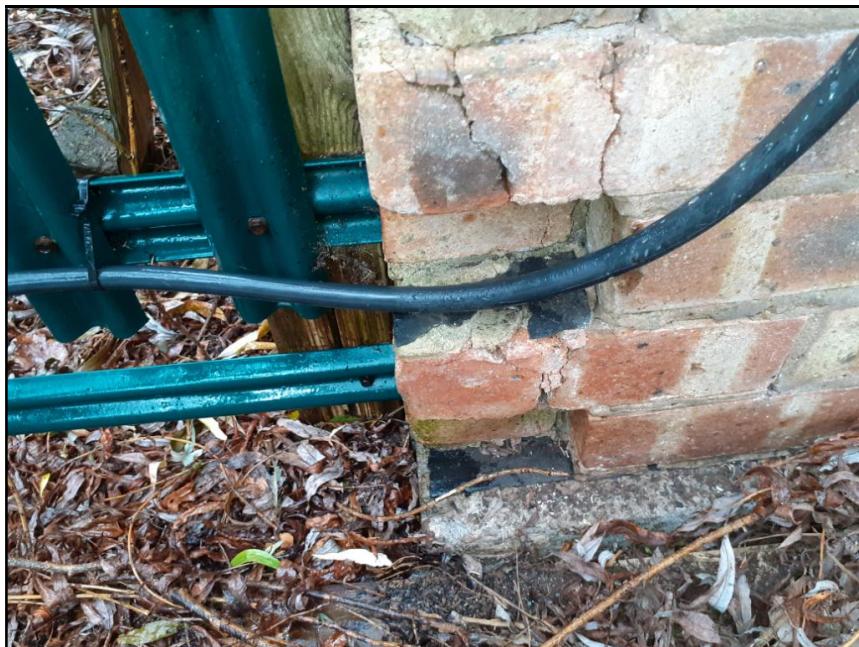
Description Damp proof course .
