Asbestos Targeted Refurbishment Survey

College Road Depot, B44 0AY

Report No	D-08084	Report Issue Date	1 June 2022
Client Name & Address	Central Housing Services North 599 College Road Kingstanding Birmingham B44 0AY	Site Address	College Road Depot, 599-603 College Road, Kingstanding, Birmingham, B44 0AY
Order Placed By	Linda Coleman	Instruction Date	4 May 2022
Order Number	B1-AVON4—EH1-JZZZZZ-TV5EB-JXXX.	Project Reference	-
Survey Date(s)	18 May 2022	Lead Surveyor	P Eaton BSc (Hons)

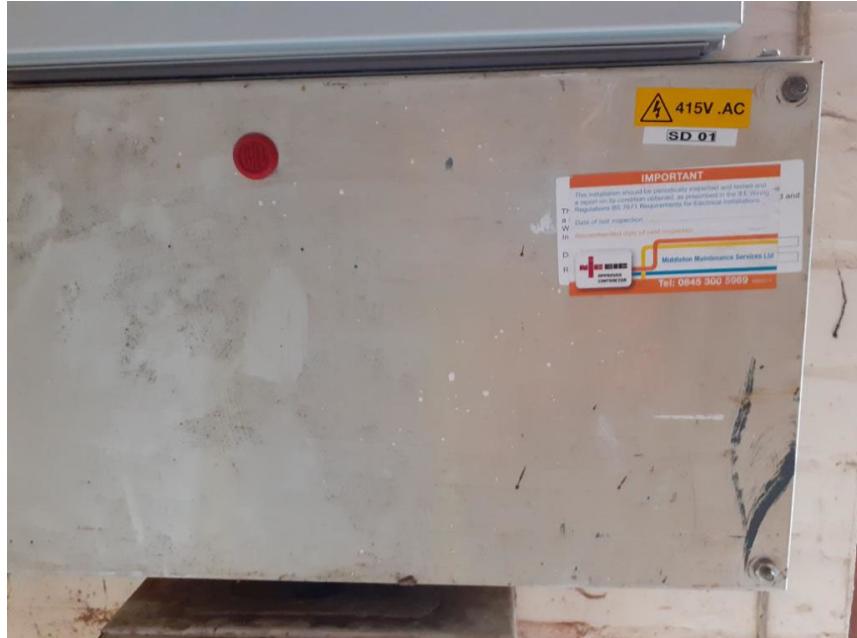
Building	Builders stores
Floor	0
Location / Room	007 - Builders stores 006a
Sample No	P016
Inspection Ref	735739

Description Fuseboard SD01.

Score
Asbestos Type	Presumed Asbestos
Product Type	-
Extent of Damage	-
Surface Treatment	-
Estimated Amount	-
Accessibility	-
Risk Score	12

Recommendation	Inspection Required
Notes	Older electrical equipment must be presumed to have asbestos containing materials present until proven otherwise. No access to live electrical equipment because of the danger of injury or death.

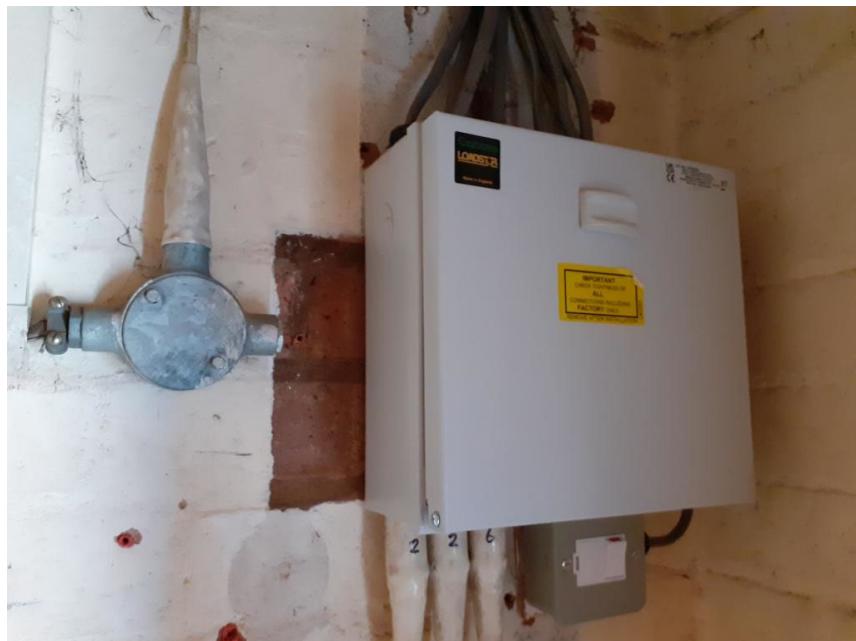
Building	Builders stores
Floor	0
Location / Room	007 - Builders stores 006a
Sample No	P019
Inspection Ref	735747

Description Fuseboard FB014.

Score
Asbestos Type	Presumed Asbestos
Product Type	-
Extent of Damage	-
Surface Treatment	-
Estimated Amount	-
Accessibility	-
Risk Score	12

Recommendation	Inspection Required
Notes	Older electrical equipment must be presumed to have asbestos containing materials present until proven otherwise. No access to live electrical equipment because of the danger of injury or death.

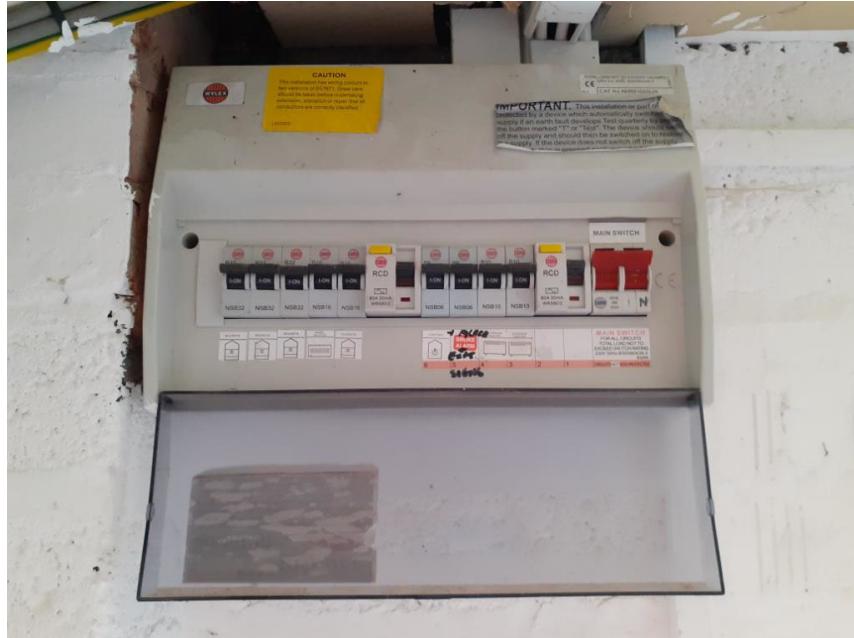
Building	Builders stores
Floor	0
Location / Room	008 - Builders stores 008
Sample No	P017
Inspection Ref	735745

Description Fuseboard FB015.

Score
Asbestos Type	Presumed Asbestos
Product Type	-
Extent of Damage	-
Surface Treatment	-
Estimated Amount	-
Accessibility	-
Risk Score	12

Recommendation	Inspection Required
Notes	Older electrical equipment must be presumed to have asbestos containing materials present until proven otherwise. No access to live electrical equipment because of the danger of injury or death.

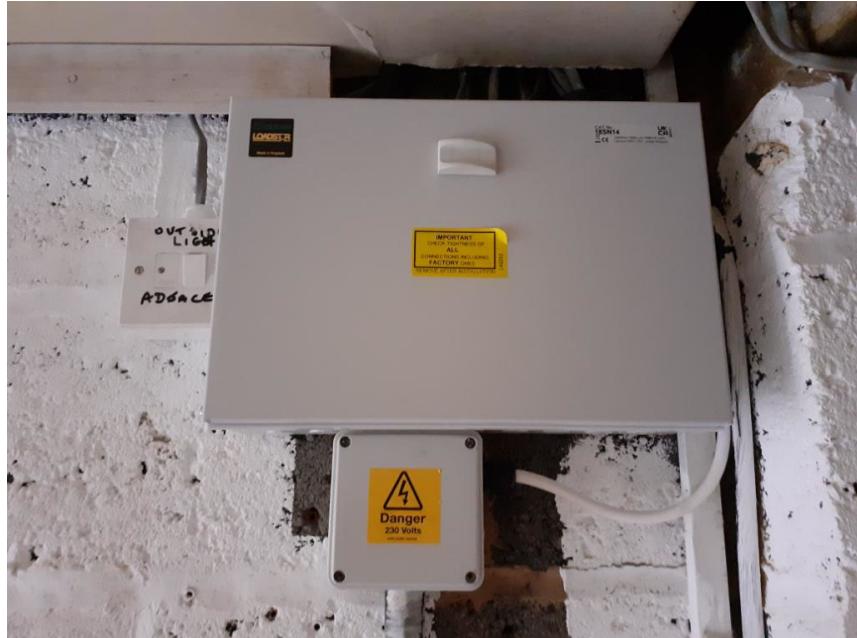
Building	Builders stores
Floor	0
Location / Room	008 - Builders stores 008
Sample No	P018
Inspection Ref	735746

Description Fuseboard FB016.

Score
Asbestos Type	Presumed Asbestos
Product Type	-
Extent of Damage	-
Surface Treatment	-
Estimated Amount	-
Accessibility	-
Risk Score	12

Recommendation	Inspection Required
Notes	Older electrical equipment must be presumed to have asbestos containing materials present until proven otherwise. No access to live electrical equipment because of the danger of injury or death.

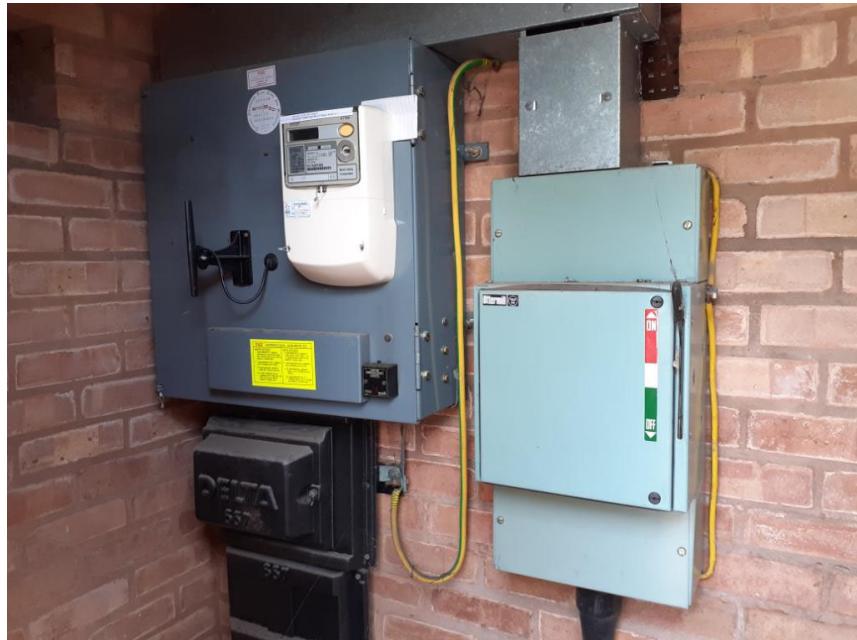
Building	Large outside electrical cupboard
Floor	0
Location / Room	009 - Large outside electrical cupboard
Sample No	P020
Inspection Ref	735754

Description Fuseboard S01.

Score
Asbestos Type	Presumed Asbestos
Product Type	-
Extent of Damage	-
Surface Treatment	-
Estimated Amount	
Accessibility	
Risk Score	12

Recommendation	Inspection Required
Notes	Older electrical equipment must be presumed to have asbestos containing materials present until proven otherwise. No access to live electrical equipment because of the danger of injury or death.

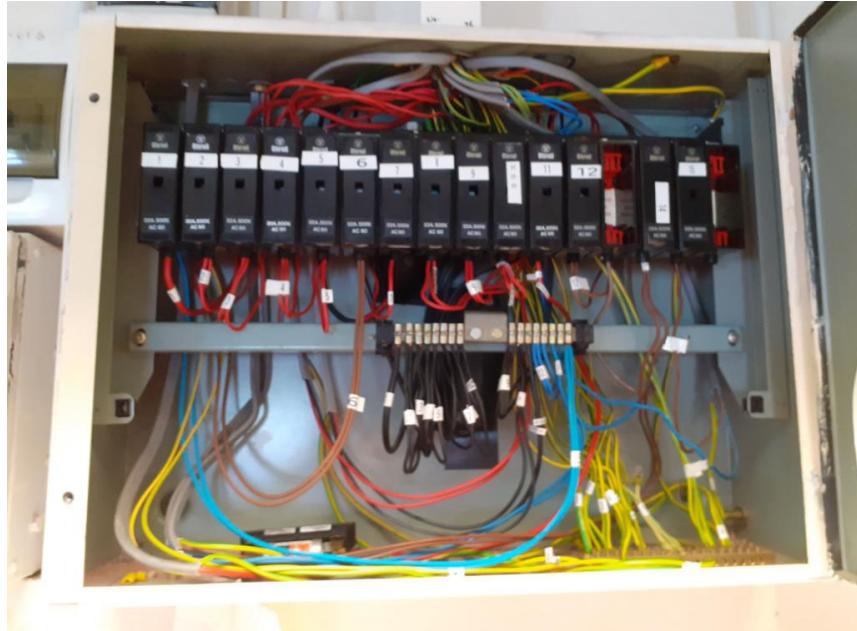
Building	Main building
Floor	0
Location / Room	001 - Office 01
Sample No	P002
Inspection Ref	735259

Description Fuseboard FB2.

Score
Asbestos Type	Presumed Asbestos
Product Type	-
Extent of Damage	-
Surface Treatment	-
Estimated Amount	-
Accessibility	-
Risk Score	12

Recommendation	Inspection Required
Notes	Older electrical equipment must be presumed to have asbestos containing materials present until proven otherwise. No access to live electrical equipment because of the danger of injury or death.

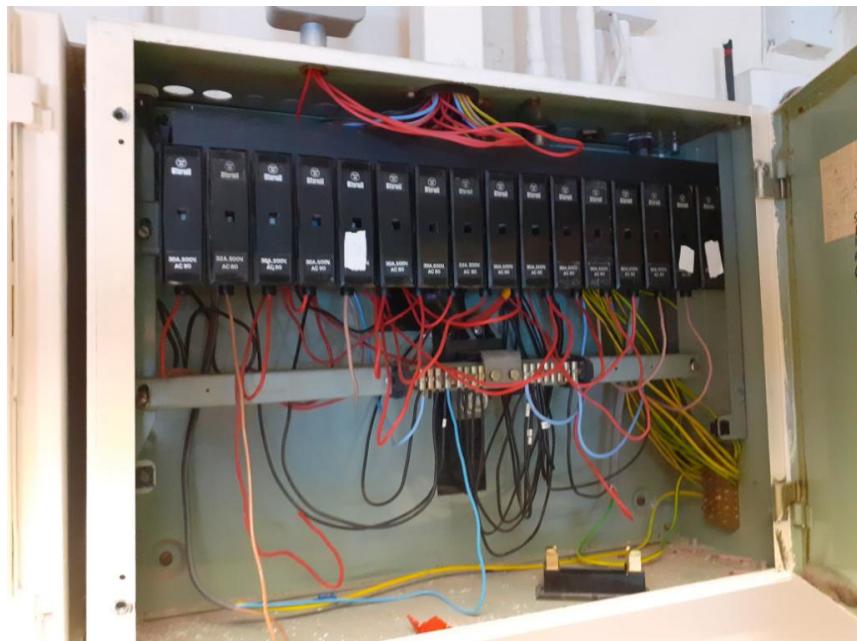
Building	Main building
Floor	0
Location / Room	001 - Office 01
Sample No	P003
Inspection Ref	735260

Description Fuseboard FB3.

Score
Asbestos Type	Presumed Asbestos
Product Type	-
Extent of Damage	-
Surface Treatment	-
Estimated Amount	-
Accessibility	-
Risk Score	12

Recommendation	Inspection Required
Notes	Older electrical equipment must be presumed to have asbestos containing materials present until proven otherwise. No access to live electrical equipment because of the danger of injury or death.

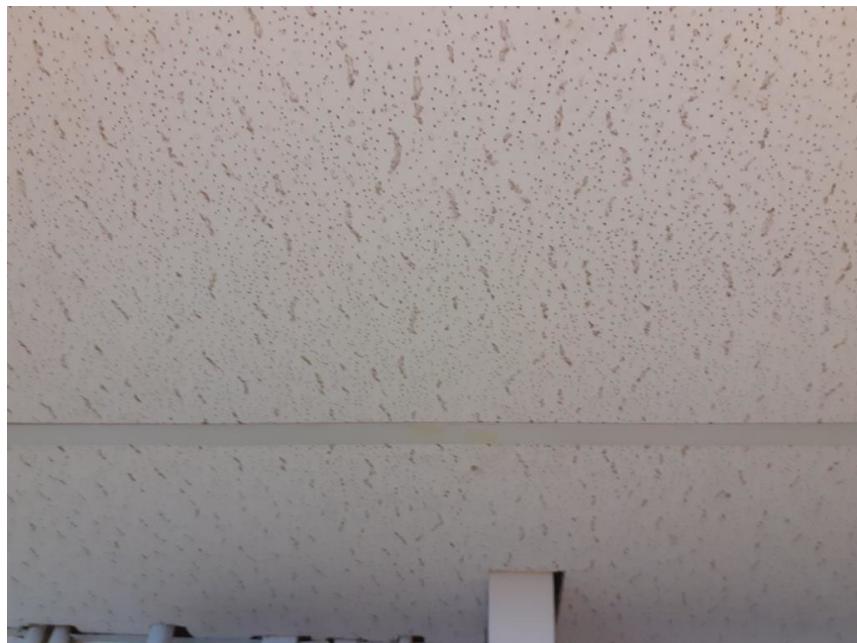
Building	Main building
Floor	0
Location / Room	001 - Office 01
Sample No	S001
Inspection Ref	735258

Description Suspended ceiling tiles.

Score
Asbestos Type	NO ASBESTOS DETECTED	-
Product Type	Board	-
Extent of Damage	Low Damage	-
Surface Treatment	Unsealed cement / Enclosed lagging or spray / Encapsulated board	-
Estimated Amount	100 m ²	
Accessibility	Occasional Disturbance	
Risk Score		0

Recommendation	No Recommendation Required
Notes	Fibrous board suspended ceiling tiles throughout area.

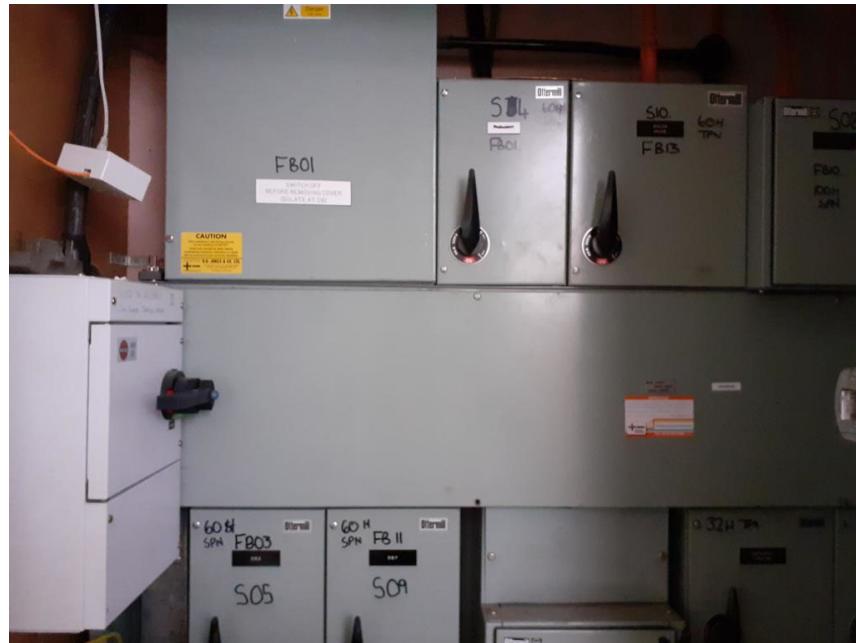
Building	Main building
Floor	0
Location / Room	011 - Main electrical distribution cupboard 01a
Sample No	P023
Inspection Ref	735769

Description Fuseboard MP1.

Score
Asbestos Type	Presumed Asbestos
Product Type	-
Extent of Damage	-
Surface Treatment	-
Estimated Amount	
Accessibility	
Risk Score	12

Recommendation	Inspection Required
Notes	Older electrical equipment must be presumed to have asbestos containing materials present until proven otherwise. No access to live electrical equipment because of the danger of injury or death.

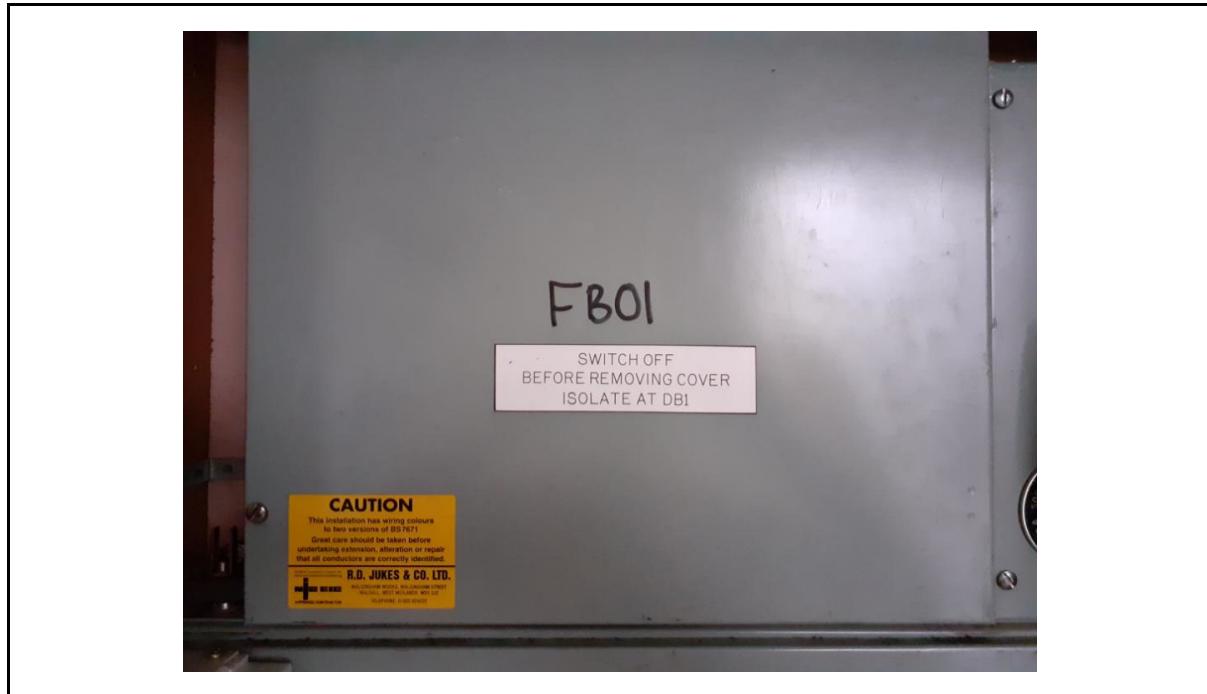
Building	Main building
Floor	0
Location / Room	011 - Main electrical distribution cupboard 01a
Sample No	P024
Inspection Ref	735770

Description Fuseboard FB01.

Score
Asbestos Type	Presumed Asbestos
Product Type	-
Extent of Damage	-
Surface Treatment	-
Estimated Amount	
Accessibility	
Risk Score	12

Recommendation	Inspection Required
Notes	Older electrical equipment must be presumed to have asbestos containing materials present until proven otherwise. No access to live electrical equipment because of the danger of injury or death.

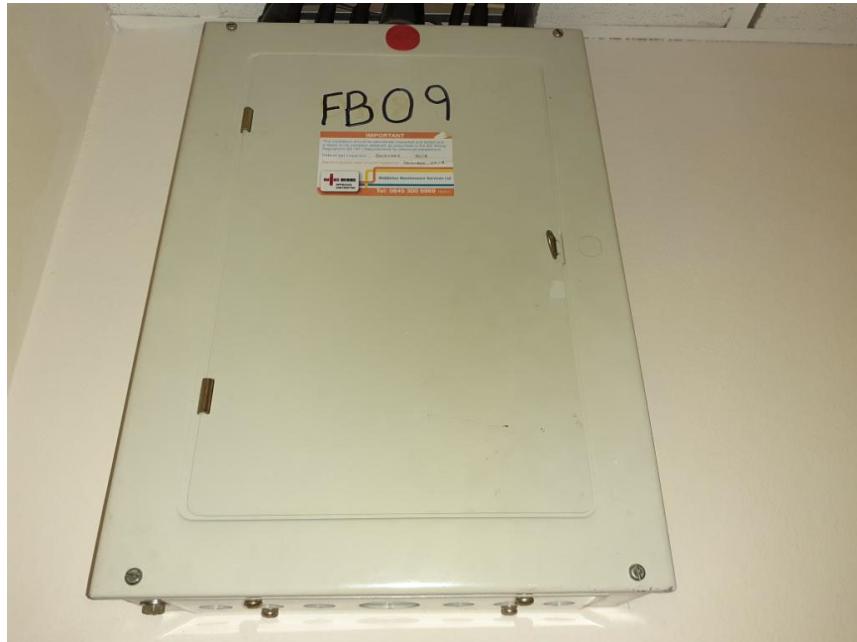
Building	Main building
Floor	0
Location / Room	012 - Toilet circulation 02a
Sample No	P025
Inspection Ref	735774

Description Fuseboard FB09.

Score
Asbestos Type	Presumed Asbestos
Product Type	-
Extent of Damage	-
Surface Treatment	-
Estimated Amount	-
Accessibility	-
Risk Score	12

Recommendation	Inspection Required
Notes	Older electrical equipment must be presumed to have asbestos containing materials present until proven otherwise. No access to live electrical equipment because of the danger of injury or death.

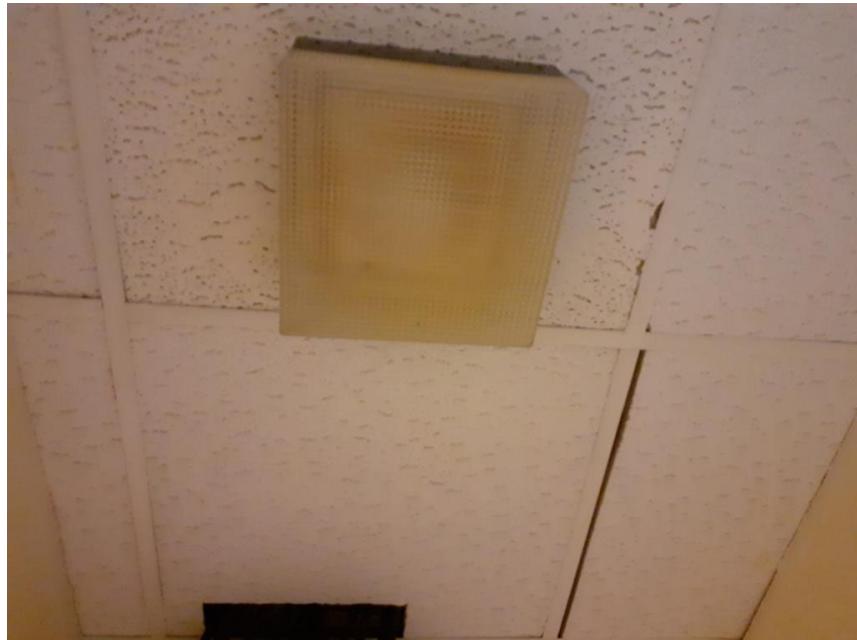
Building	Main building
Floor	0
Location / Room	012 - Toilet circulation 02a
Sample No	X001
Inspection Ref	735773

Description Suspended ceiling tiles. Visually consistent with Sample 1.

Score
Asbestos Type	NO ASBESTOS DETECTED	-
Product Type	Board	-
Extent of Damage	Low Damage	-
Surface Treatment	Unsealed cement / Enclosed lagging or spray / Encapsulated board	-
Estimated Amount	2 m ²	
Accessibility	Occasional Disturbance	
Risk Score		0

Recommendation	No Recommendation Required
Notes	Fibrous board suspended ceiling tiles throughout area.

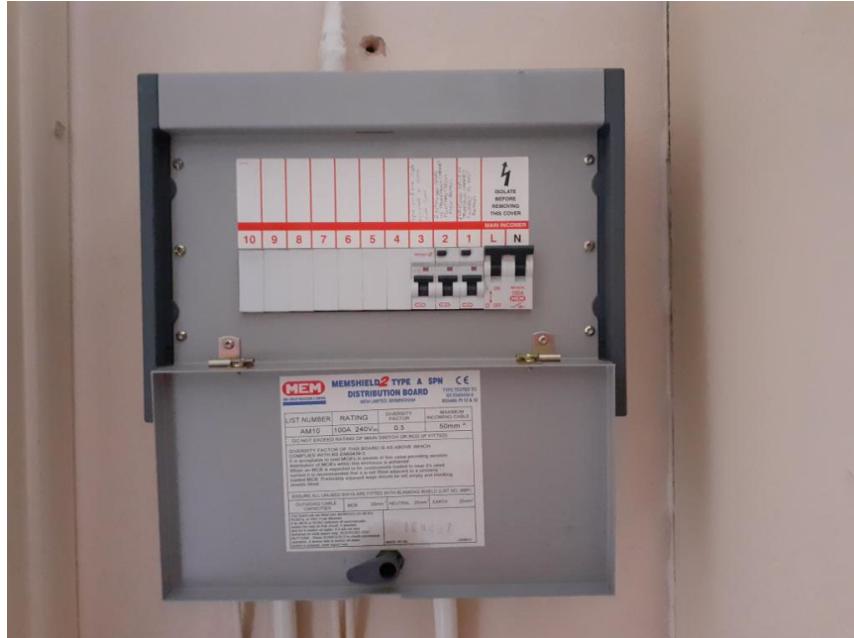
Building	Main building
Floor	0
Location / Room	013 - Server room 06
Sample No	P027
Inspection Ref	735785

Description Fuseboard FB26.

Score
Asbestos Type	Presumed Asbestos	-
Product Type		-
Extent of Damage		-
Surface Treatment		-
Estimated Amount		
Accessibility		
Risk Score		12

Recommendation	Inspection Required
Notes	Older electrical equipment must be presumed to have asbestos containing materials present until proven otherwise. No access to live electrical equipment because of the danger of injury or death.

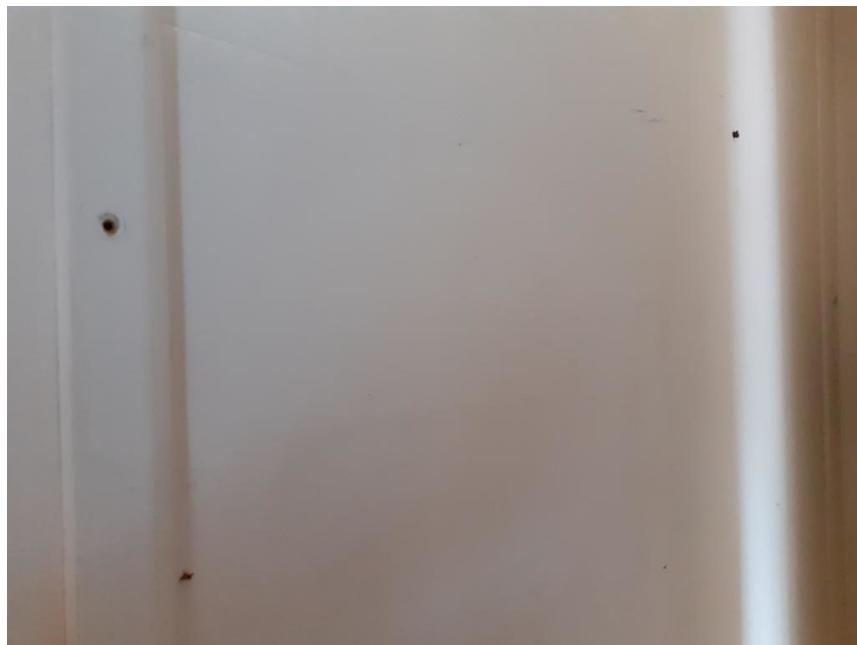
Building	Main building
Floor	0
Location / Room	013 - Server room 06
Sample No	S026
Inspection Ref	735779

Description Notice board.

Score
Asbestos Type	NO ASBESTOS DETECTED	-
Product Type	Board	-
Extent of Damage	Good Condition	-
Surface Treatment	Unsealed cement / Enclosed lagging or spray / Encapsulated board	-
Estimated Amount	1 Item	
Accessibility	Easily Disturbed	
Risk Score		0

Recommendation	No Recommendation Required
Notes	Fibrous notice board on masonry wall to left of fuseboard.

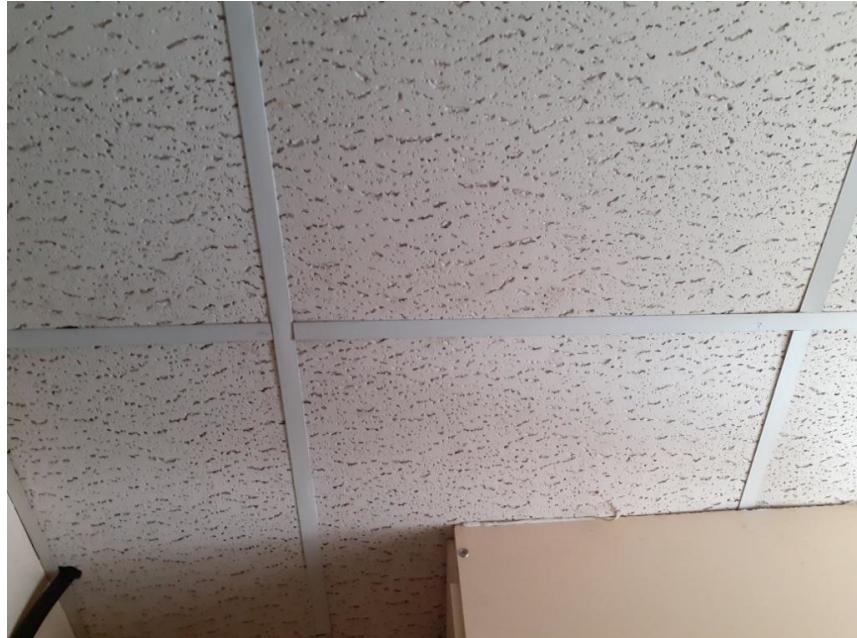
Building	Main building
Floor	0
Location / Room	013 - Server room 06
Sample No	X001
Inspection Ref	735778

Description Suspended ceiling tiles. Visually consistent with Sample 1.

Score
Asbestos Type	NO ASBESTOS DETECTED
Product Type	Board
Extent of Damage	Low Damage
Surface Treatment	Unsealed cement / Enclosed lagging or spray / Encapsulated board
Estimated Amount	16 m ²
Accessibility	Occasional Disturbance
Risk Score	0

Recommendation	No Recommendation Required
Notes	Fibrous board suspended ceiling tiles throughout area.

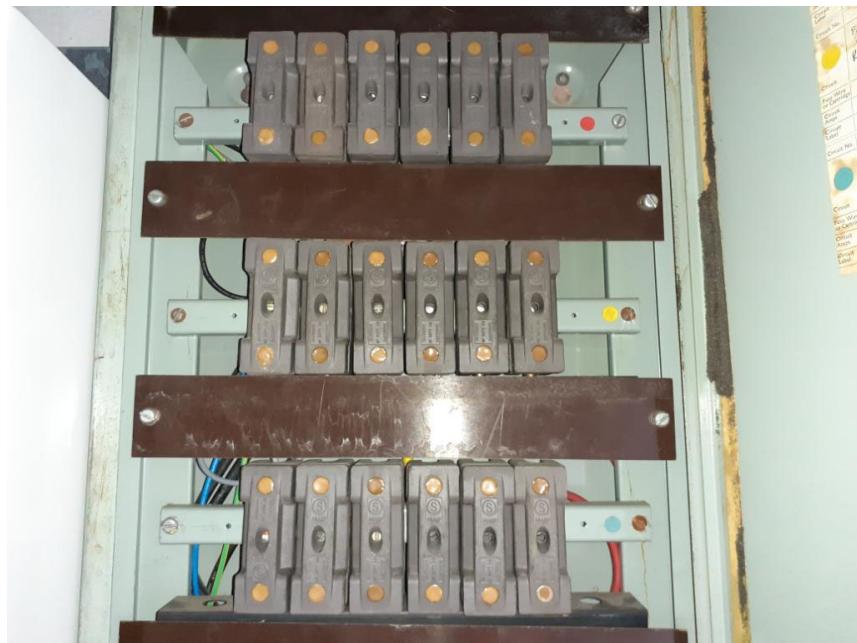
Building	Main building
Floor	0
Location / Room	014 - Boiler room 49
Sample No	P028
Inspection Ref	735786

Description Fuseboard FB13.

Score
Asbestos Type	Presumed Asbestos
Product Type	-
Extent of Damage	-
Surface Treatment	-
Estimated Amount	-
Accessibility	-
Risk Score	12

Recommendation	Inspection Required
Notes	Older electrical equipment must be presumed to have asbestos containing materials present until proven otherwise. No access to live electrical equipment because of the danger of injury or death.

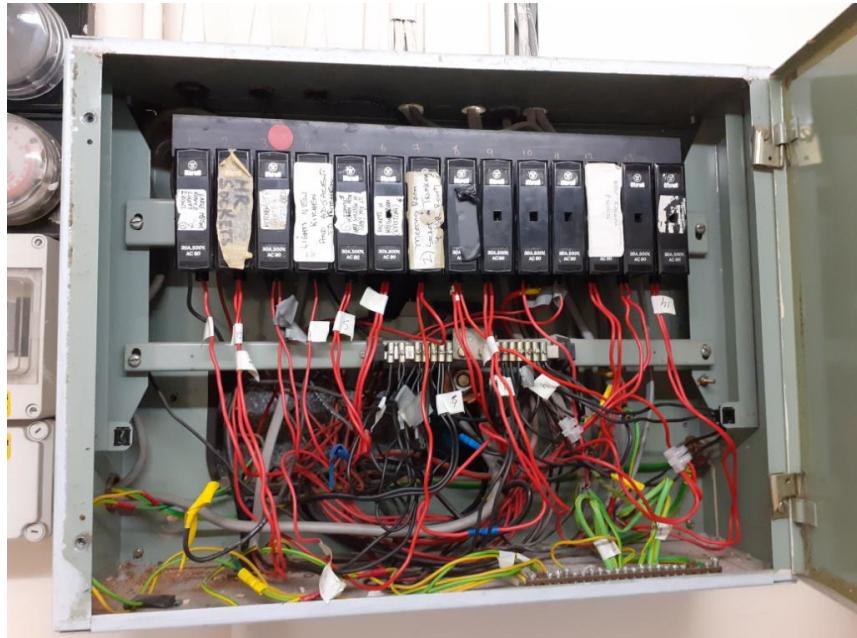
Building	Main building
Floor	1
Location / Room	002 - Kitchen 36
Sample No	P005
Inspection Ref	735269

Description Fuseboard FB10.

Score
Asbestos Type	Presumed Asbestos
Product Type	-
Extent of Damage	-
Surface Treatment	-
Estimated Amount	-
Accessibility	-
Risk Score	12

Recommendation	Inspection Required
Notes	Older electrical equipment must be presumed to have asbestos containing materials present until proven otherwise. No access to live electrical equipment because of the danger of injury or death.

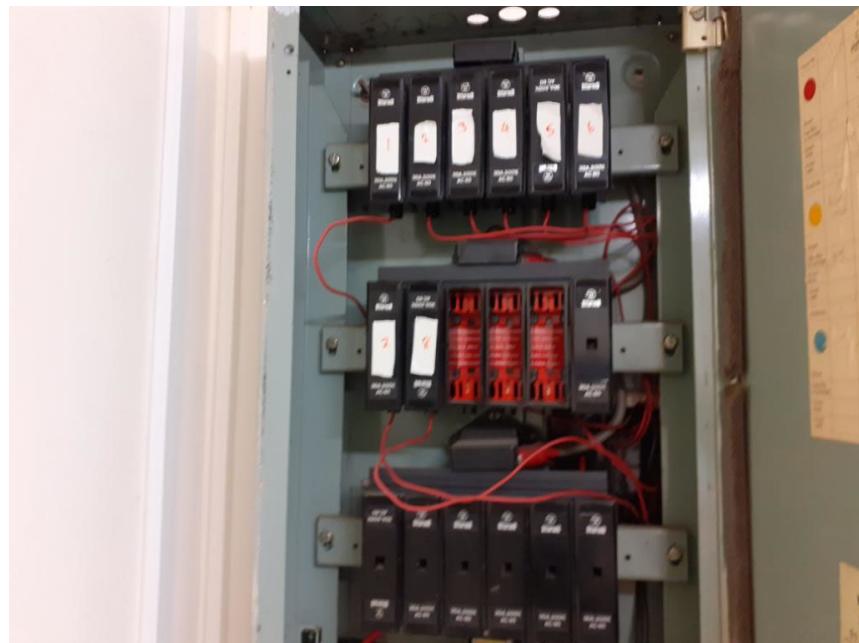
Building	Main building
Floor	1
Location / Room	002 - Kitchen 36
Sample No	P006
Inspection Ref	735268

Description Fuseboard FB12.

Score
Asbestos Type	Presumed Asbestos
Product Type	-
Extent of Damage	-
Surface Treatment	-
Estimated Amount	-
Accessibility	-
Risk Score	12

Recommendation	Inspection Required
Notes	Older electrical equipment must be presumed to have asbestos containing materials present until proven otherwise. No access to live electrical equipment because of the danger of injury or death.

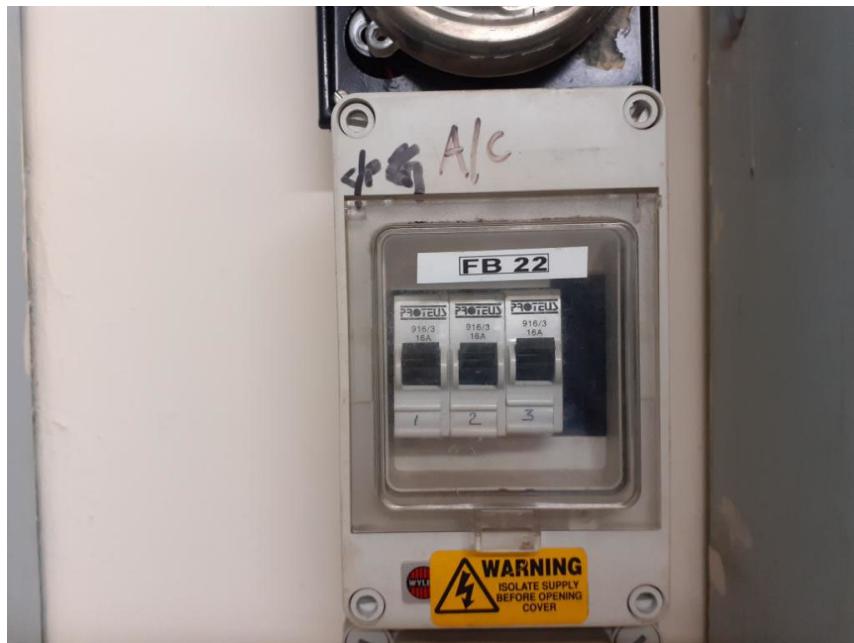
Building	Main building
Floor	1
Location / Room	002 - Kitchen 36
Sample No	P007
Inspection Ref	735267

Description Fuseboard FB22.

Score
Asbestos Type	Presumed Asbestos
Product Type	-
Extent of Damage	-
Surface Treatment	-
Estimated Amount	
Accessibility	
Risk Score	12

Recommendation	Inspection Required
Notes	Older electrical equipment must be presumed to have asbestos containing materials present until proven otherwise. No access to live electrical equipment because of the danger of injury or death.

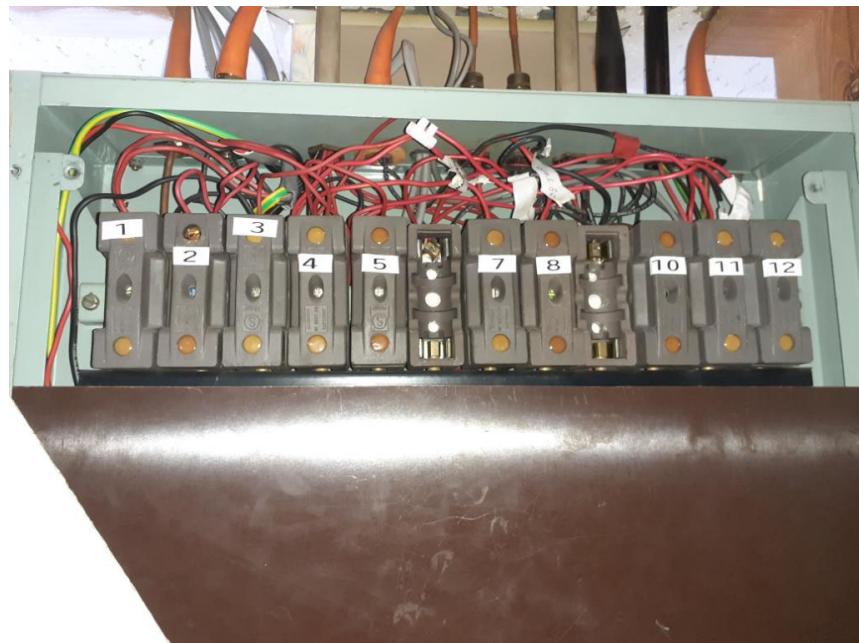
Building	Main building
Floor	1
Location / Room	003 - Office 31
Sample No	P009
Inspection Ref	735284

Description Fuseboard FB06.

Score
Asbestos Type	Presumed Asbestos
Product Type	-
Extent of Damage	-
Surface Treatment	-
Estimated Amount	
Accessibility	
Risk Score	12

Recommendation	Inspection Required
Notes	Older electrical equipment must be presumed to have asbestos containing materials present until proven otherwise. No access to live electrical equipment because of the danger of injury or death.

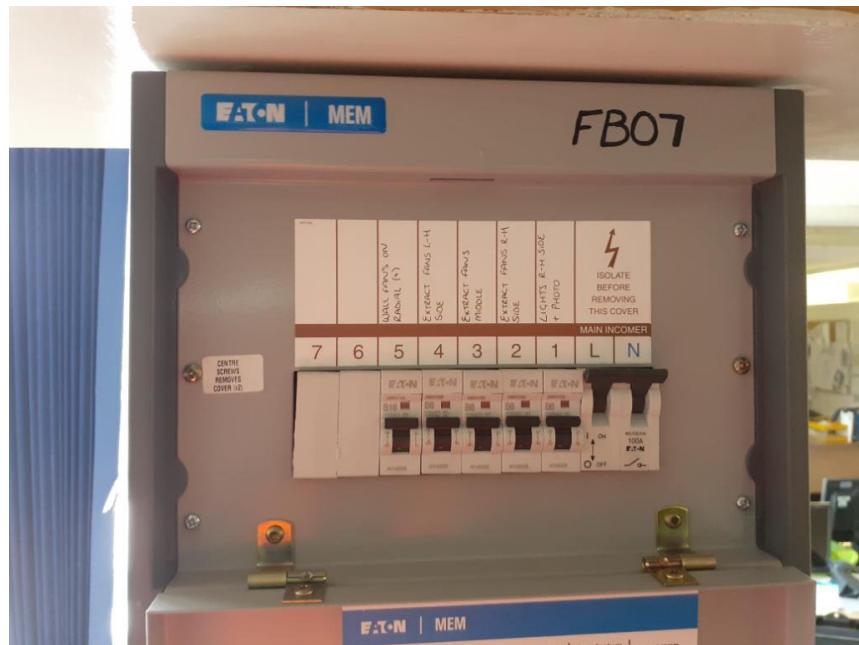
Building	Main building
Floor	1
Location / Room	003 - Office 31
Sample No	P010
Inspection Ref	735285

Description Fuseboard FB07.

Score
Asbestos Type	Presumed Asbestos
Product Type	-
Extent of Damage	-
Surface Treatment	-
Estimated Amount	-
Accessibility	-
Risk Score	12

Recommendation	Inspection Required
Notes	Older electrical equipment must be presumed to have asbestos containing materials present until proven otherwise. No access to live electrical equipment because of the danger of injury or death.

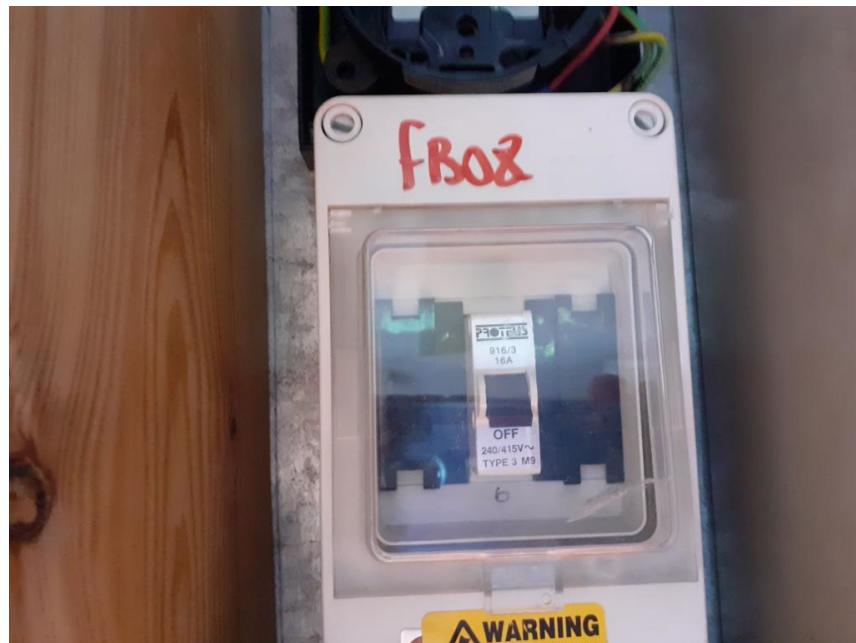
Building	Main building
Floor	1
Location / Room	003 - Office 31
Sample No	P011
Inspection Ref	735286

Description Fuseboard FB08.

Score
Asbestos Type	Presumed Asbestos
Product Type	-
Extent of Damage	-
Surface Treatment	-
Estimated Amount	
Accessibility	
Risk Score	12

Recommendation	Inspection Required
Notes	Older electrical equipment must be presumed to have asbestos containing materials present until proven otherwise. No access to live electrical equipment because of the danger of injury or death.

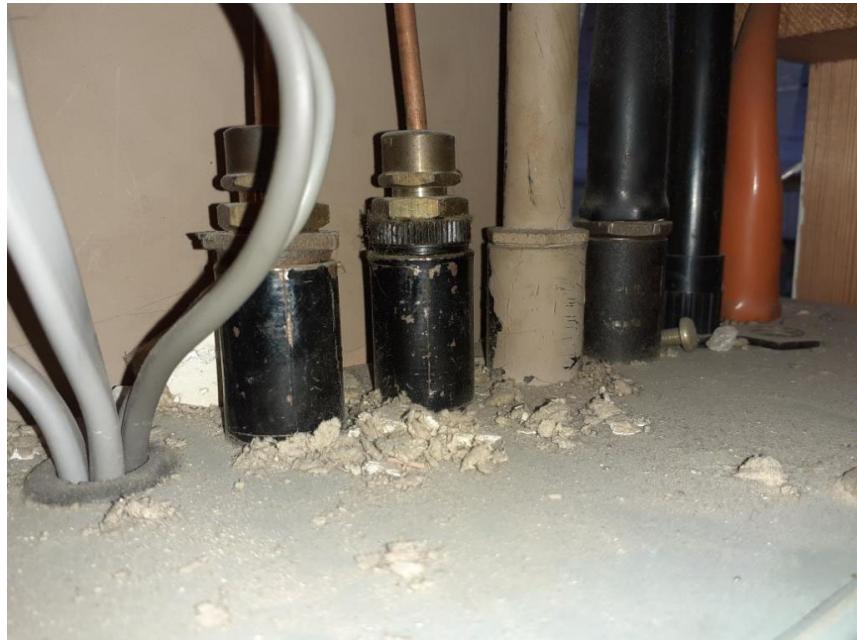
Building	Main building
Floor	1
Location / Room	003 - Office 31
Sample No	S008
Inspection Ref	735283

Description Upper surface of FB06 casing.

Score
Asbestos Type	NO ASBESTOS DETECTED
Product Type	-
Extent of Damage	-
Surface Treatment	-
Estimated Amount	-
Accessibility	-
Risk Score	0

Recommendation	No Recommendation Required
Notes	Fibrous debris on upper surfaces of FB07 casing inside wooden boxing.

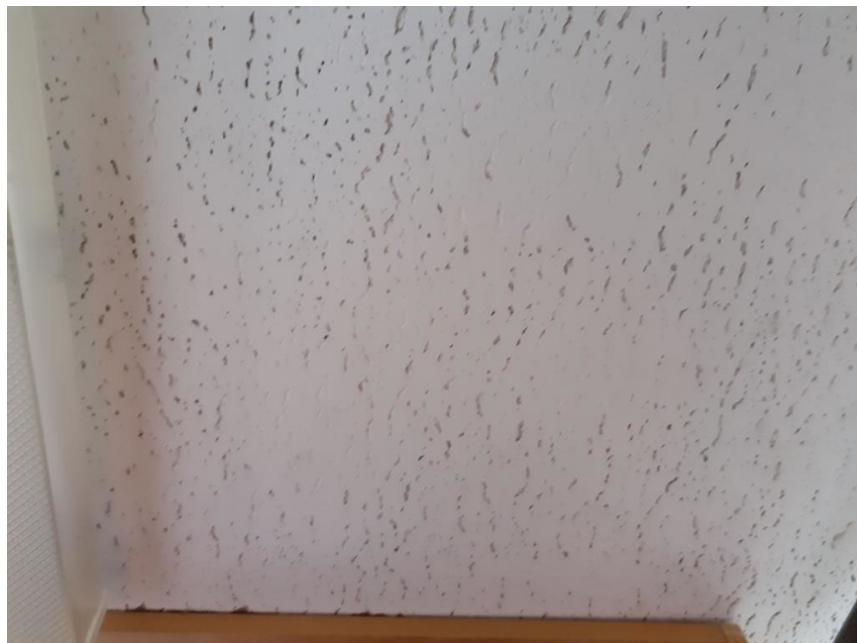
Building	Main building
Floor	1
Location / Room	003 - Office 31
Sample No	X001
Inspection Ref	735282

Description Suspended ceiling tiles. Visually consistent with Sample 1.

Score
Asbestos Type	NO ASBESTOS DETECTED	-
Product Type	Board	-
Extent of Damage	Low Damage	-
Surface Treatment	Unsealed cement / Enclosed lagging or spray / Encapsulated board	-
Estimated Amount	100 m ²	
Accessibility	Occasional Disturbance	
Risk Score		0

Recommendation	No Recommendation Required
Notes	Fibrous board suspended ceiling tiles throughout area.

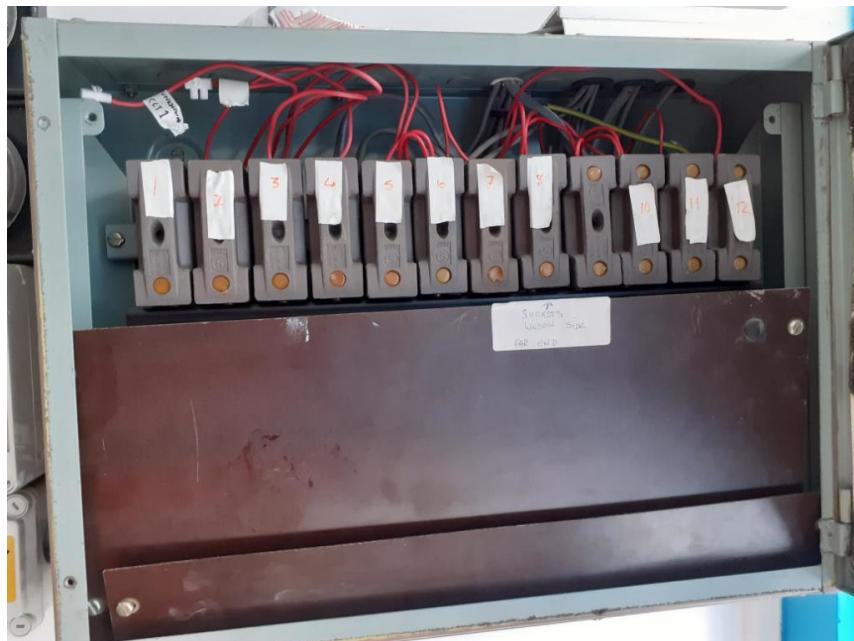
Building	Main building
Floor	1
Location / Room	004 - Office 27
Sample No	P013
Inspection Ref	735294

Description Fuseboards FB11, FB21 & FB24.

Score
Asbestos Type	Presumed Asbestos
Product Type	-
Extent of Damage	-
Surface Treatment	-
Estimated Amount	-
Accessibility	-
Risk Score	12

Recommendation	Inspection Required
Notes	Older electrical equipment must be presumed to have asbestos containing materials present until proven otherwise. No access to live electrical equipment because of the danger of injury or death.

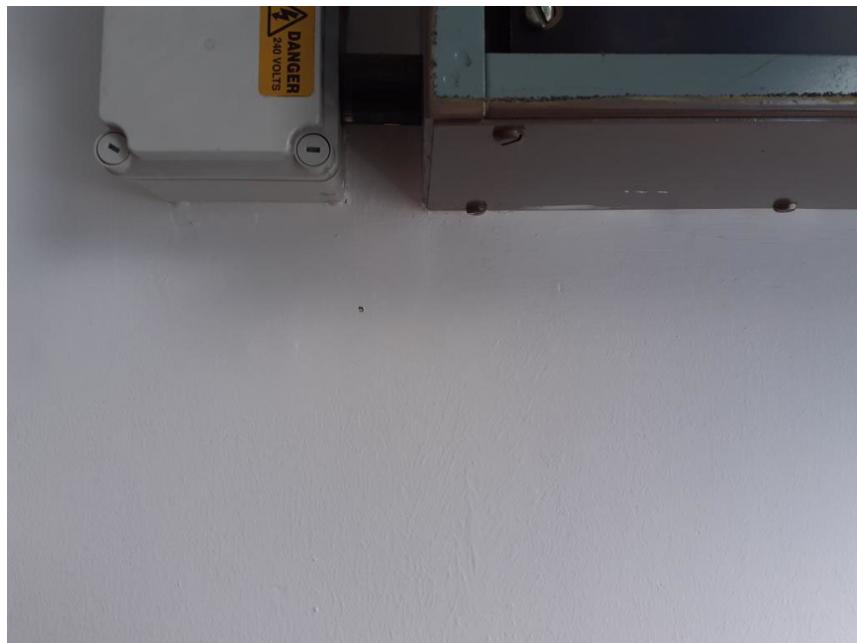
Building	Main building
Floor	1
Location / Room	004 - Office 27
Sample No	S012
Inspection Ref	735293

Description Wall surrounding fuseboard.

Score
Asbestos Type	NO ASBESTOS DETECTED	-
Product Type	Board	-
Extent of Damage	Low Damage	-
Surface Treatment	Unsealed cement / Enclosed lagging or spray / Encapsulated board	-
Estimated Amount	10 m ²	
Accessibility	Easily Disturbed	
Risk Score		0

Recommendation	No Recommendation Required
Notes	Fibrous board wall behind & around fuseboard casing.

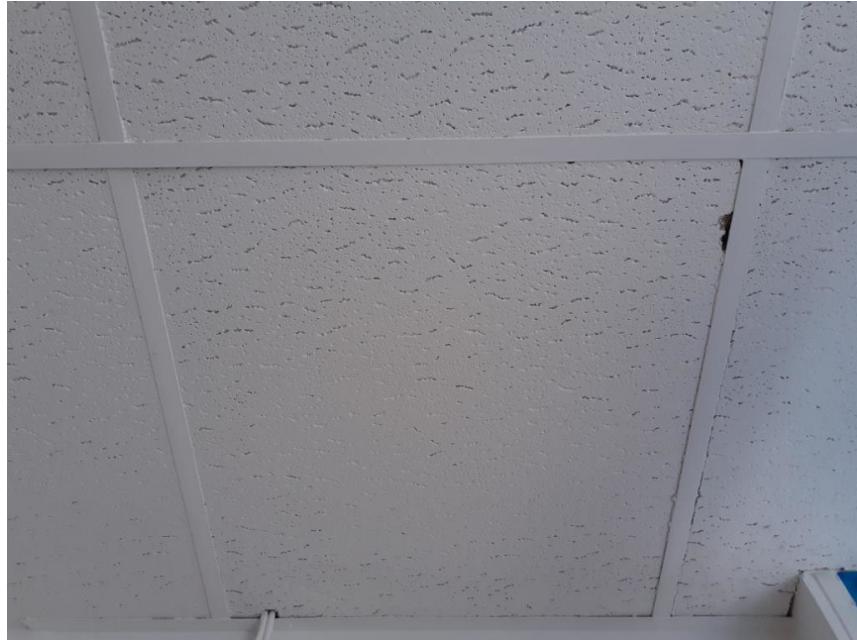
Building	Main building
Floor	1
Location / Room	004 - Office 27
Sample No	X001
Inspection Ref	735292

Description Suspended ceiling tiles. Visually consistent with Sample 1.

Score
Asbestos Type	NO ASBESTOS DETECTED	-
Product Type	Board	-
Extent of Damage	Low Damage	-
Surface Treatment	Unsealed cement / Enclosed lagging or spray / Encapsulated board	-
Estimated Amount	100 m ²	
Accessibility	Occasional Disturbance	
Risk Score		0

Recommendation	No Recommendation Required
Notes	Fibrous board suspended ceiling tiles throughout area.

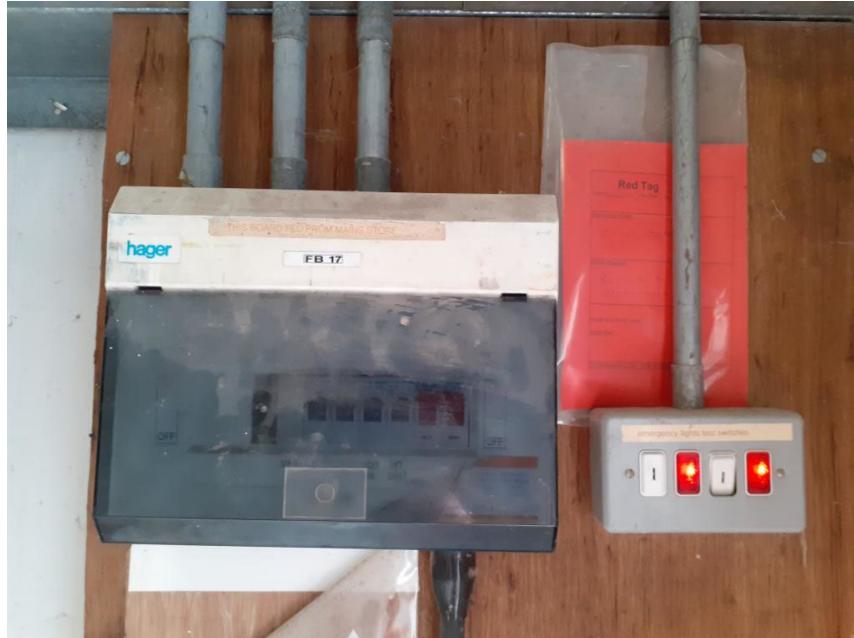
Building	Plasterers store
Floor	0
Location / Room	005 - Plasterers store 010
Sample No	P014
Inspection Ref	735729

Description Fuseboard FB17.

Score
Asbestos Type	Presumed Asbestos
Product Type	-
Extent of Damage	-
Surface Treatment	-
Estimated Amount	-
Accessibility	-
Risk Score	12

Recommendation	Inspection Required
Notes	Older electrical equipment must be presumed to have asbestos containing materials present until proven otherwise. No access to live electrical equipment because of the danger of injury or death.

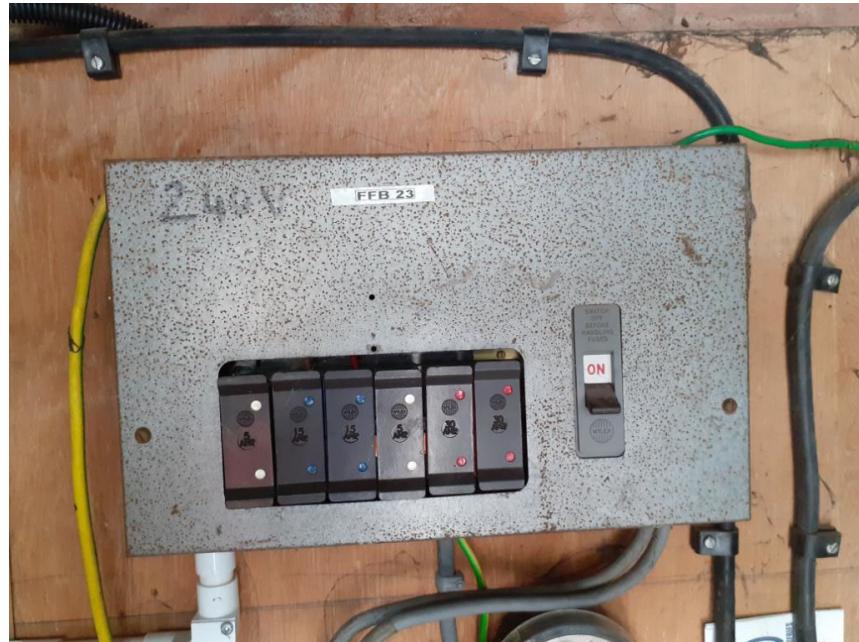
Building	Small outside electrical cupboard
Floor	0
Location / Room	010 - Small outside electrical cupboard
Sample No	P021
Inspection Ref	735761

Description Fuseboard FB023.

Score
Asbestos Type	Presumed Asbestos
Product Type	-
Extent of Damage	-
Surface Treatment	-
Estimated Amount	
Accessibility	
Risk Score	12

Recommendation	Inspection Required
Notes	Older electrical equipment must be presumed to have asbestos containing materials present until proven otherwise. No access to live electrical equipment because of the danger of injury or death.

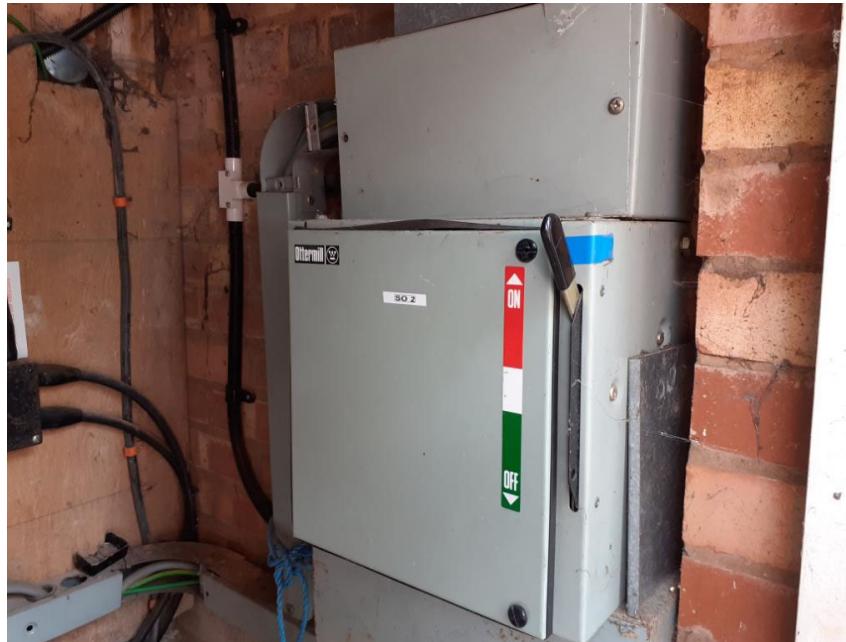
Building	Small outside electrical cupboard
Floor	0
Location / Room	010 - Small outside electrical cupboard
Sample No	P022
Inspection Ref	735762

Description Fuseboard S02.

Score
Asbestos Type	Presumed Asbestos
Product Type	-
Extent of Damage	-
Surface Treatment	-
Estimated Amount	
Accessibility	
Risk Score	12

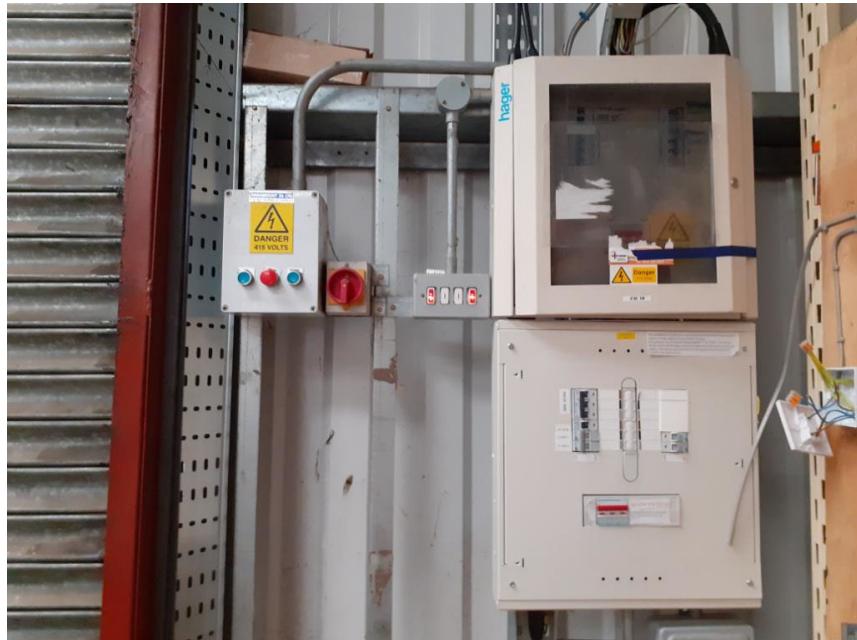
Building	Store 1
Floor	0
Location / Room	006 - Store 1 013
Sample No	P015
Inspection Ref	735738

Description Fuseboard FB19.

Score
Asbestos Type	Presumed Asbestos
Product Type	-
Extent of Damage	-
Surface Treatment	-
Estimated Amount	-
Accessibility	-
Risk Score	12
