Asbestos Targeted Refurbishment Survey

College Road Depot, B44 0AY

Report No	D-11185	Report Issue Date	14 May 2025
Client Name & Address	Central Housing Services North 599 - 603 College Road Kingstanding Birmingham B44 0AY	Site Address	College Road Depot, 599-603 College Road, Kingstanding, Birmingham, B44 0AY
Order Placed By	Linda Coleman	Instruction Date	8 May 2025
Order Number	B1-AV0N4-4Z09-EH1-JZZZZZ-TV5EB-JZZZ-JXXX	Project Reference	-
Survey Date(s)	on 09/05/2025	Lead Surveyor	Luke Murphy

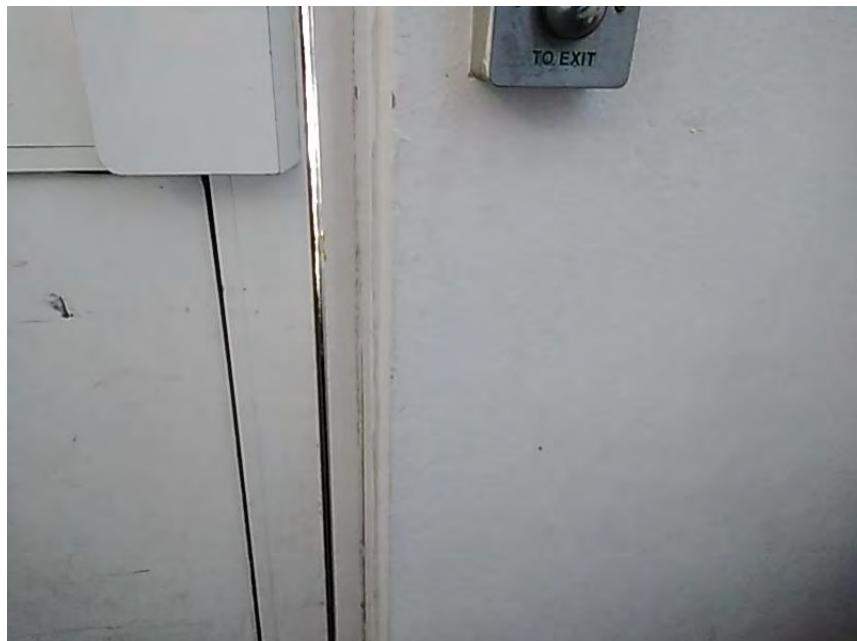
Building	Main building
Floor	0
Location / Room	0001 - Entrance lobby 21
Sample No	S001
Inspection Ref	1054203

Description Walls.

Score
Asbestos Type	NO ASBESTOS DETECTED
Product Type	Textured Coating
Extent of Damage	Low Damage
Surface Treatment	Composite, reinforced or bonded
Estimated Amount	8 m ²
Accessibility	Easily Disturbed
Risk Score	0

Recommendation	No Recommendation Required
Notes

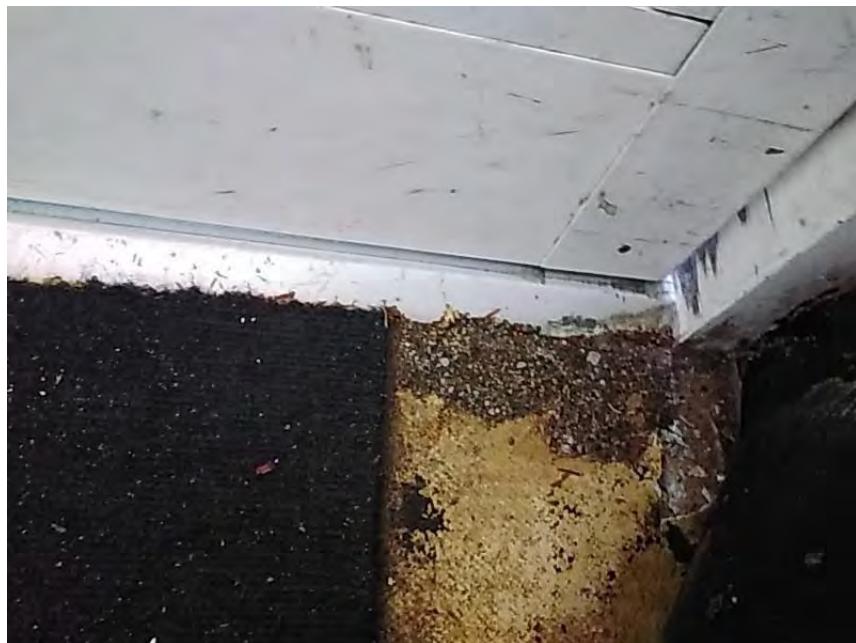
Building	Main building
Floor	0
Location / Room	0001 - Entrance lobby 21
Sample No	S002
Inspection Ref	1054204

Description Floor tiles and adhesive .

Score
Asbestos Type	NO ASBESTOS DETECTED
Product Type	Floor Tiles & Adhesive
Extent of Damage	Good Condition
Surface Treatment	Composite, reinforced or bonded
Estimated Amount	3 m ²
Accessibility	Usually Inaccessible
Risk Score	0

Recommendation	No Recommendation Required
Notes	Located beneath carpet tiles.

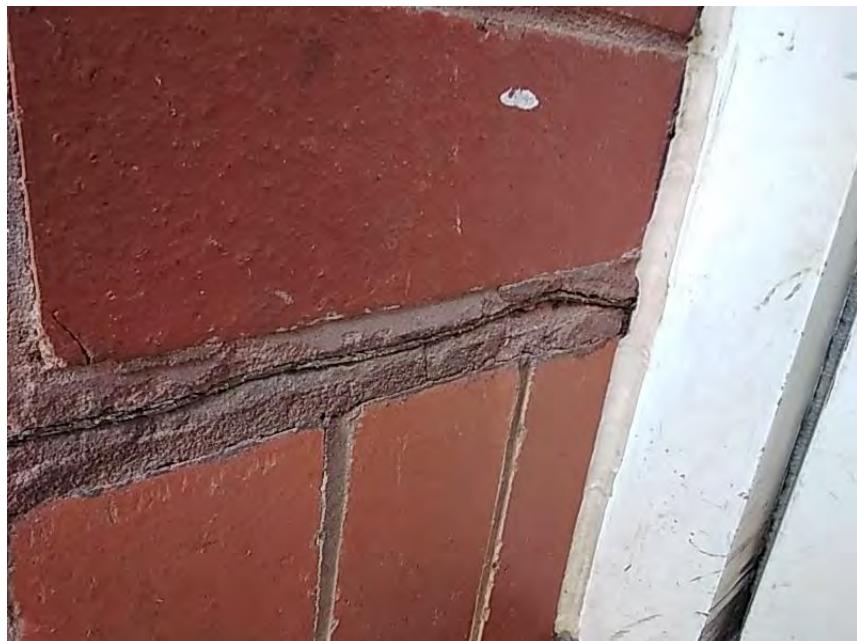
Building	Main building
Floor	External
Location / Room	0002 - Exterior to Entrance Lobby
Sample No	S003
Inspection Ref	1054209

Building	Floor	Location/ Room	Position	Item	Sample No.	Inspection Ref	Risk Score
Main building	External	0002 - Exterior to Entrance Lobby	Damp proof course	Bitumen Products	S003	1054209	2

Description Damp proof course .

Score
Asbestos Type	CHrysotile	1
Product Type	Bitumen Products	1
Extent of Damage	Good Condition	0
Surface Treatment	Composite, reinforced or bonded	0
Estimated Amount	Unknown	
Accessibility	Occasional Disturbance	
Risk Score		2

Recommendation	Remove
Notes	Identified at low level adjacent to the door frame.

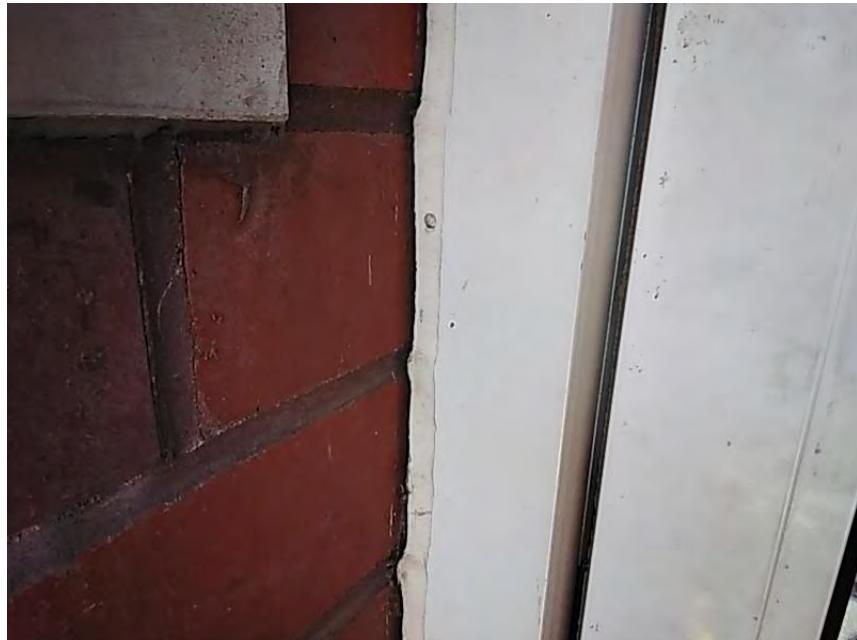
Building	Main building
Floor	External
Location / Room	0002 - Exterior to Entrance Lobby
Sample No	S004
Inspection Ref	1054210

Description Seals to door frame .

Score
Asbestos Type	NO ASBESTOS DETECTED
Product Type	Putty
Extent of Damage	Good Condition
Surface Treatment	Composite, reinforced or bonded
Estimated Amount	5 L/M
Accessibility	Occasional Disturbance
Risk Score	0

Recommendation	No Recommendation Required
Notes
