Asbestos Management Survey

Mole Street Depot, B11 1XA

Report No	D-05898	Report Issue Date	11 June 2020
Client Name & Address	Asset Management & Maintenance Division Mole Street Centre Mole Street Sparkbrook Birmingham B11 1XA	Site Address	Mole Street Depot, Mole Street, Sparkbrook, Birmingham, B11 1XA
Order Placed By	John Flaherty	Instruction Date	17 January 2020
Order Number	RHTBP C000 A00	Project Reference	-
Survey Date(s)	12 February and 8 June 2020	Lead Surveyor	Richard Arnold

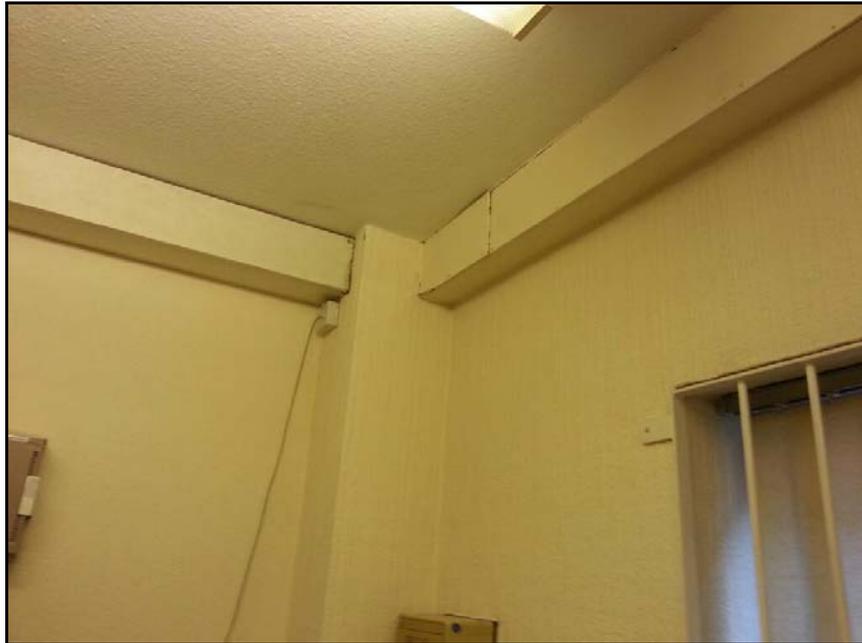
Surveyor	Richard Arnold	Building	Main building
Survey Type	Management	Floor	0
Survey Date	12/02/2020	Location/ Room	001 - Store 001
Next Inspection	12/02/2021	Sample No	P001
Level of Identification	Presumed	Inspection Ref	534386

Description Inside boxing.

Score
Asbestos Type	Presumed Asbestos	-
Product Type		-
Extent of Damage		-
Surface Treatment		-
Estimated Amount		
Accessibility		
Risk Score		12

Recommendation	Inspection Required
Notes	Cannot open without irreparable damage.

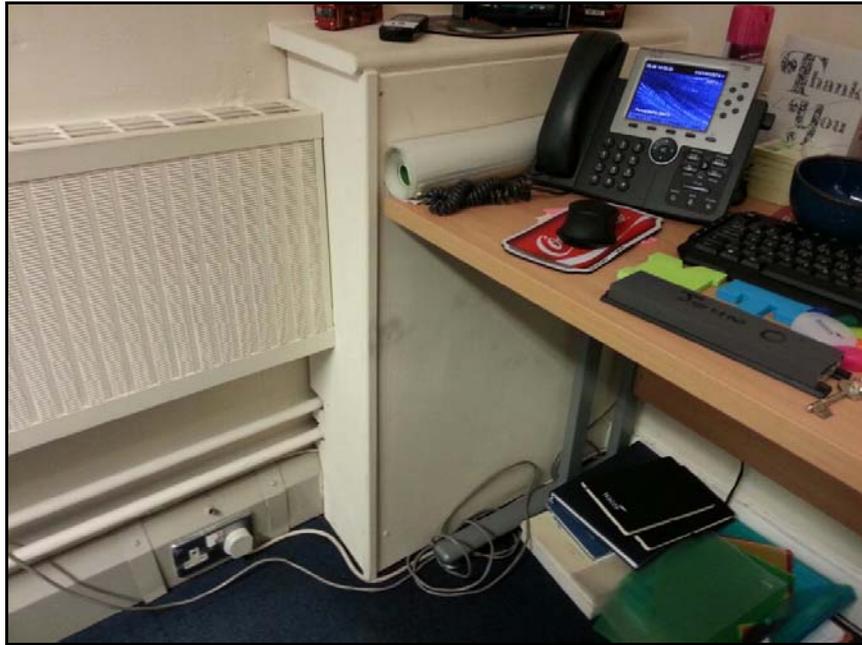
Surveyor	Richard Arnold	Building	Main building
Survey Type	Management	Floor	0
Survey Date	12/02/2020	Location/ Room	002 - Office 002
Next Inspection	12/02/2021	Sample No	P002
Level of Identification	Presumed	Inspection Ref	534393

Description Inside boxing.

Score
Asbestos Type	Presumed Asbestos	-
Product Type		-
Extent of Damage		-
Surface Treatment		-
Estimated Amount		
Accessibility		
Risk Score		12

Recommendation	Inspection Required
Notes	Cannot open without irreparable damage

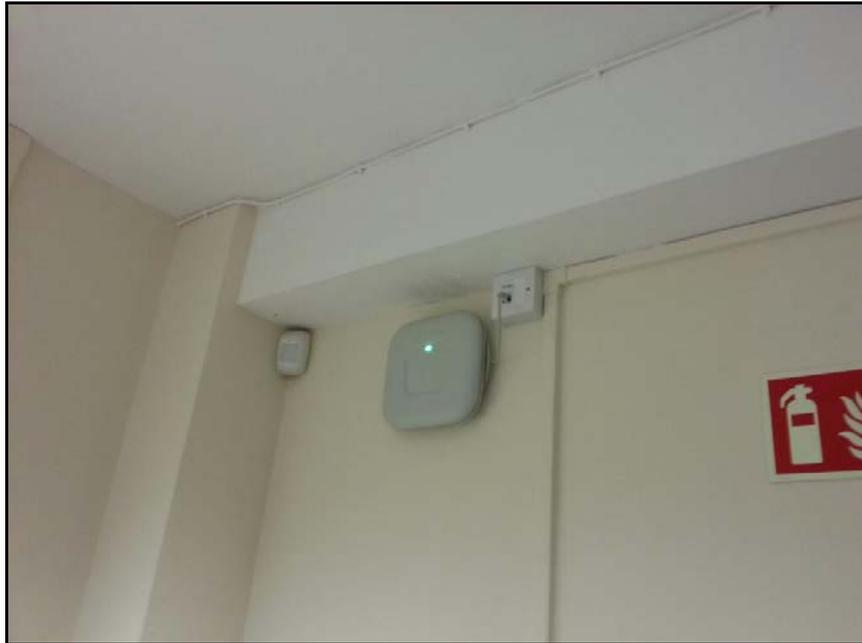
Surveyor	Richard Arnold	Building	Main building
Survey Type	Management	Floor	0
Survey Date	12/02/2020	Location/ Room	003 - Office 003
Next Inspection	12/02/2021	Sample No	P005
Level of Identification	Presumed	Inspection Ref	534402

Description Inside boxing.

Score
Asbestos Type	Presumed Asbestos	-
Product Type		-
Extent of Damage		-
Surface Treatment		-
Estimated Amount		
Accessibility		
Risk Score		12

Recommendation	Inspection Required
Notes	Cannot open without irreparable damage.

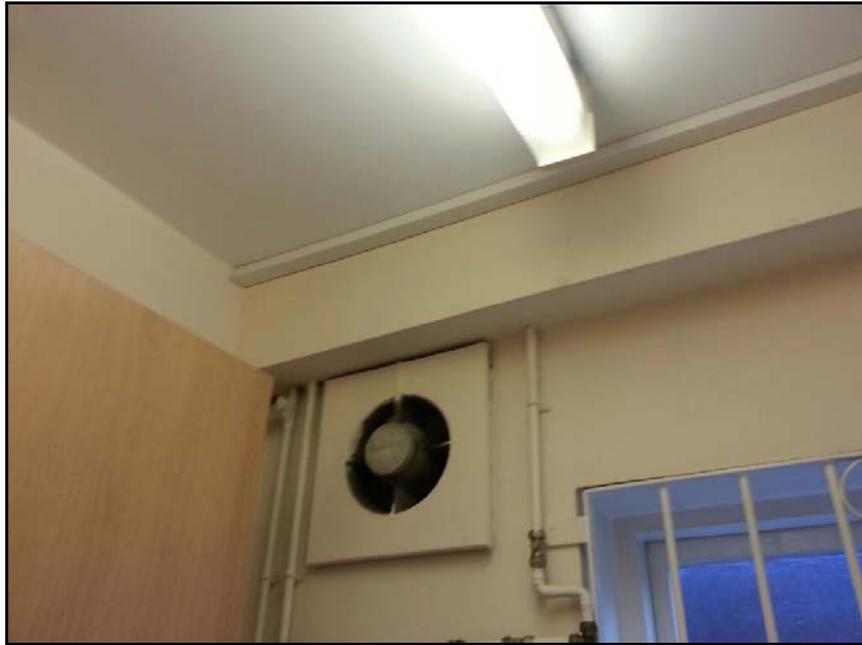
Surveyor	Richard Arnold	Building	Main building
Survey Type	Management	Floor	0
Survey Date	12/02/2020	Location/ Room	004 - Kitchen 004
Next Inspection	12/02/2021	Sample No	P004
Level of Identification	Presumed	Inspection Ref	534537

Description Inside boxing.

Score
Asbestos Type	Presumed Asbestos	-
Product Type		-
Extent of Damage		-
Surface Treatment		-
Estimated Amount		
Accessibility		
Risk Score		12

Recommendation	Inspection Required
Notes	Cannot open without irreparable damage.

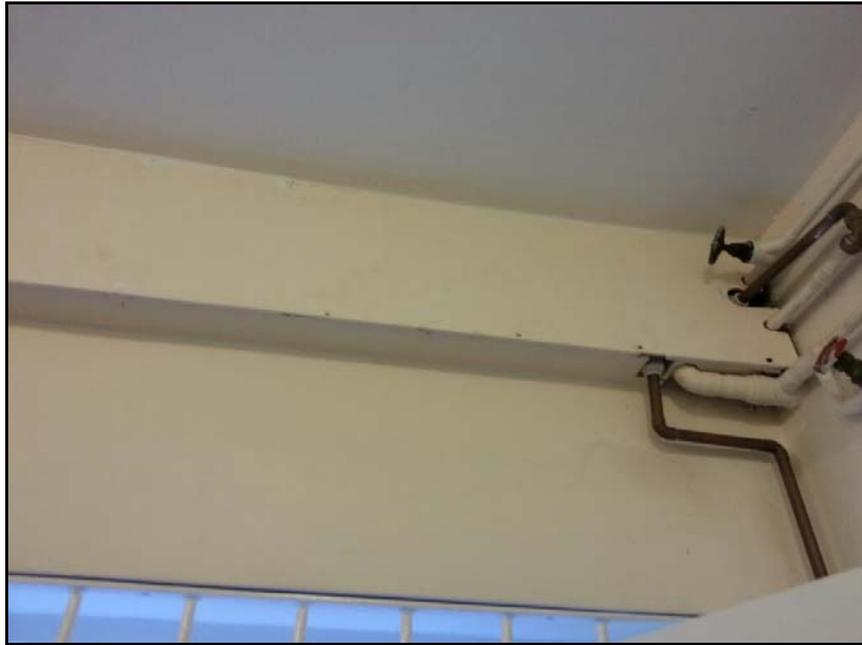
Surveyor	Richard Arnold	Building	Main building
Survey Type	Management	Floor	0
Survey Date	12/02/2020	Location/ Room	005 - WC/shower 005
Next Inspection	12/02/2021	Sample No	P008
Level of Identification	Presumed	Inspection Ref	534409

Description Inside boxing.

Score
Asbestos Type	Presumed Asbestos	-
Product Type		-
Extent of Damage		-
Surface Treatment		-
Estimated Amount		
Accessibility		
Risk Score		12

Recommendation	Inspection Required
Notes	Cannot open without irreparable damage.

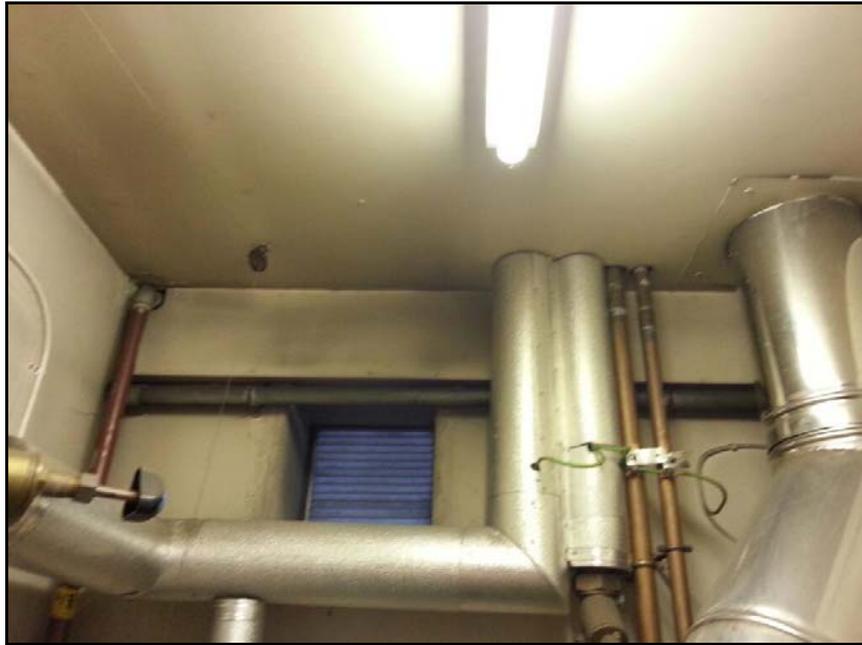
Surveyor	Richard Arnold	Building	Main building
Survey Type	Management	Floor	0
Survey Date	12/02/2020	Location/ Room	006 - Boiler room 006
Next Inspection	12/02/2021	Sample No	P010
Level of Identification	Presumed	Inspection Ref	534419

Description Inside boxing.

Score
Asbestos Type	Presumed Asbestos	-
Product Type		-
Extent of Damage		-
Surface Treatment		-
Estimated Amount		
Accessibility		
Risk Score		12

Recommendation	Inspection Required
Notes	Cannot open without irreparable damage.

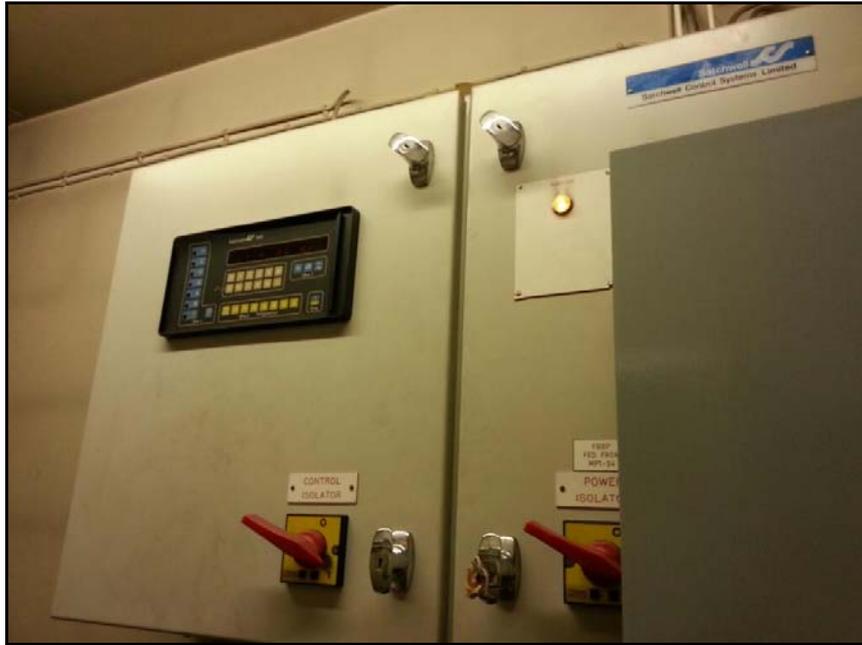
Surveyor	Richard Arnold	Building	Main building
Survey Type	Management	Floor	0
Survey Date	12/02/2020	Location/ Room	006 - Boiler room 006
Next Inspection	12/02/2021	Sample No	P011
Level of Identification	Presumed	Inspection Ref	534418

Description Electrical equipment.

Score
Asbestos Type	Presumed Asbestos	-
Product Type		-
Extent of Damage		-
Surface Treatment		-
Estimated Amount		
Accessibility		
Risk Score		12

Recommendation	Inspection Required
Notes	Equipment alive.

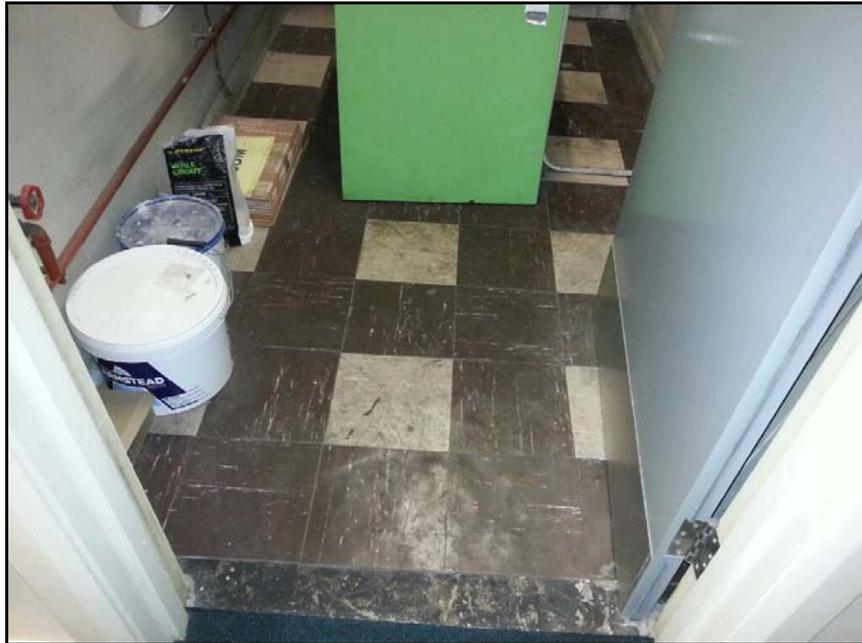
Surveyor	Richard Arnold	Building	Main building
Survey Type	Management	Floor	0
Survey Date	08/06/2020	Location/ Room	006 - Boiler room 006
Next Inspection	08/06/2021	Sample No	S009
Level of Identification	Sample Analysed	Inspection Ref	534426

Description Floor tiles/adhesive.

Score
Asbestos Type	CHRYSTILE (CHRYSTILE PRESENT IN BITUMEN ADHESIVE ONLY)	1
Product Type	Floor Tiles & Adhesive	1
Extent of Damage	Low Damage	1
Surface Treatment	Composite, reinforced or bonded	0
Estimated Amount	5 m ²	
Accessibility	Easily Disturbed	
Risk Score		3

Recommendation	Manage & Re-inspect
Notes

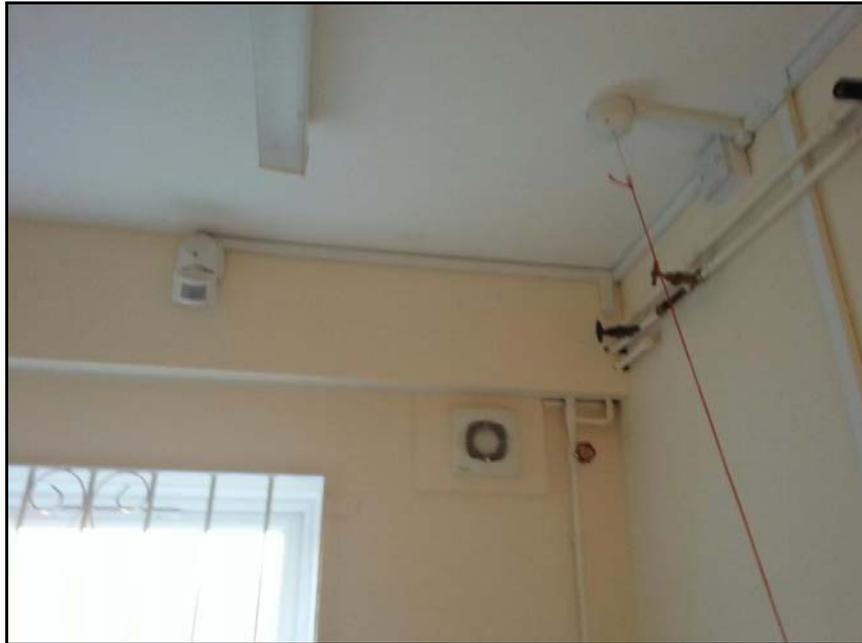
Surveyor	Richard Arnold	Building	Main building
Survey Type	Management	Floor	0
Survey Date	12/02/2020	Location/ Room	007 - WC 007
Next Inspection	12/02/2021	Sample No	P015
Level of Identification	Presumed	Inspection Ref	534427

Description Inside boxing.

Score
Asbestos Type	Presumed Asbestos	-
Product Type		-
Extent of Damage		-
Surface Treatment		-
Estimated Amount		
Accessibility		
Risk Score		12

Recommendation	Inspection Required
Notes	Cannot open without irreparable damage.

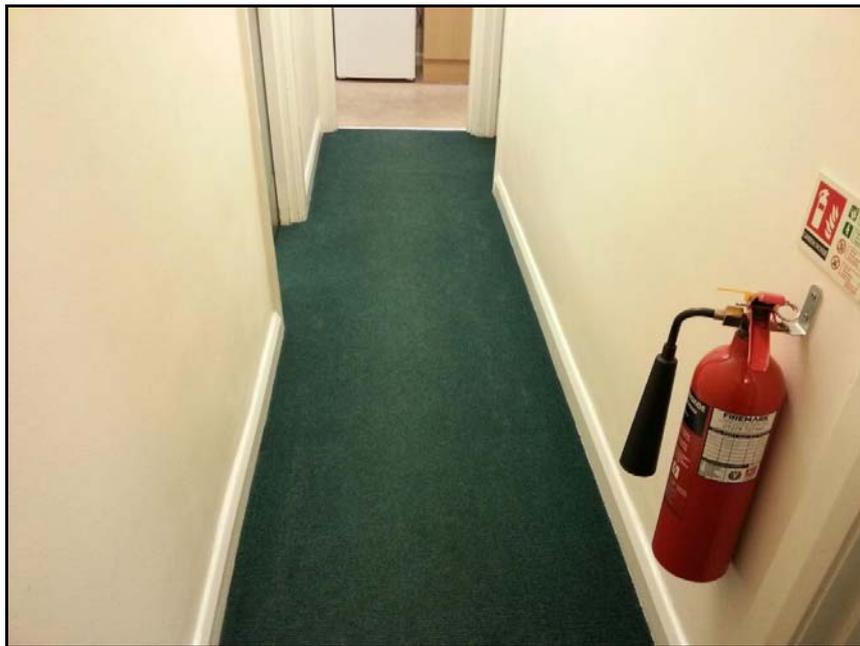
Surveyor	Richard Arnold	Building	Main building
Survey Type	Management	Floor	0
Survey Date	12/02/2020	Location/ Room	008 - Circulation 008
Next Inspection	12/02/2021	Sample No	PS012
Level of Identification	Previously Sampled	Inspection Ref	534434

Description Adhesive .
Concealed by fitted carpet and screed.

Score
Asbestos Type	CHRYSTILE;	1
Product Type	Bitumen Products	1
Extent of Damage	Good Condition	0
Surface Treatment	Composite, reinforced or bonded	0
Estimated Amount	6 m ²	
Accessibility	Usually Inaccessible	
Risk Score		2

Recommendation	Manage & Re-inspect
Notes	Sampled Previously Report Ref: D-01848-12.

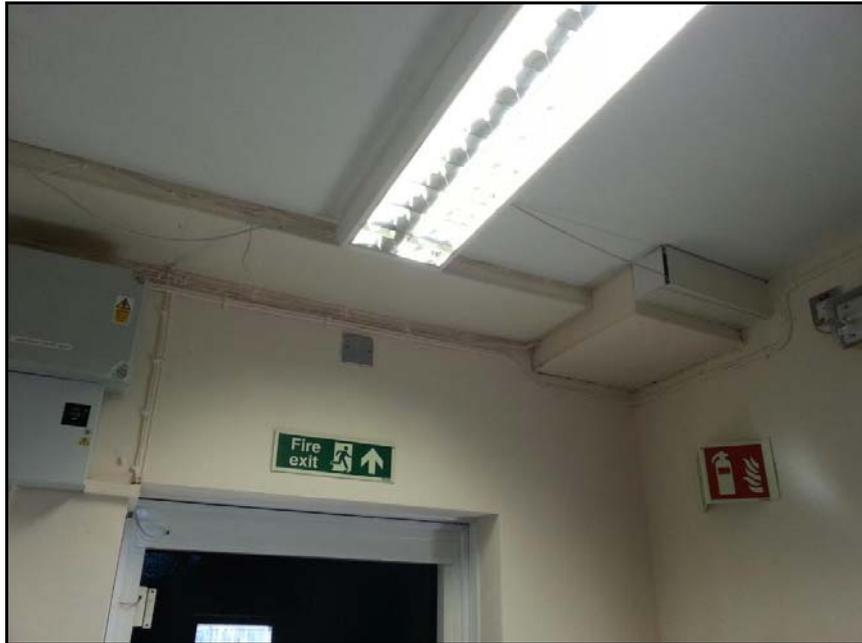
Surveyor	Richard Arnold	Building	Main building
Survey Type	Management	Floor	0
Survey Date	12/02/2020	Location/ Room	009 - Circulation & St 009
Next Inspection	12/02/2021	Sample No	P014
Level of Identification	Presumed	Inspection Ref	534380

Description Inside boxing.

Score
Asbestos Type	Presumed Asbestos	-
Product Type		-
Extent of Damage		-
Surface Treatment		-
Estimated Amount		
Accessibility		
Risk Score		12

Recommendation	Inspection Required
Notes

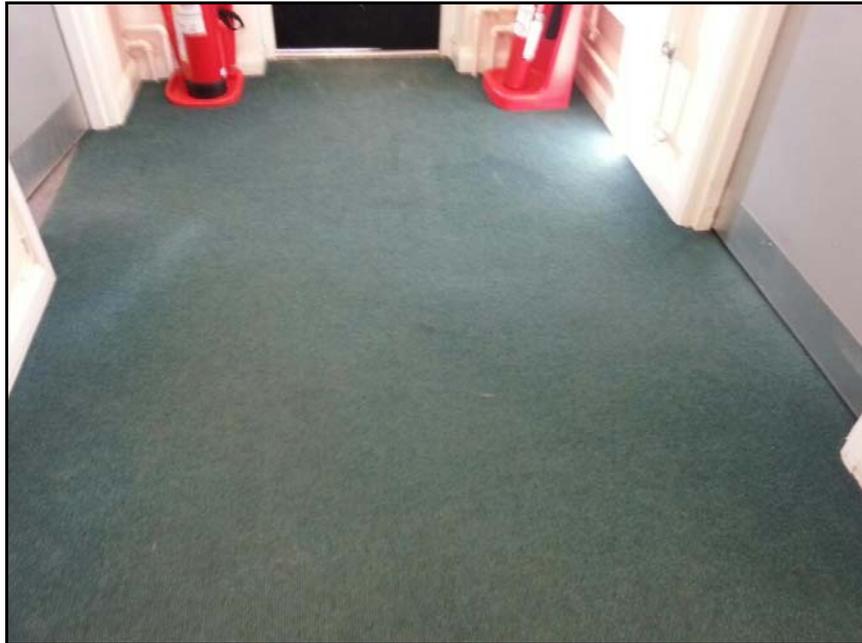
Surveyor	Richard Arnold	Building	Main building
Survey Type	Management	Floor	0
Survey Date	12/02/2020	Location/ Room	009 - Circulation & stairs 009
Next Inspection	12/02/2021	Sample No	X013
Level of Identification	Strongly Presumed	Inspection Ref	534438

Description Adhesive . Visually consistent with Sample 13.
Under carpet.

Score
Asbestos Type	CHRYSTILE (CHRYSTILE PRESENT IN BITUMEN ADHESIVE ONLY)	1
Product Type	Bitumen Products	1
Extent of Damage	Good Condition	0
Surface Treatment	Composite, reinforced or bonded	0
Estimated Amount	15 m ²	
Accessibility	Usually Inaccessible	
Risk Score		2

Recommendation	Manage & Re-inspect
Notes

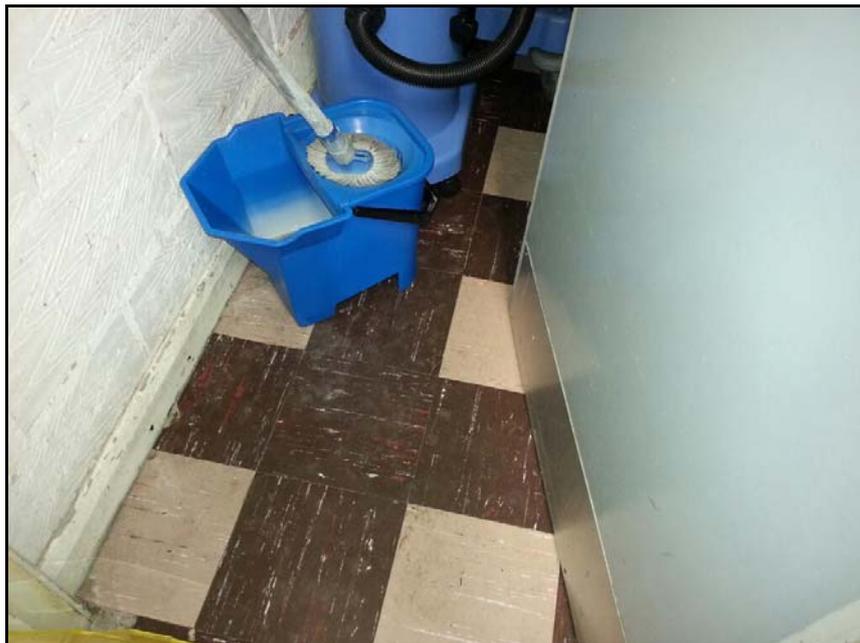
Surveyor	Richard Arnold	Building	Main building
Survey Type	Management	Floor	0
Survey Date	12/02/2020	Location/ Room	010 - Understairs cupboard 010
Next Inspection	12/02/2021	Sample No	S013
Level of Identification	Sample Analysed	Inspection Ref	534439

Description Floor tiles/adhesive.

Score
Asbestos Type	CHRYSTILE (CHRYSTILE PRESENT IN BITUMEN ADHESIVE ONLY)	1
Product Type	Floor Tiles & Adhesive	1
Extent of Damage	Low Damage	1
Surface Treatment	Composite, reinforced or bonded	0
Estimated Amount	2 m ²	
Accessibility	Routinely Disturbed	
Risk Score		3

Recommendation	Manage & Re-inspect
Notes

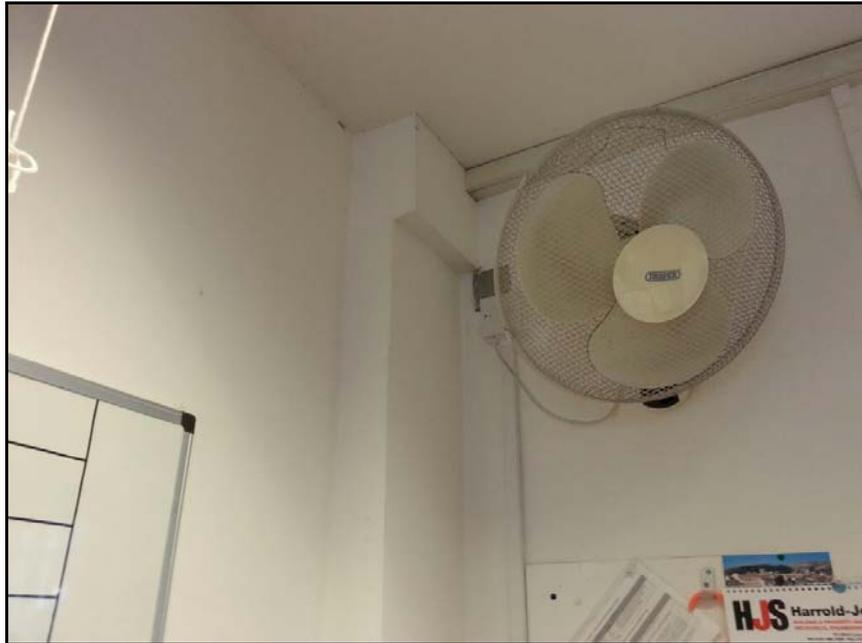
Surveyor	Richard Arnold	Building	Main building
Survey Type	Management	Floor	0
Survey Date	12/02/2020	Location/ Room	011 - Office 011
Next Inspection	12/02/2021	Sample No	P016
Level of Identification	Presumed	Inspection Ref	534443

Description Inside boxing.

Score
Asbestos Type	Presumed Asbestos	-
Product Type		-
Extent of Damage		-
Surface Treatment		-
Estimated Amount		
Accessibility		
Risk Score		12

Recommendation	Inspection Required
Notes	Cannot open without irreparable damage.

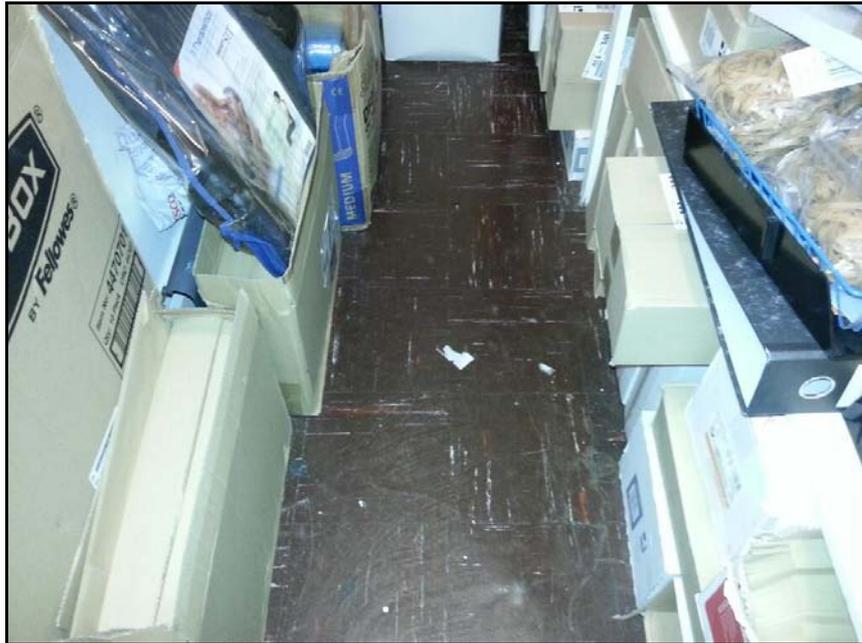
Surveyor	Richard Arnold	Building	Main building
Survey Type	Management	Floor	0
Survey Date	08/06/2020	Location/ Room	012 - Store 012
Next Inspection	08/06/2021	Sample No	S018
Level of Identification	Sample Analysed	Inspection Ref	534450

Description Floor tiles/adhesive.

Score
Asbestos Type	CHRYSTILE (CHRYSTILE PRESENT IN BITUMEN ADHESIVE ONLY)	1
Product Type	Floor Tiles & Adhesive	1
Extent of Damage	Low Damage	1
Surface Treatment	Composite, reinforced or bonded	0
Estimated Amount	3 m ²	
Accessibility	Easily Disturbed	
Risk Score		3

Recommendation	Manage & Re-inspect
Notes

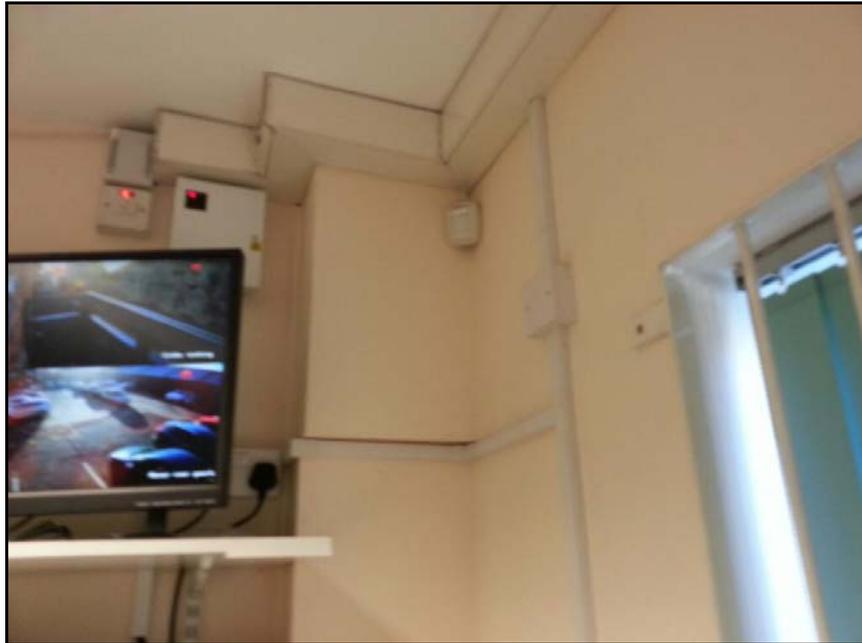
Surveyor	Richard Arnold	Building	Main building
Survey Type	Management	Floor	0
Survey Date	12/02/2020	Location/ Room	026 - Office 026
Next Inspection	12/02/2021	Sample No	P003
Level of Identification	Presumed	Inspection Ref	534359

Description Inside boxing.

Score
Asbestos Type	Presumed Asbestos	-
Product Type		-
Extent of Damage		-
Surface Treatment		-
Estimated Amount		
Accessibility		
Risk Score		12

Recommendation	Inspection Required
Notes	Cannot open without irreparable damage.

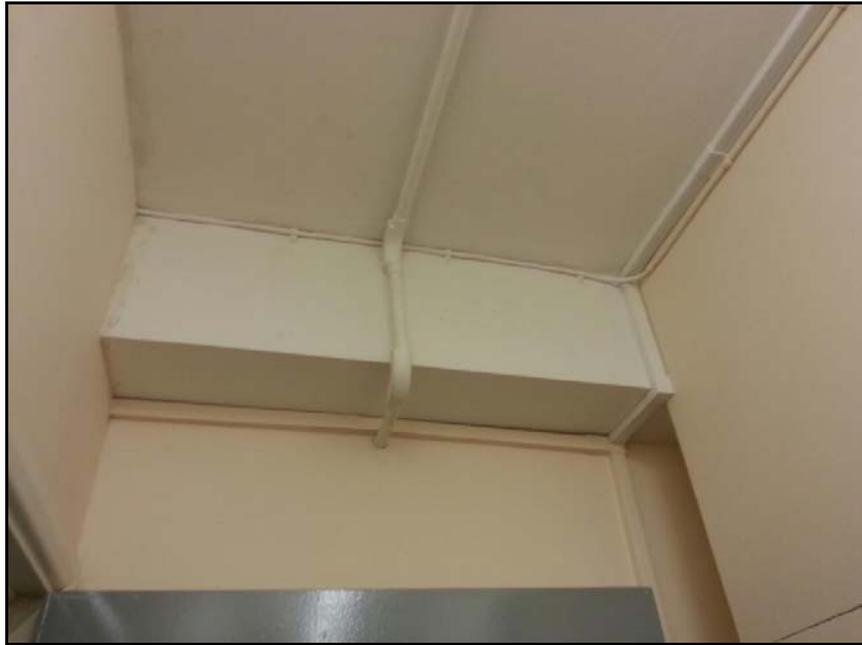
Surveyor	Richard Arnold	Building	Main building
Survey Type	Management	Floor	0
Survey Date	12/02/2020	Location/ Room	027 - Electrical eqpt room 027
Next Inspection	12/02/2021	Sample No	P006
Level of Identification	Presumed	Inspection Ref	534374

Description Inside boxing.

Score
Asbestos Type	Presumed Asbestos	-
Product Type		-
Extent of Damage		-
Surface Treatment		-
Estimated Amount		
Accessibility		
Risk Score		12

Recommendation	Inspection Required
Notes	Cannot open without irreparable damage.

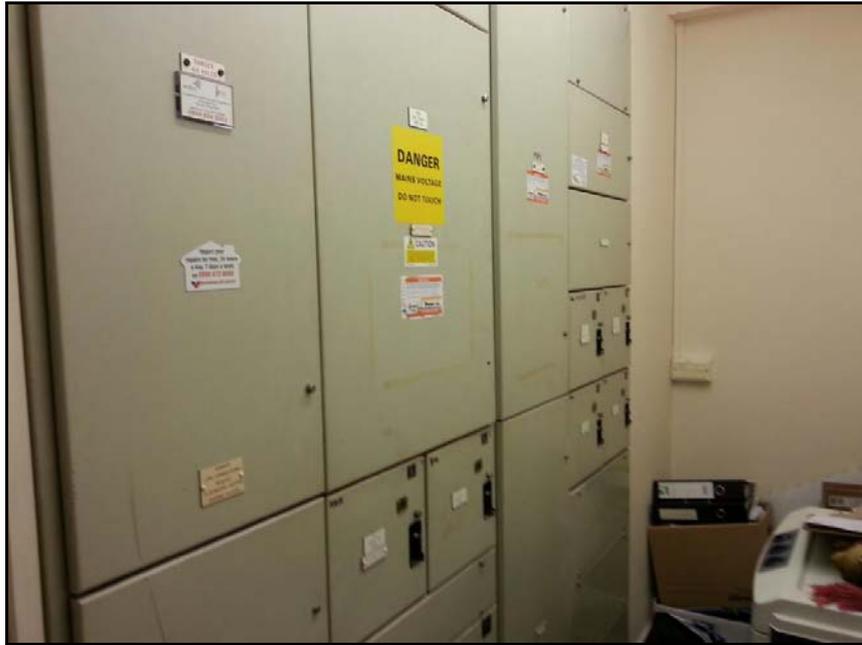
Surveyor	Richard Arnold	Building	Main building
Survey Type	Management	Floor	0
Survey Date	12/02/2020	Location/ Room	027 - Electrical eqpt room 027
Next Inspection	12/02/2021	Sample No	P007
Level of Identification	Presumed	Inspection Ref	534358

Description Electrical equipment.

Score
Asbestos Type	Presumed Asbestos	-
Product Type		-
Extent of Damage		-
Surface Treatment		-
Estimated Amount		
Accessibility		
Risk Score		12

Recommendation	Inspection Required
Notes	Equipment alive.

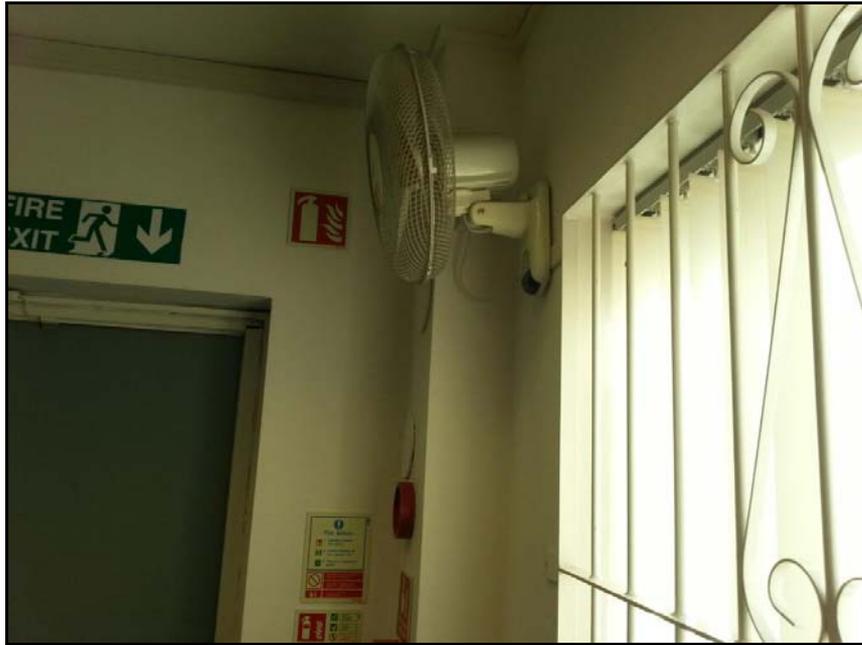
Surveyor	Richard Arnold	Building	Main building
Survey Type	Management	Floor	0
Survey Date	12/02/2020	Location/ Room	028 - Meeting room 1 028
Next Inspection	12/02/2021	Sample No	P017
Level of Identification	Presumed	Inspection Ref	534367

Description Inside boxing.

Score
Asbestos Type	Presumed Asbestos	-
Product Type		-
Extent of Damage		-
Surface Treatment		-
Estimated Amount		
Accessibility		
Risk Score		12

Recommendation	Inspection Required
Notes	Cannot open without irreparable damage.

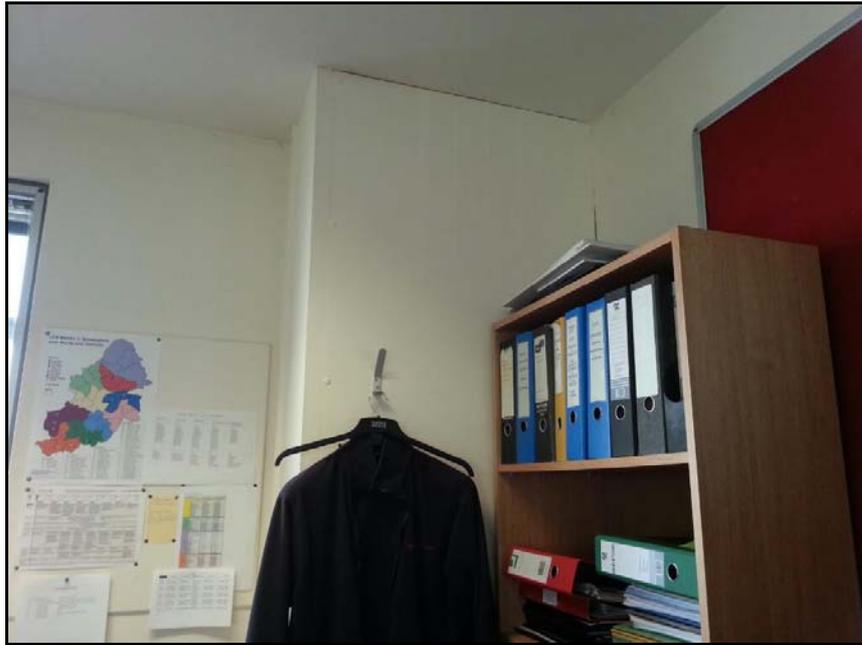
Surveyor	Richard Arnold	Building	Main building
Survey Type	Management	Floor	1
Survey Date	12/02/2020	Location/ Room	017 - Office 017
Next Inspection	12/02/2021	Sample No	P019
Level of Identification	Presumed	Inspection Ref	534464

Description Inside boxing.

Score
Asbestos Type	Presumed Asbestos	-
Product Type		-
Extent of Damage		-
Surface Treatment		-
Estimated Amount		
Accessibility		
Risk Score		12

Recommendation	Inspection Required
Notes	Cannot open without irreparable damage.

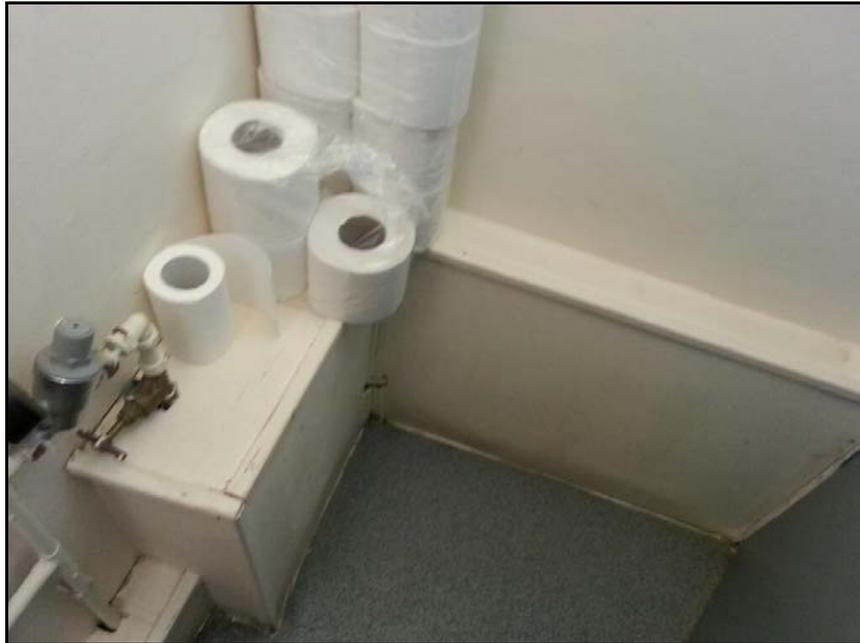
Surveyor	Richard Arnold	Building	Main building
Survey Type	Management	Floor	1
Survey Date	12/02/2020	Location/ Room	018 - WC 018
Next Inspection	12/02/2021	Sample No	P020
Level of Identification	Presumed	Inspection Ref	534470

Description Inside boxing.

Score
Asbestos Type	Presumed Asbestos	-
Product Type		-
Extent of Damage		-
Surface Treatment		-
Estimated Amount		
Accessibility		
Risk Score		12

Recommendation	Inspection Required
Notes	Cannot open without irreparable damage.

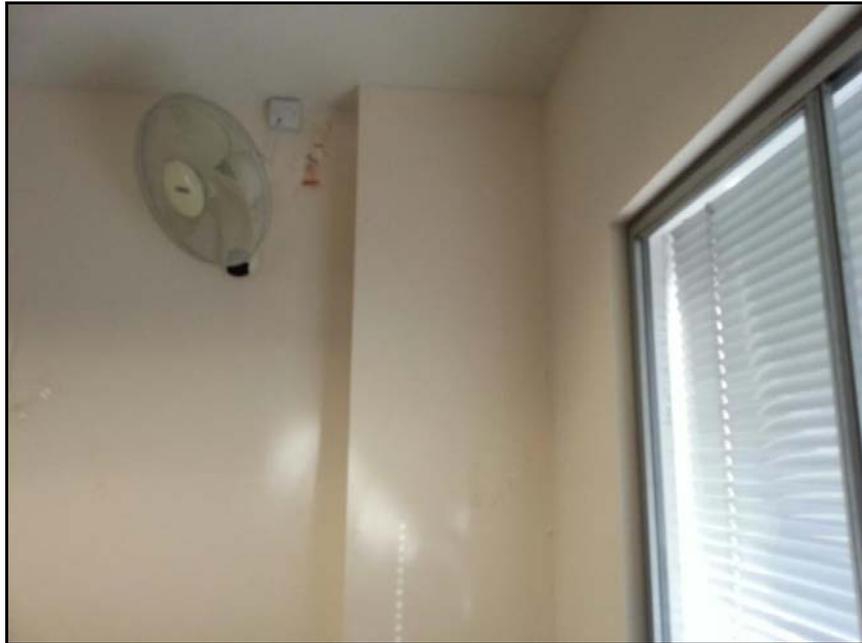
Surveyor	Richard Arnold	Building	Main building
Survey Type	Management	Floor	1
Survey Date	12/02/2020	Location/ Room	022 - Office 022
Next Inspection	12/02/2021	Sample No	P022
Level of Identification	Presumed	Inspection Ref	534489

Description Inside boxing.

Score
Asbestos Type	Presumed Asbestos	-
Product Type		-
Extent of Damage		-
Surface Treatment		-
Estimated Amount		
Accessibility		
Risk Score		12

Recommendation	Inspection Required
Notes	Cannot open without irreparable damage.

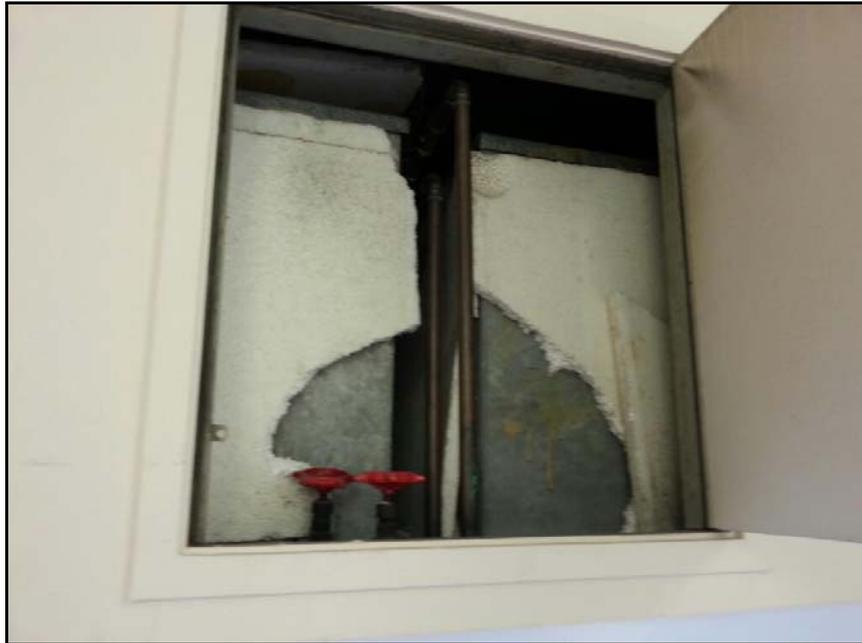
Surveyor	Richard Arnold	Building	Main building
Survey Type	Management	Floor	1
Survey Date	12/02/2020	Location/ Room	031 - Tank cupboard 031
Next Inspection	12/02/2021	Sample No	P021
Level of Identification	Presumed	Inspection Ref	534508

Description Inside tank cupboard.

Score
Asbestos Type	Presumed Asbestos	-
Product Type		-
Extent of Damage		-
Surface Treatment		-
Estimated Amount		
Accessibility		
Risk Score		12

Recommendation	Inspection Required
Notes	No access to all areas because blocked by water tanks.

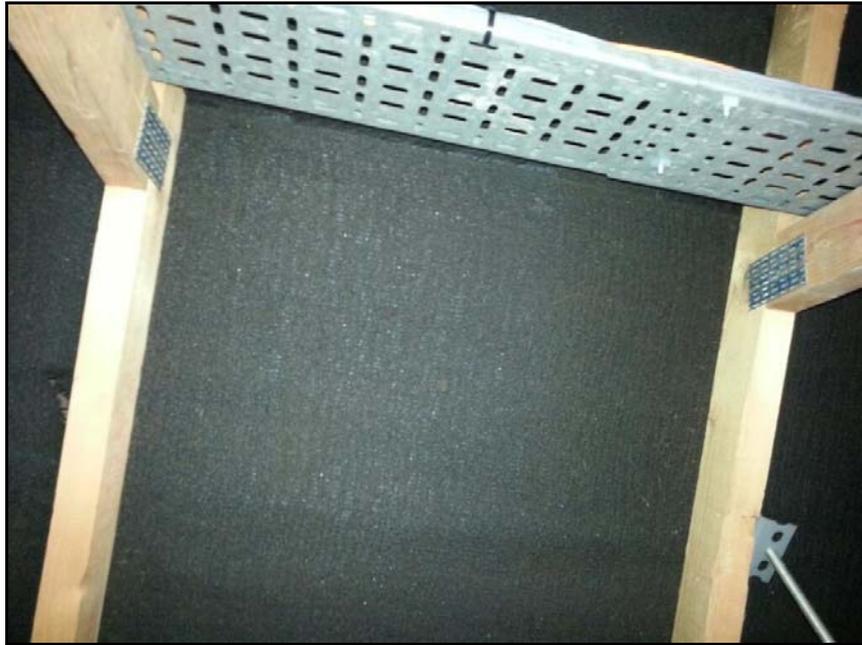
Surveyor	Richard Arnold	Building	Main building
Survey Type	Management	Floor	2
Survey Date	12/02/2020	Location/ Room	032 - Roof space
Next Inspection	12/02/2021	Sample No	S023
Level of Identification	Sample Analysed	Inspection Ref	534515

Description Sarking.

Score
Asbestos Type	NO ASBESTOS DETECTED	-
Product Type	Felt	-
Extent of Damage	Good Condition	-
Surface Treatment	Composite, reinforced or bonded	-
Estimated Amount	160 m ²	
Accessibility	Usually Inaccessible	
Risk Score		0

Recommendation	No Recommendation Required
Notes

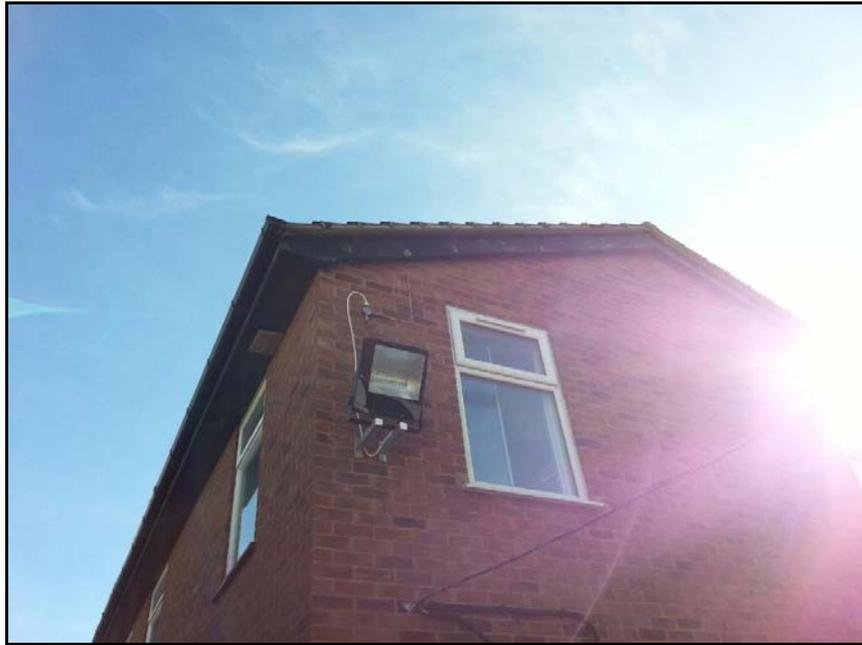
Surveyor	Richard Arnold	Building	Main building
Survey Type	Management	Floor	2
Survey Date	12/02/2020	Location/ Room	033 - External
Next Inspection	12/02/2021	Sample No	P024
Level of Identification	Presumed	Inspection Ref	534523

Description Roof verge undercloaking.

Score
Asbestos Type	Presumed Asbestos	-
Product Type		-
Extent of Damage		-
Surface Treatment		-
Estimated Amount		
Accessibility		
Risk Score		12

Recommendation	Inspection Required
Notes	No access because of height.

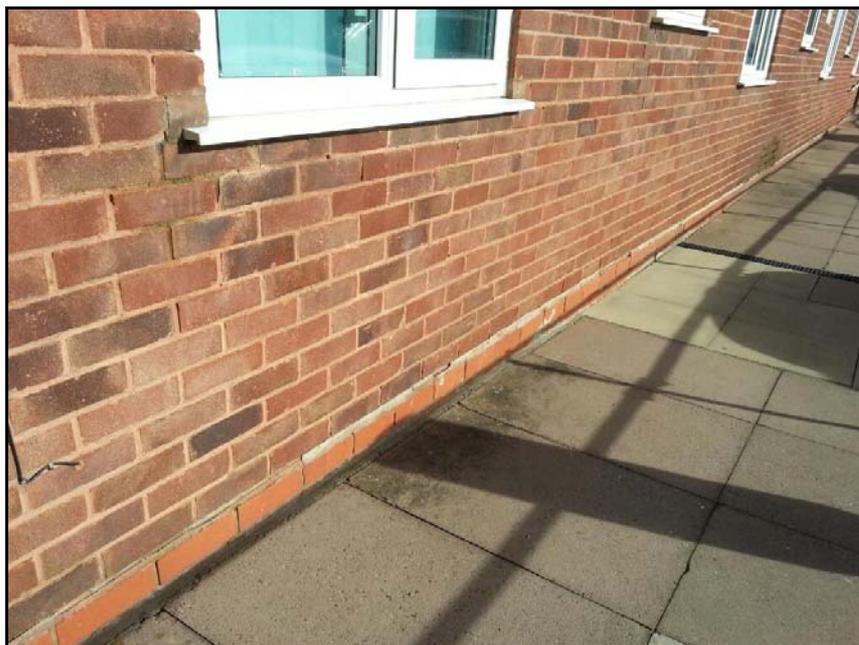
Surveyor	Richard Arnold	Building	Main building
Survey Type	Management	Floor	2
Survey Date	12/02/2020	Location/ Room	033 - External
Next Inspection	12/02/2021	Sample No	PS025
Level of Identification	Previously Sampled	Inspection Ref	534522

Description DPC .

Score
Asbestos Type	CHRYSTILE;	1
Product Type	Bitumen Products	1
Extent of Damage	Good Condition	0
Surface Treatment	Composite, reinforced or bonded	0
Estimated Amount	200 L/M	
Accessibility	Usually Inaccessible	
Risk Score		2

Recommendation	Manage & Re-inspect
Notes	Sampled Previously Report Ref: D-1848-22.
