Asbestos Management Survey

Mole Street Depot, B11 1XA

Report No	D-11066	Report Issue Date	7 April 2025
Client Name & Address	Property Services Place, Prosperity & Sustainability Directorate Birmingham City Council PO Box 16255 Birmingham B2 2WT	Site Address	Mole Street Depot, Mole Street, Birmingham, B11 1XA
Order Placed By	Phil Andrews	Instruction Date	12 March 2025
Order Number	B1-AV056-2Z09-E00-JZZZZZ-TV2GN- JZZZ-JXXX	Project Reference	IPBL001826
Survey Date(s)	Between 14/03/2025 and 26/03/2025	Lead Surveyor	Luke Murphy

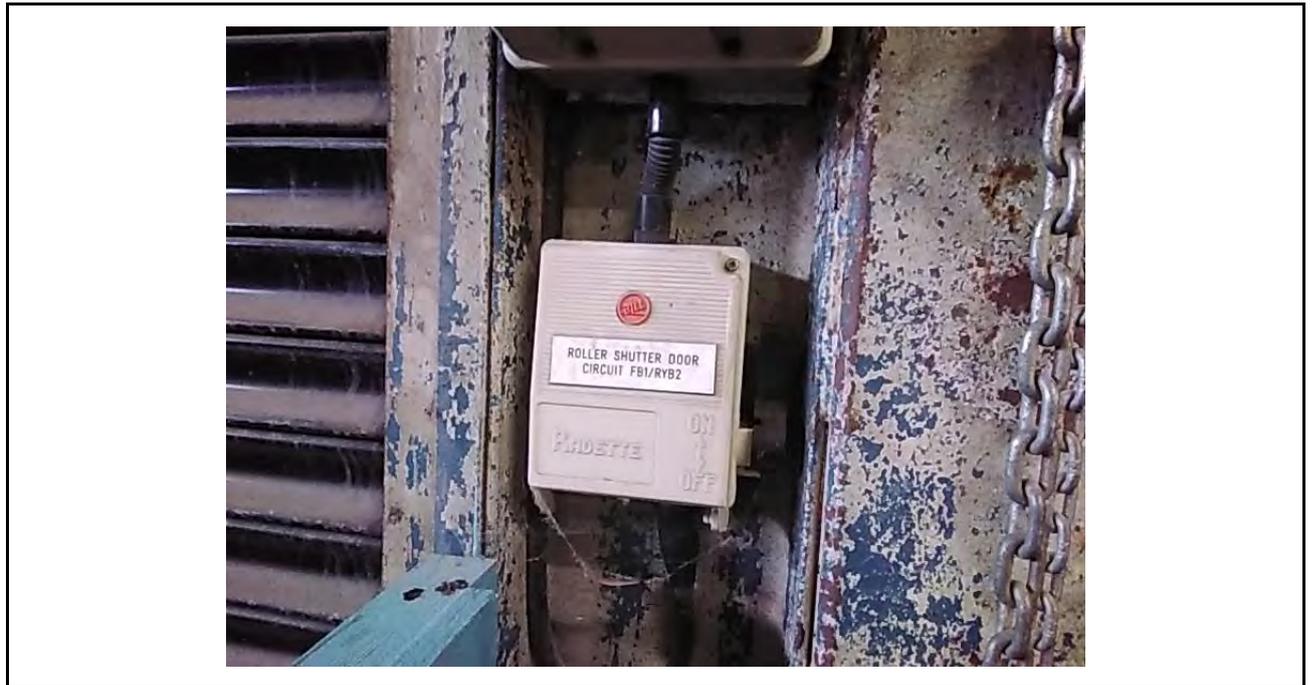
Description Electrics (older items).

Score
Asbestos Type	Presumed Asbestos	-
Product Type		-
Extent of Damage		-
Surface Treatment		-
Estimated Amount		
Accessibility		
Risk Score		12

Recommendation	Inspection Required
Notes	Unable to safely inspect internally to live electrical items. Asbestos content presumed.

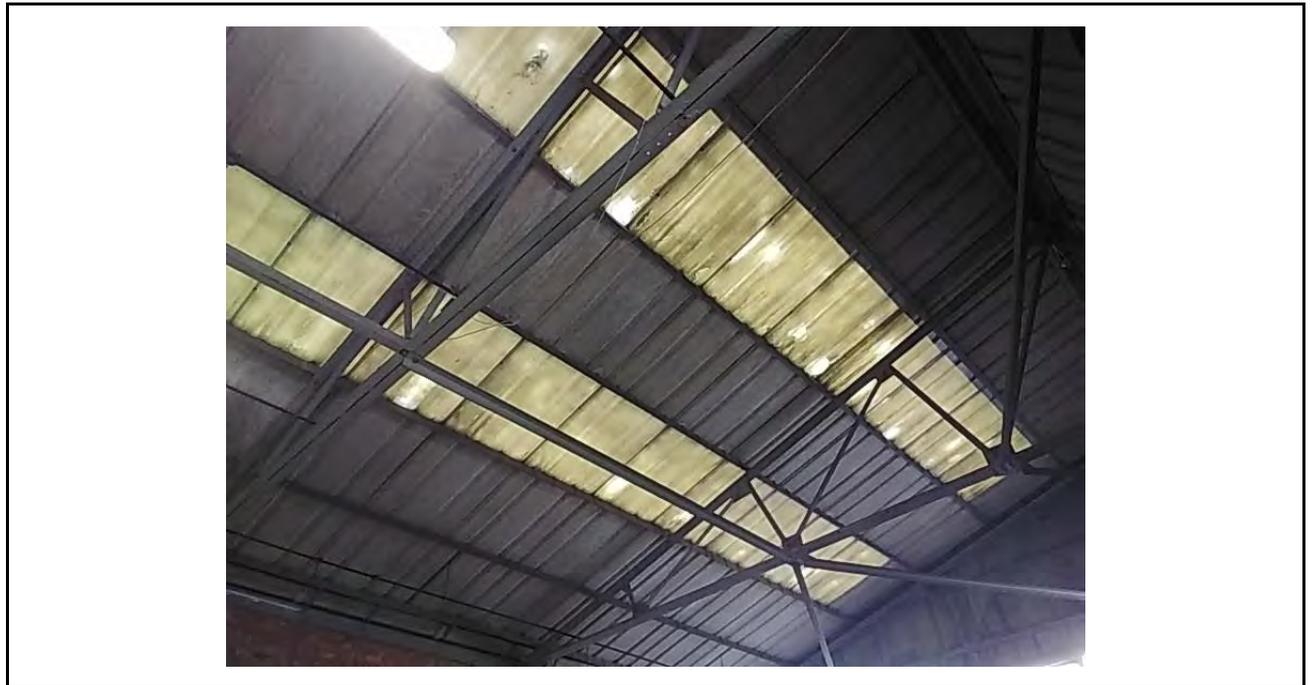
Description Roof sheets .

Score
Asbestos Type	CHRYSTILE	1
Product Type	Cement Products	1
Extent of Damage	Good Condition	0
Surface Treatment	Unsealed cement / Enclosed lagging or spray / Encapsulated board	1
Estimated Amount	130 m ²	
Accessibility	Usually Inaccessible	
Risk Score		3

Recommendation	Manage & Re-inspect
Notes

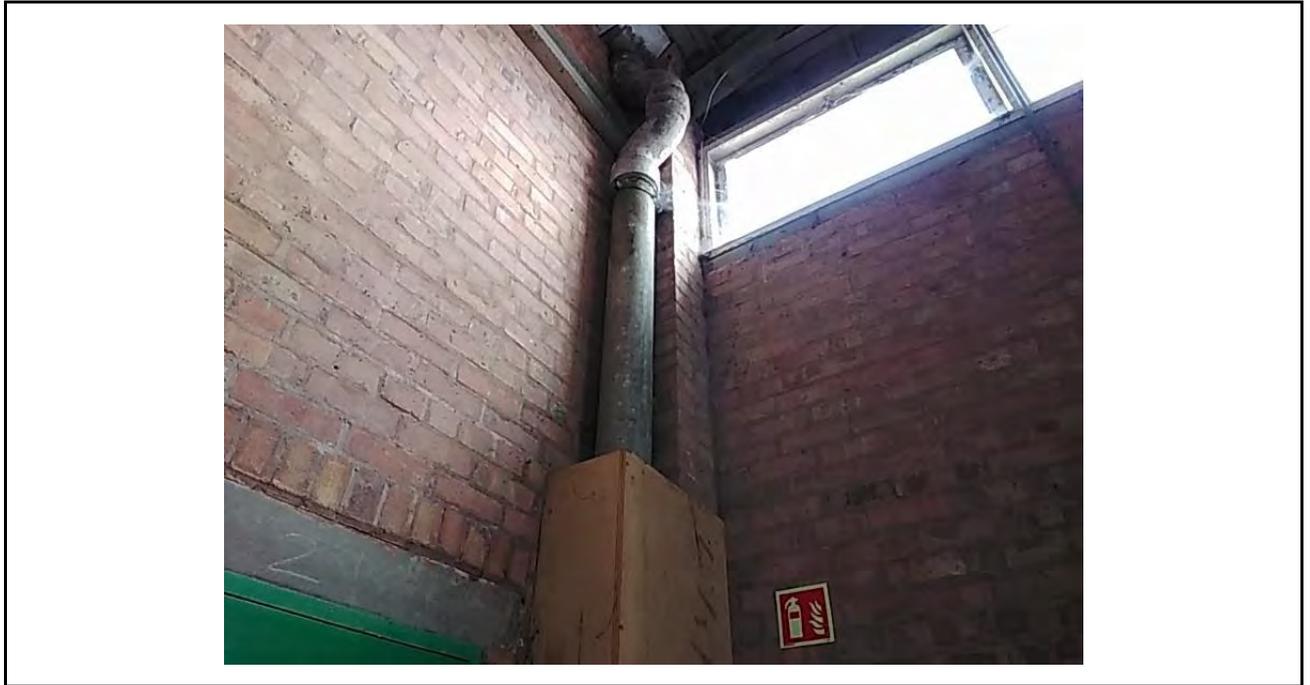
Description Flue pipe .

Score
Asbestos Type	CHRYSTILE	1
Product Type	Cement Products	1
Extent of Damage	Good Condition	0
Surface Treatment	Unsealed cement / Enclosed lagging or spray / Encapsulated board	1
Estimated Amount	5 L/M	
Accessibility	Occasional Disturbance	
Risk Score		3

Recommendation	Manage & Re-inspect
Notes	Also located behind timber boxing.

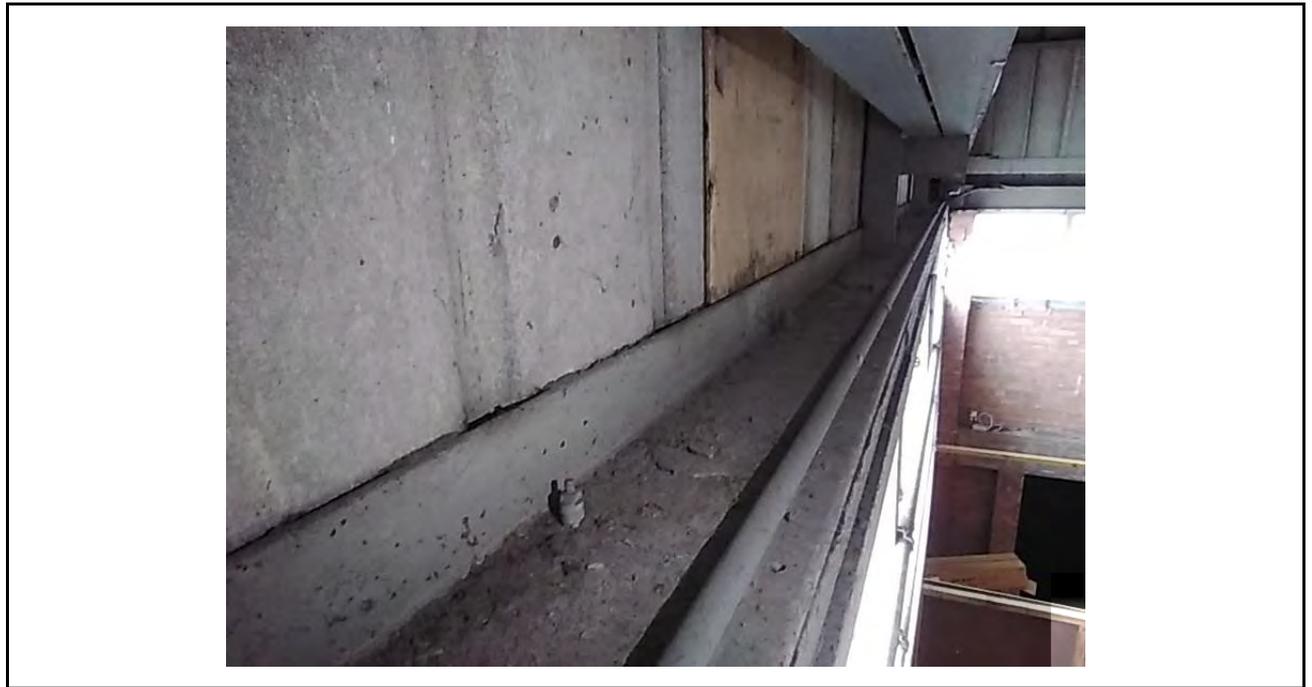
Building	Floor	Location/ Room	Position	Item	Sample No.	Inspection Ref	Risk Score
Main building	0	0001 - Main entrance / loading bay area 01	Debris above windows	Cement Products	S010	1047593	6

Description Debris above windows.

Score
Asbestos Type	CHRYSTILE	1
Product Type	Cement Products	1
Extent of Damage	High Damage	3
Surface Treatment	Unsealed cement / Enclosed lagging or spray / Encapsulated board	1
Estimated Amount	2 m ²	
Accessibility	Usually Inaccessible	
Risk Score		6

Recommendation	Restrict Access. Remove As Planned Work
Notes	Located above the windows at high level.

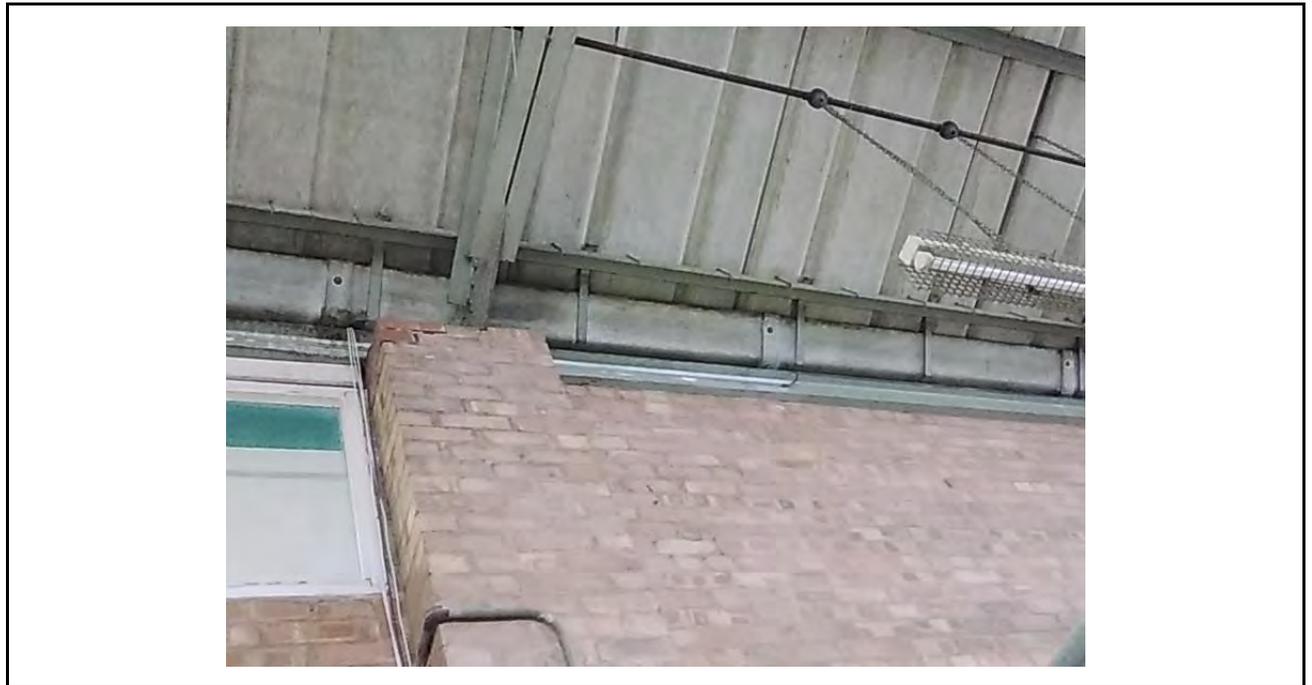
Description Gully / trough . Visually consistent with Sample 1.

Score
Asbestos Type	CHRYSTILE	1
Product Type	Cement Products	1
Extent of Damage	Good Condition	0
Surface Treatment	Unsealed cement / Enclosed lagging or spray / Encapsulated board	1
Estimated Amount	10 m ²	
Accessibility	Usually Inaccessible	
Risk Score		3

Recommendation	Manage & Re-inspect
Notes	Located at high level to middle of the roof structure.

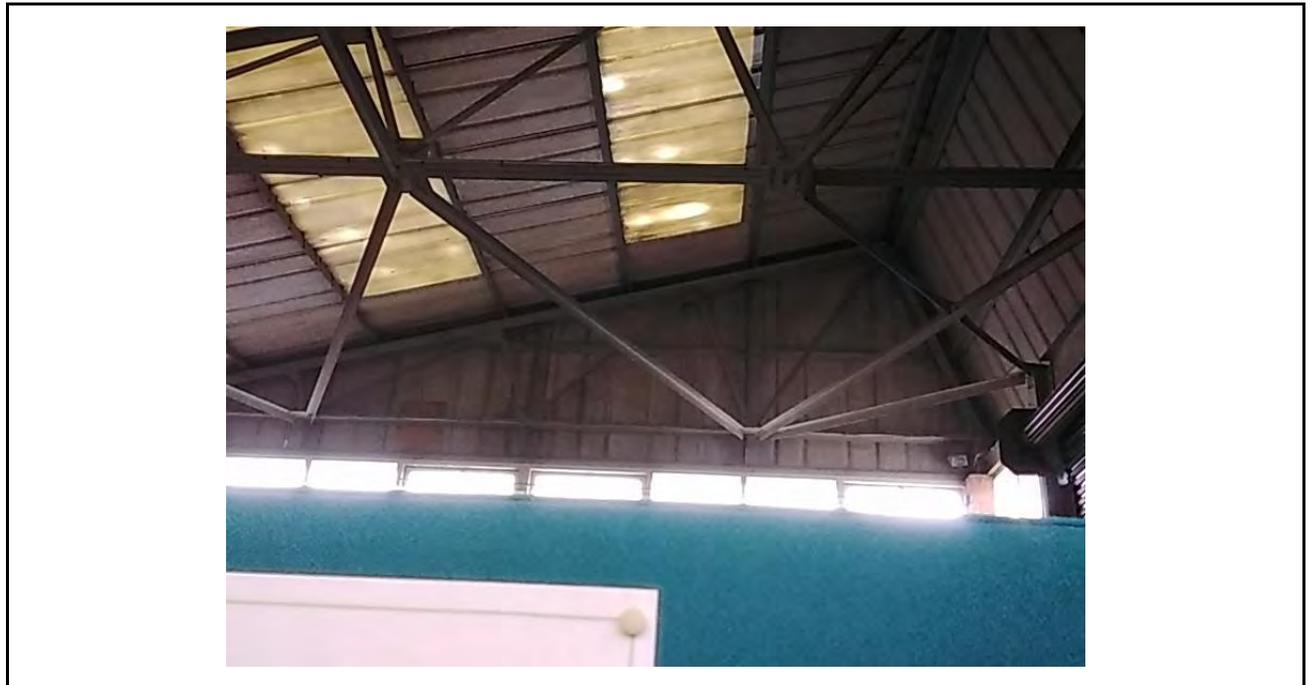
Description Wall panels . Visually consistent with Sample 1.

Score
Asbestos Type	CHRYSTOLE	1
Product Type	Cement Products	1
Extent of Damage	Good Condition	0
Surface Treatment	Unsealed cement / Enclosed lagging or spray / Encapsulated board	1
Estimated Amount	12 m ²	
Accessibility	Usually Inaccessible	
Risk Score		3

Recommendation	Manage & Re-inspect
Notes	Located to gable end of building at high level to the roof structure.

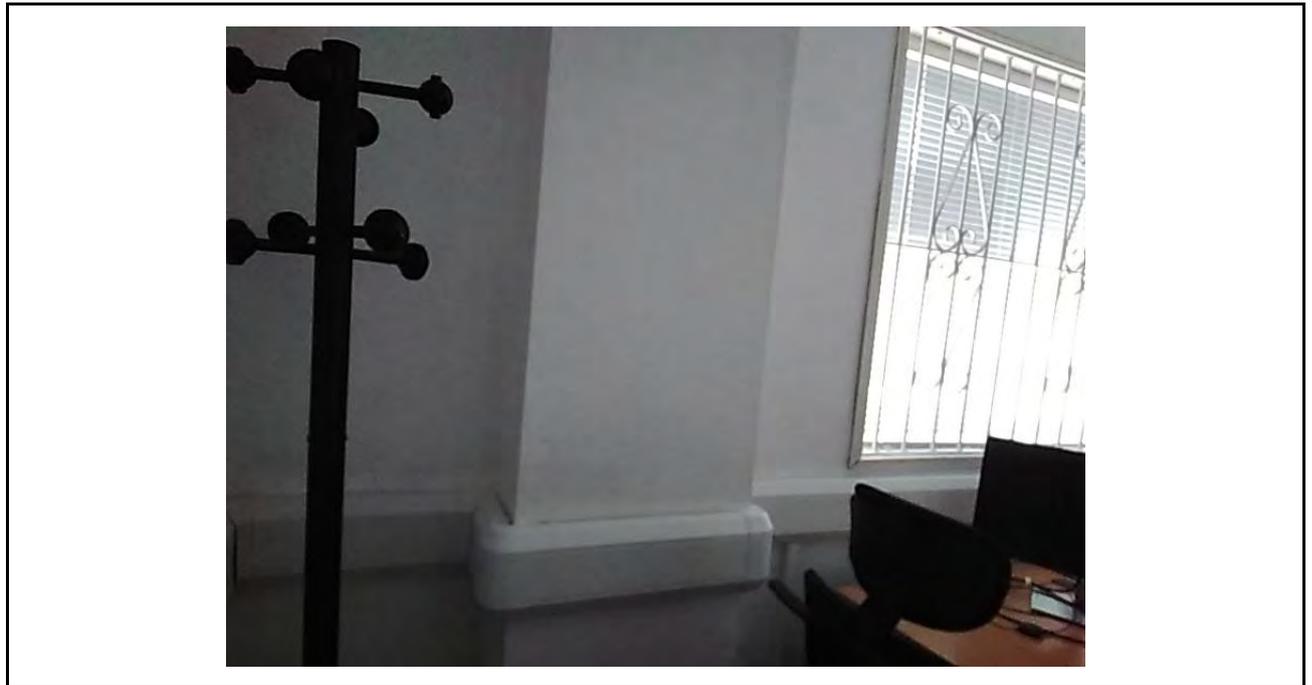
Description Behind boxing .

Score
Asbestos Type	Presumed Asbestos	-
Product Type		-
Extent of Damage		-
Surface Treatment		-
Estimated Amount		
Accessibility		
Risk Score		12

Recommendation	Inspection Required
Notes	Unable to remove due to damage limitation. The building/area is in use on a daily basis.

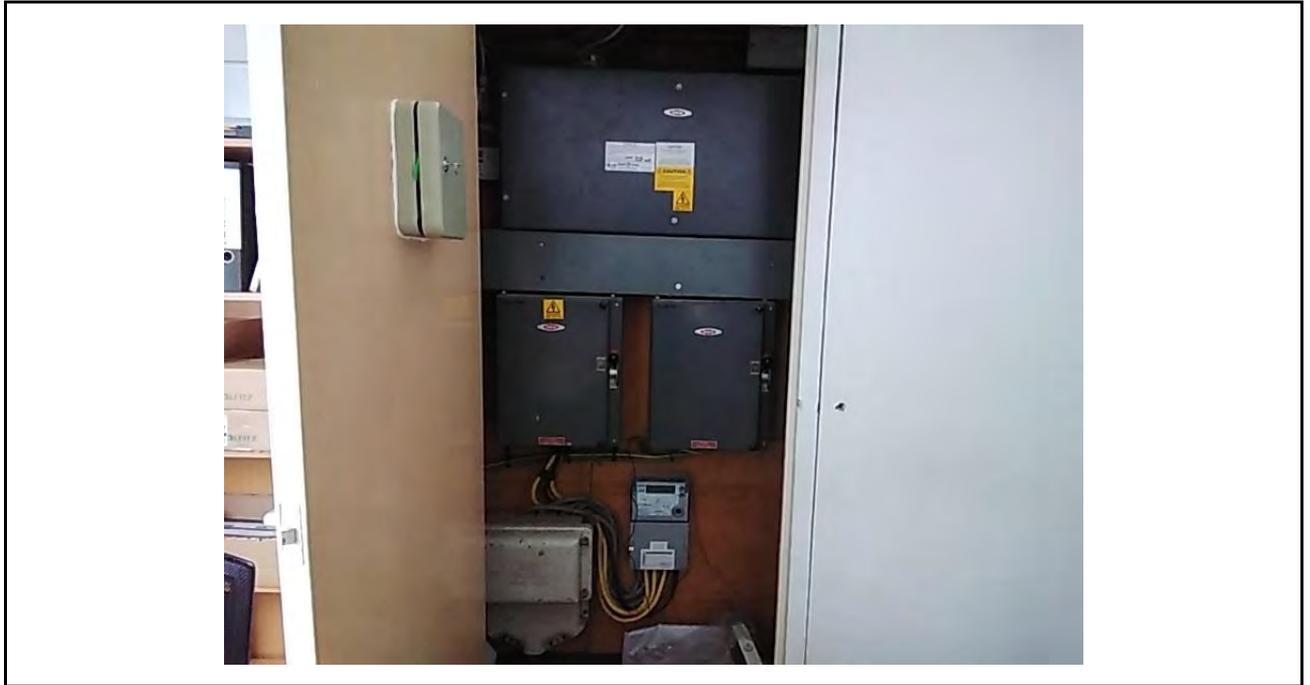
Description Electrics .

Score
Asbestos Type	Presumed Asbestos	-
Product Type		-
Extent of Damage		-
Surface Treatment		-
Estimated Amount		
Accessibility		
Risk Score		12

Recommendation	Inspection Required
Notes	Unable to safely inspect internally to live electrical items. Asbestos content presumed.

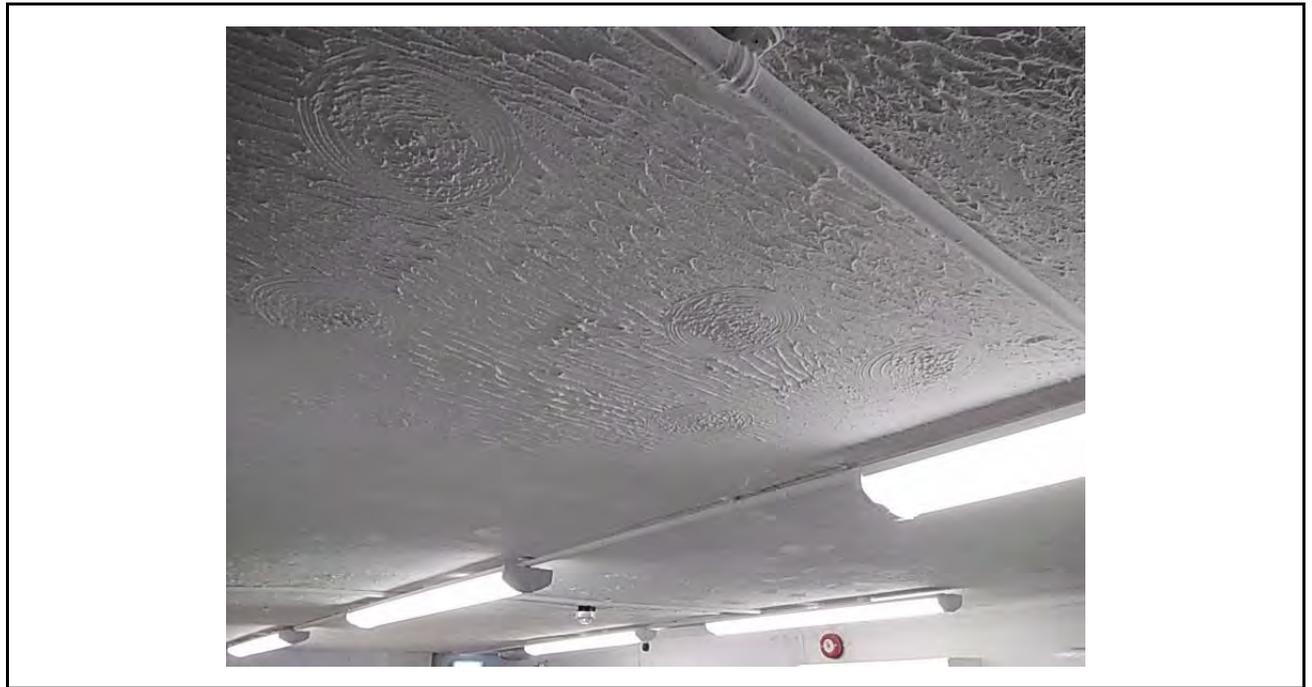
Description Ceiling .

Score
Asbestos Type	NO ASBESTOS DETECTED	-
Product Type	Textured Coating	-
Extent of Damage	Good Condition	-
Surface Treatment	Composite, reinforced or bonded	-
Estimated Amount	70 m ²	
Accessibility	Occasional Disturbance	
Risk Score		0

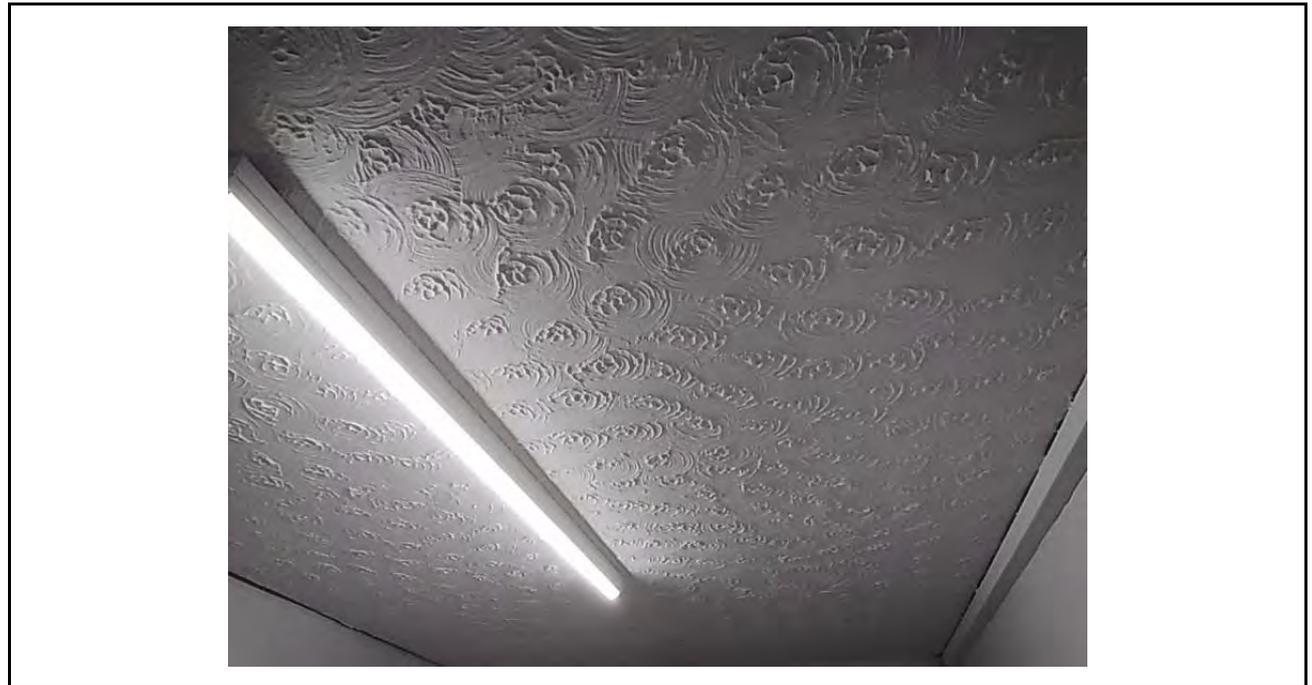
Description Ceiling .

Score
Asbestos Type	NO ASBESTOS DETECTED	-
Product Type	Textured Coating	-
Extent of Damage	Good Condition	-
Surface Treatment	Composite, reinforced or bonded	-
Estimated Amount	9 m ²	
Accessibility	Occasional Disturbance	
Risk Score		0

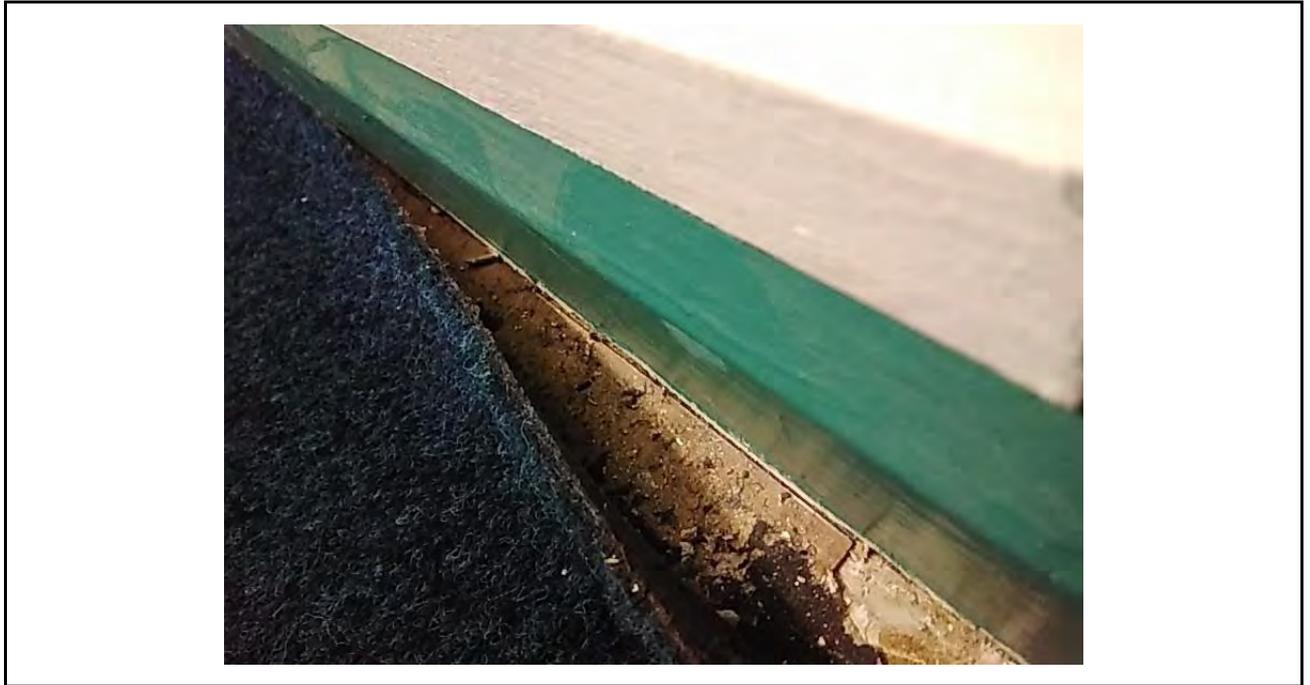
Description Floor tiles .

Score
Asbestos Type	NO ASBESTOS DETECTED	-
Product Type	Reinforced composites	-
Extent of Damage	Good Condition	-
Surface Treatment	Composite, reinforced or bonded	-
Estimated Amount	9 m ²	
Accessibility	Usually Inaccessible	
Risk Score		0

Recommendation	No Recommendation Required
Notes	Located beneath carpet.

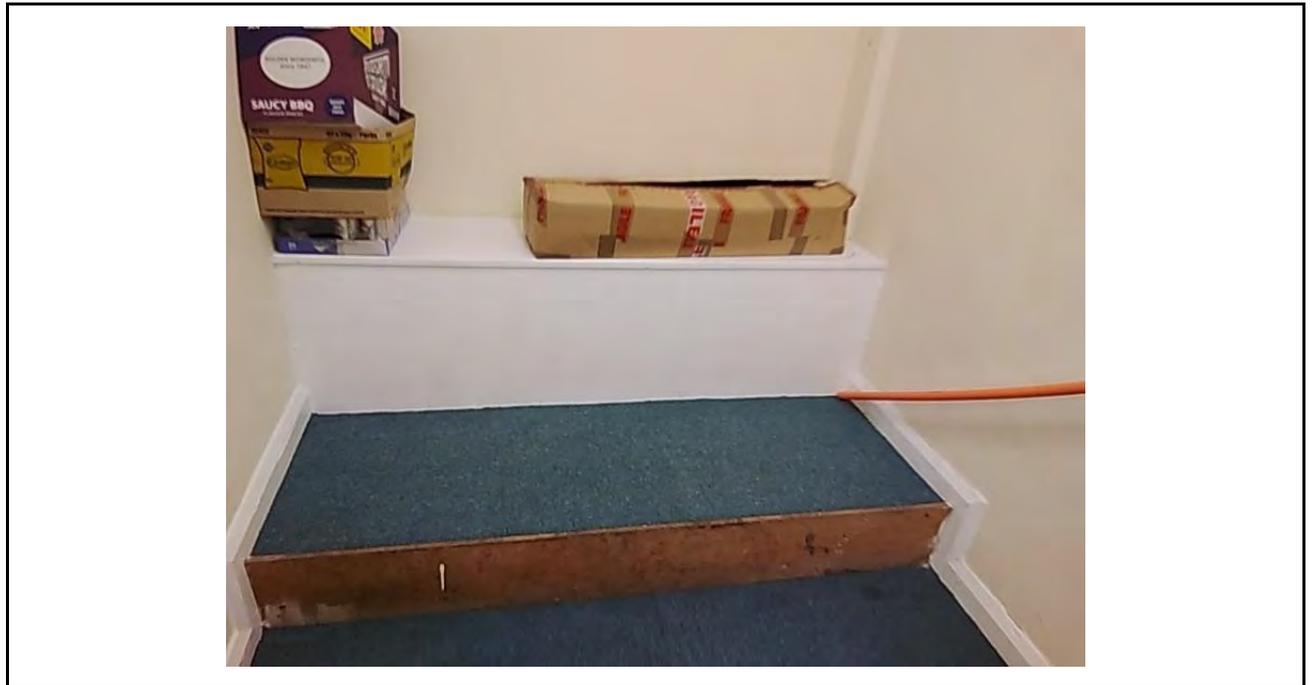
Description Behind boxing .

Score
Asbestos Type	Presumed Asbestos	-
Product Type		-
Extent of Damage		-
Surface Treatment		-
Estimated Amount		
Accessibility		
Risk Score		12

Recommendation	Inspection Required
Notes	Unable to remove due to damage limitation. The building/area is in use on a daily basis.

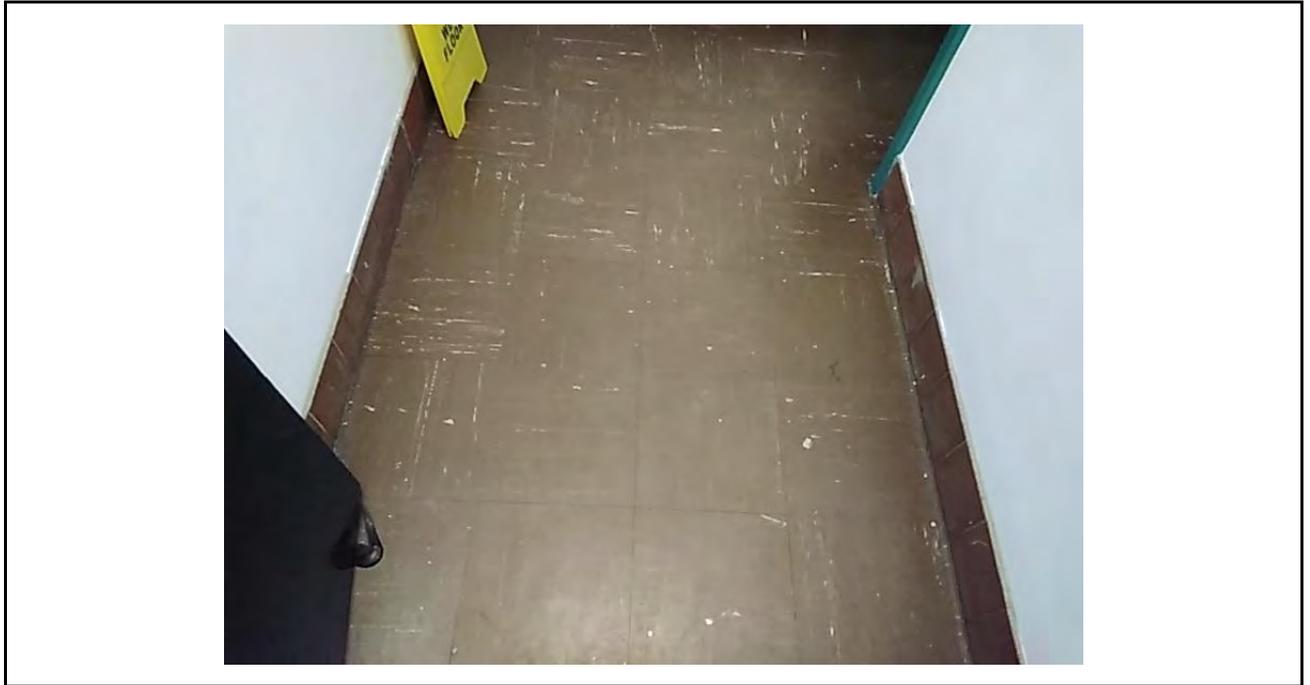
Description Floor tiles .

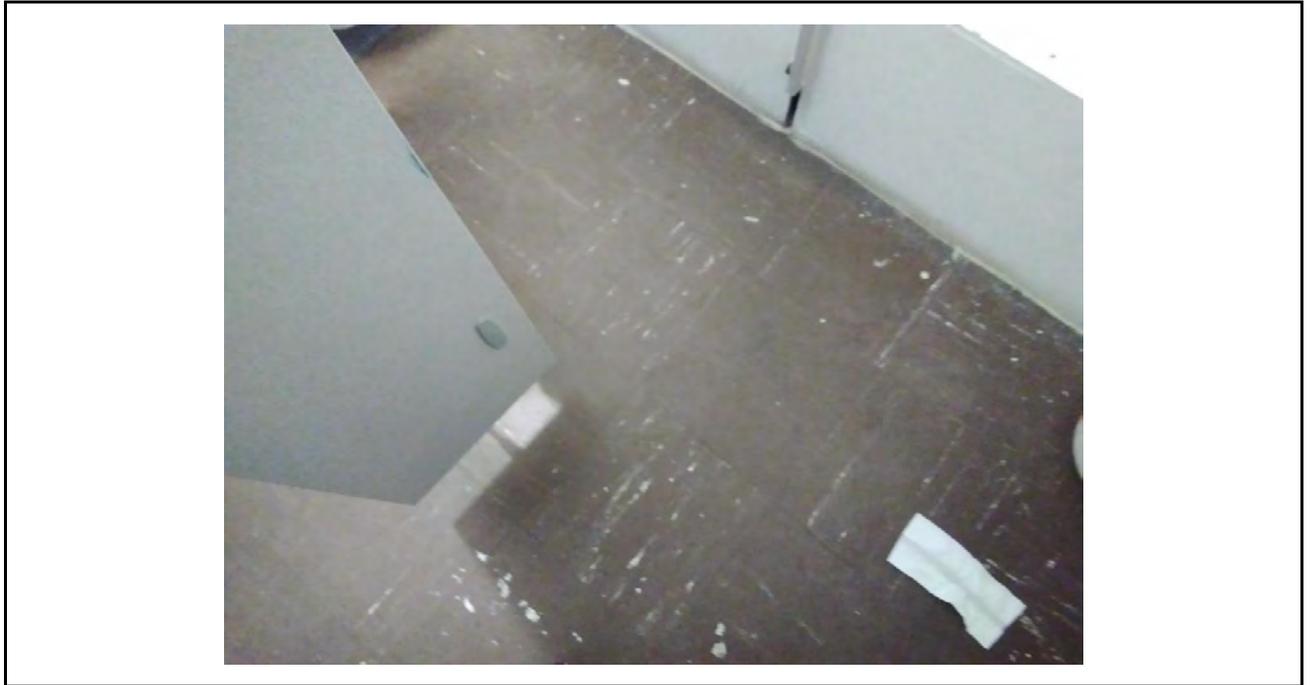
Description Floor tiles . Visually consistent with Sample 11.

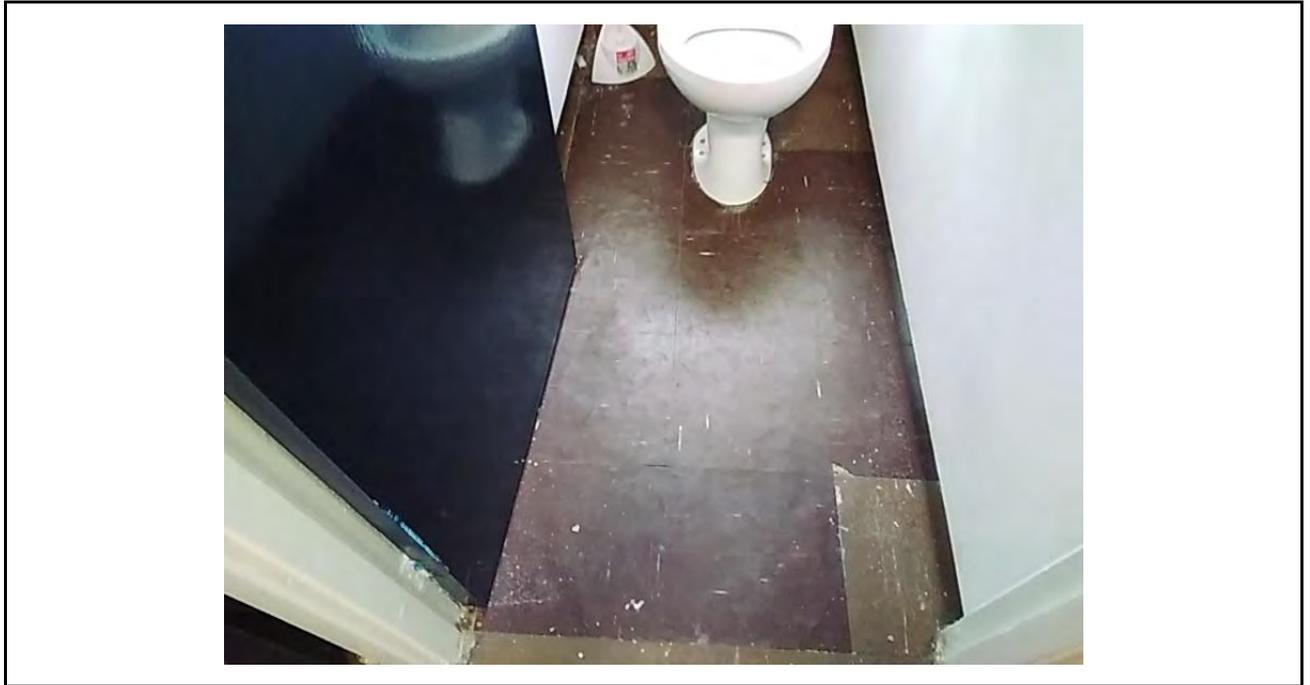
Description Floor tiles .

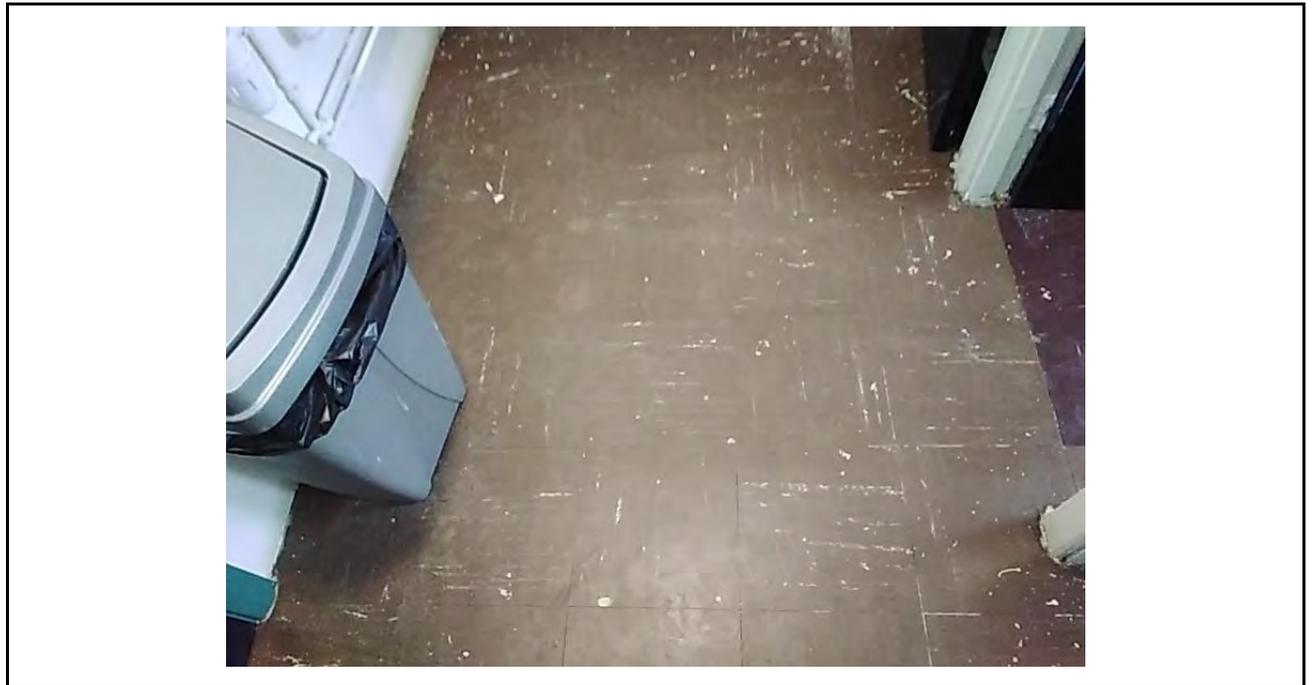
Description Floor tiles . Visually consistent with Sample 11.

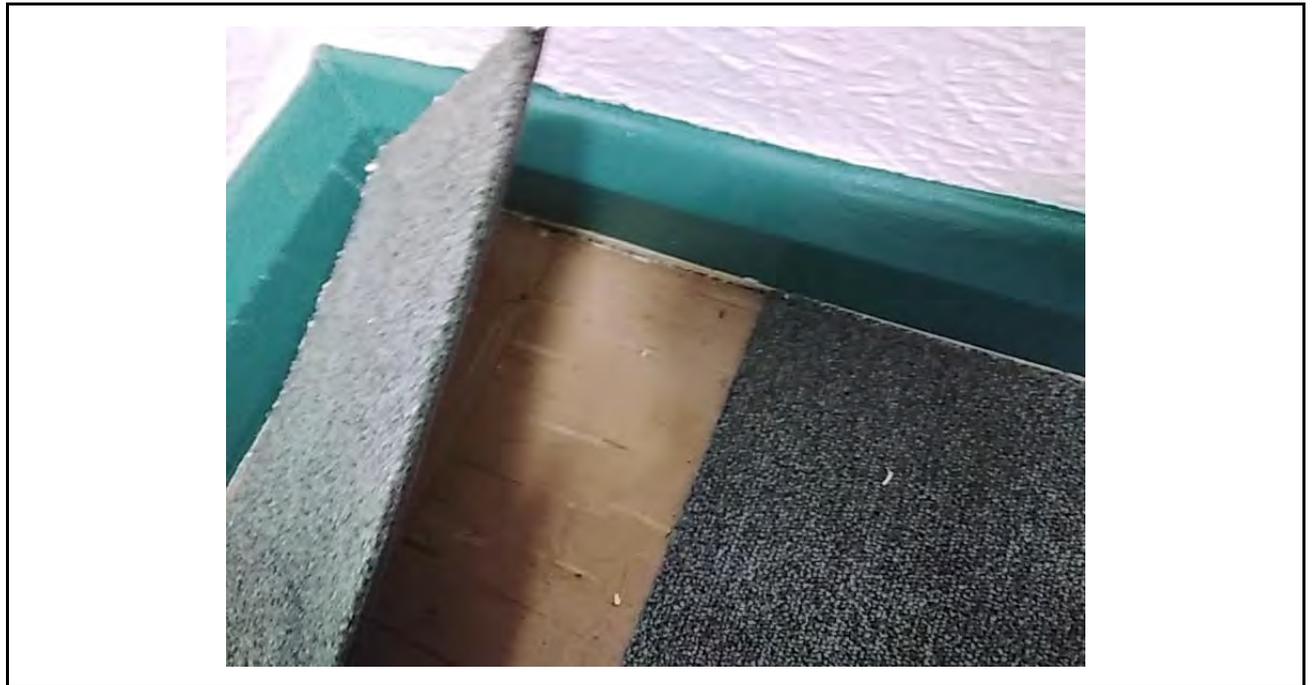
Description Floor tiles .

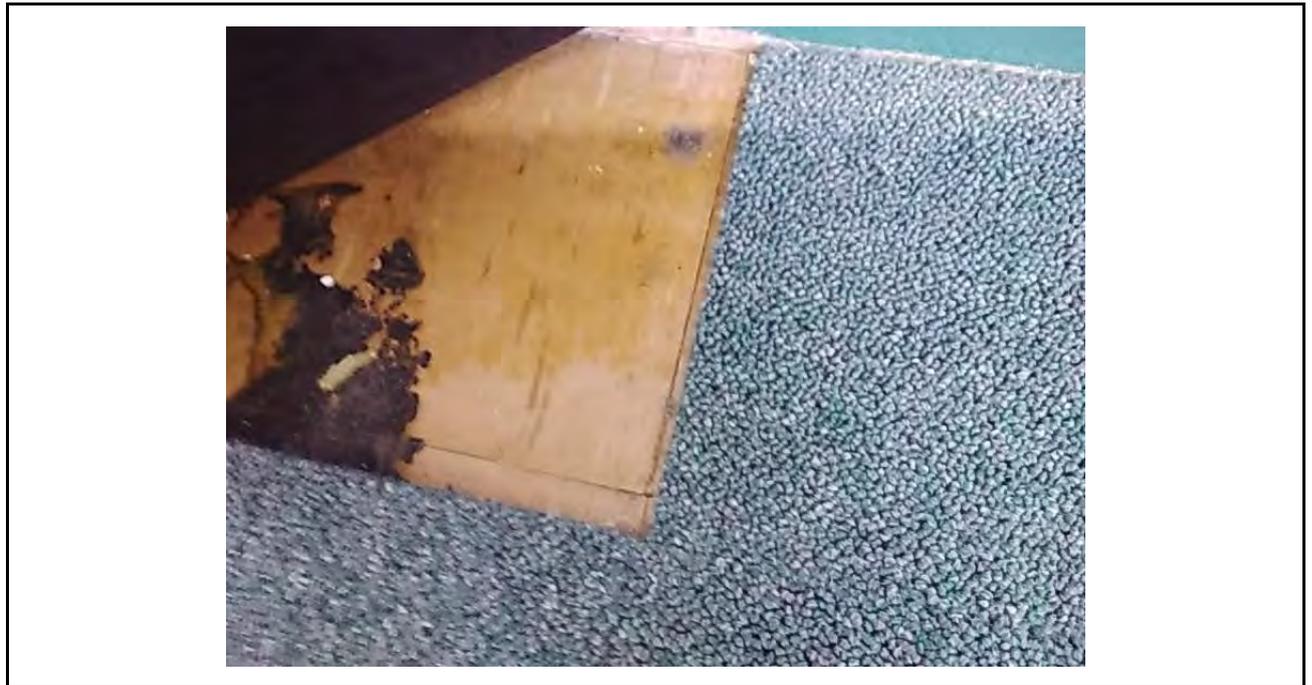
Description Floor tiles . Visually consistent with Sample 13.

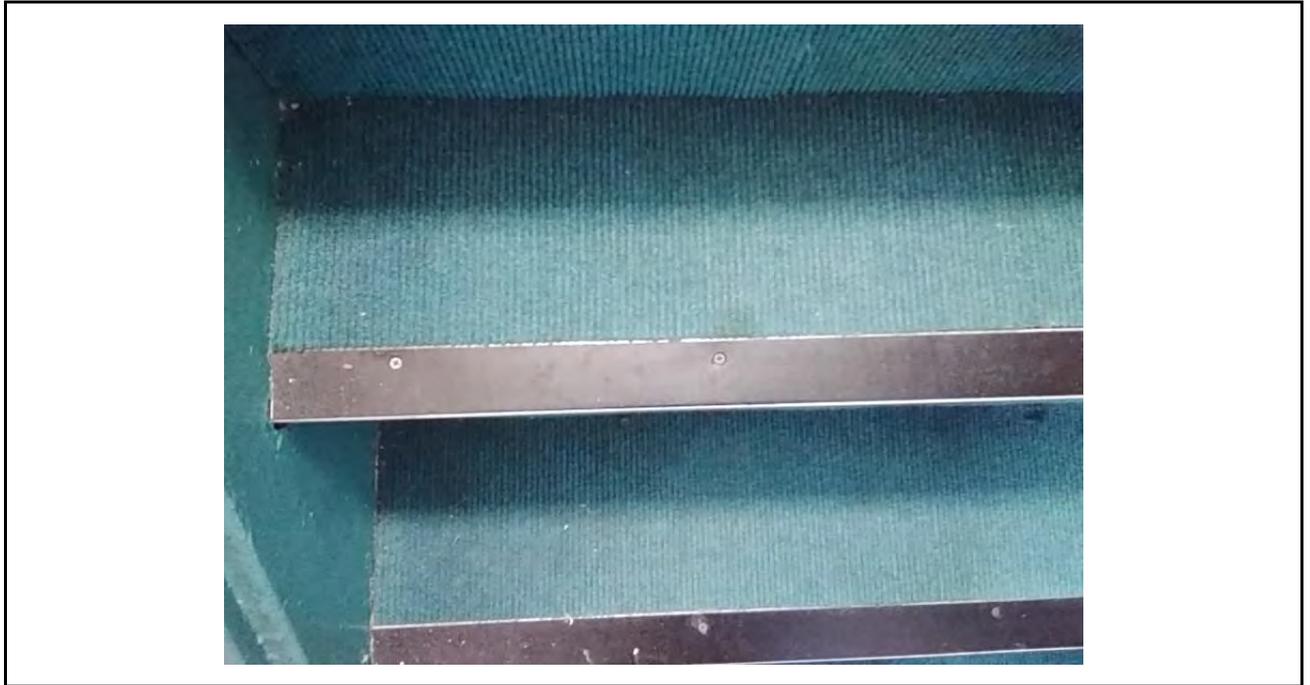
Description Stair nosing .

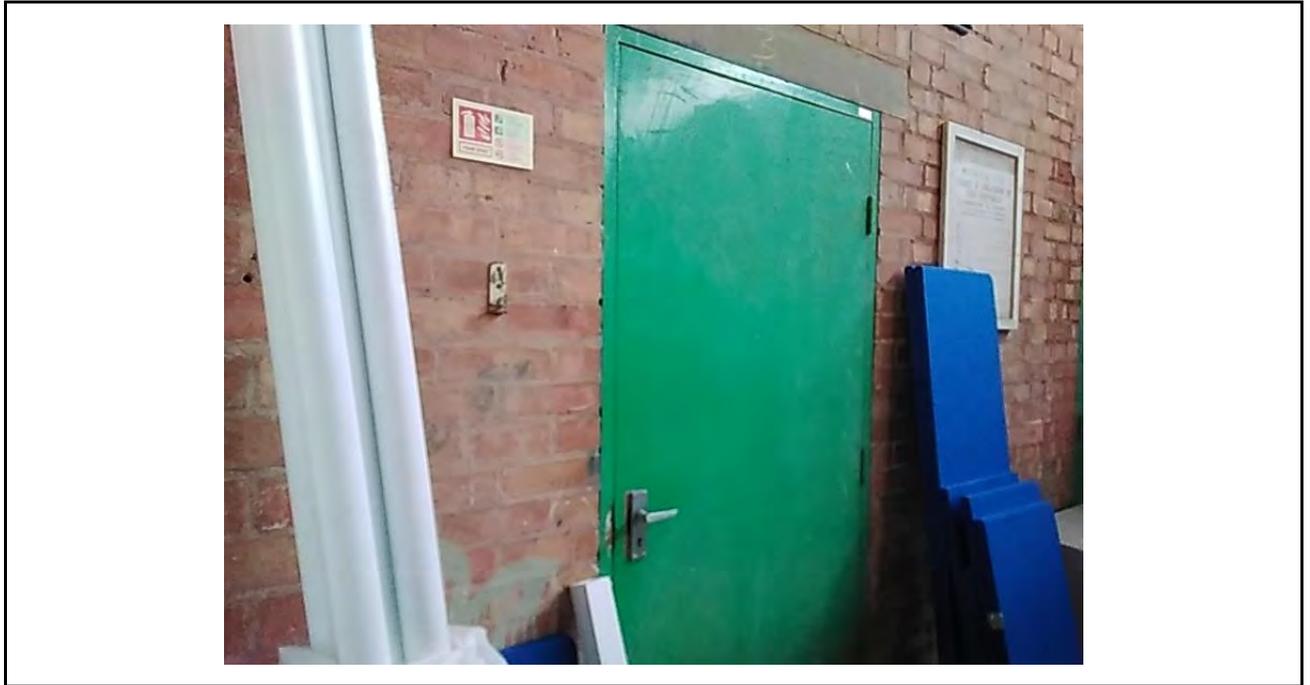
Description No access .

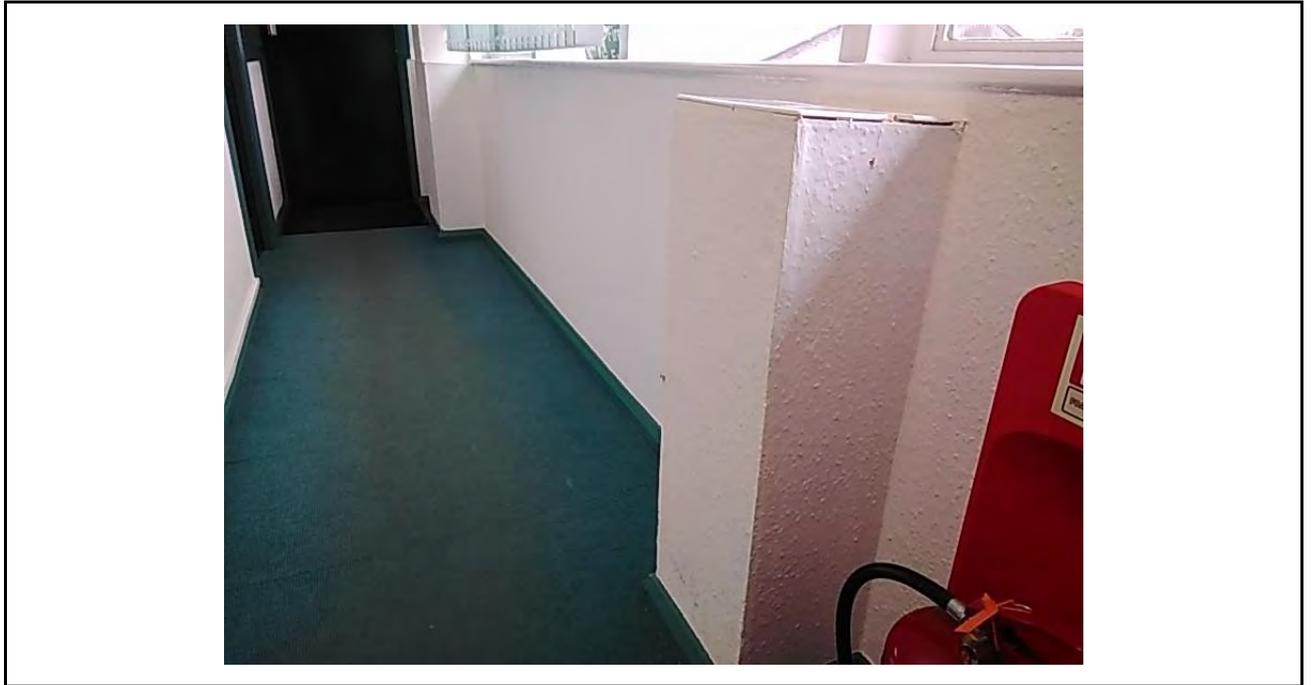
Description Behind boxing .

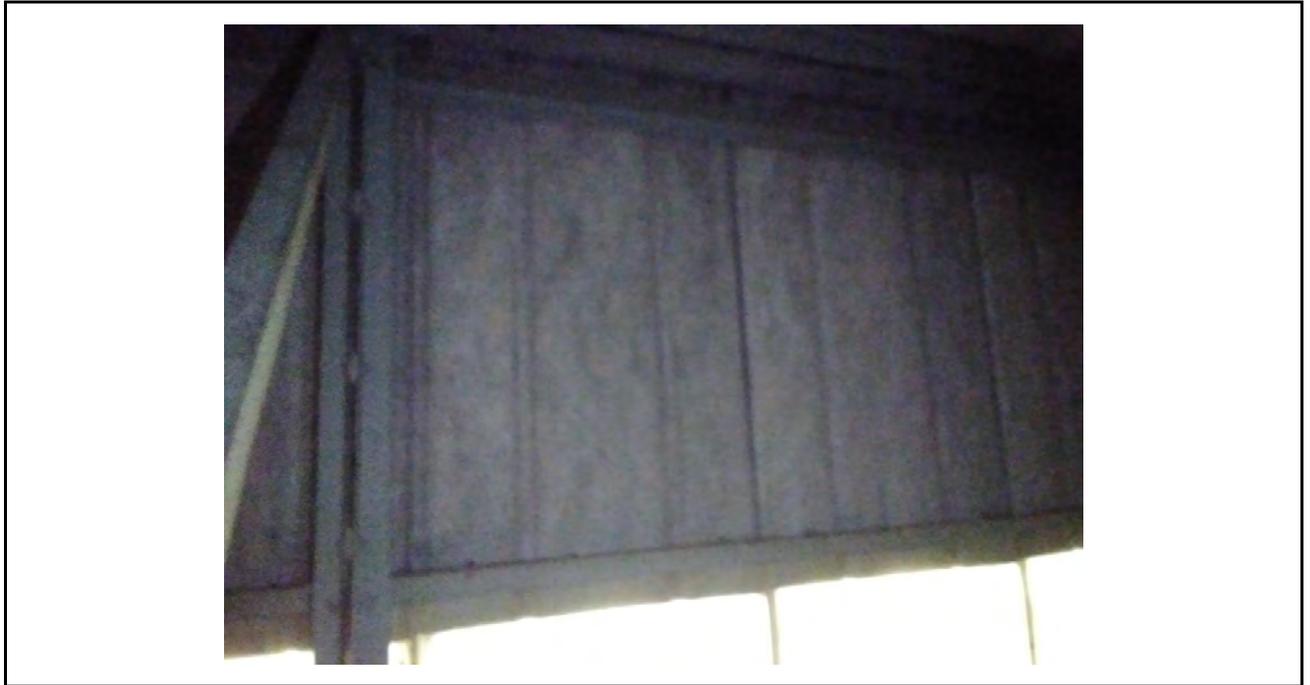
Description Roof sheets . Visually consistent with Sample 1.

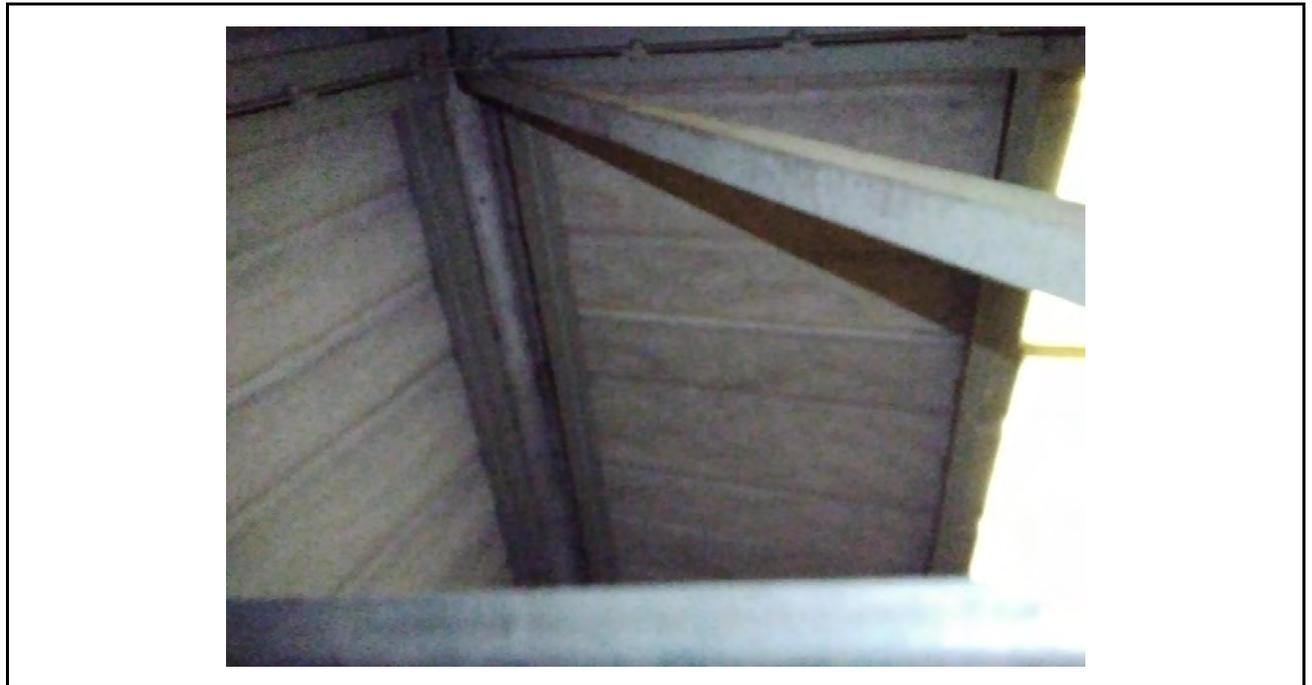
Description Roof sheets . Visually consistent with Sample 1.

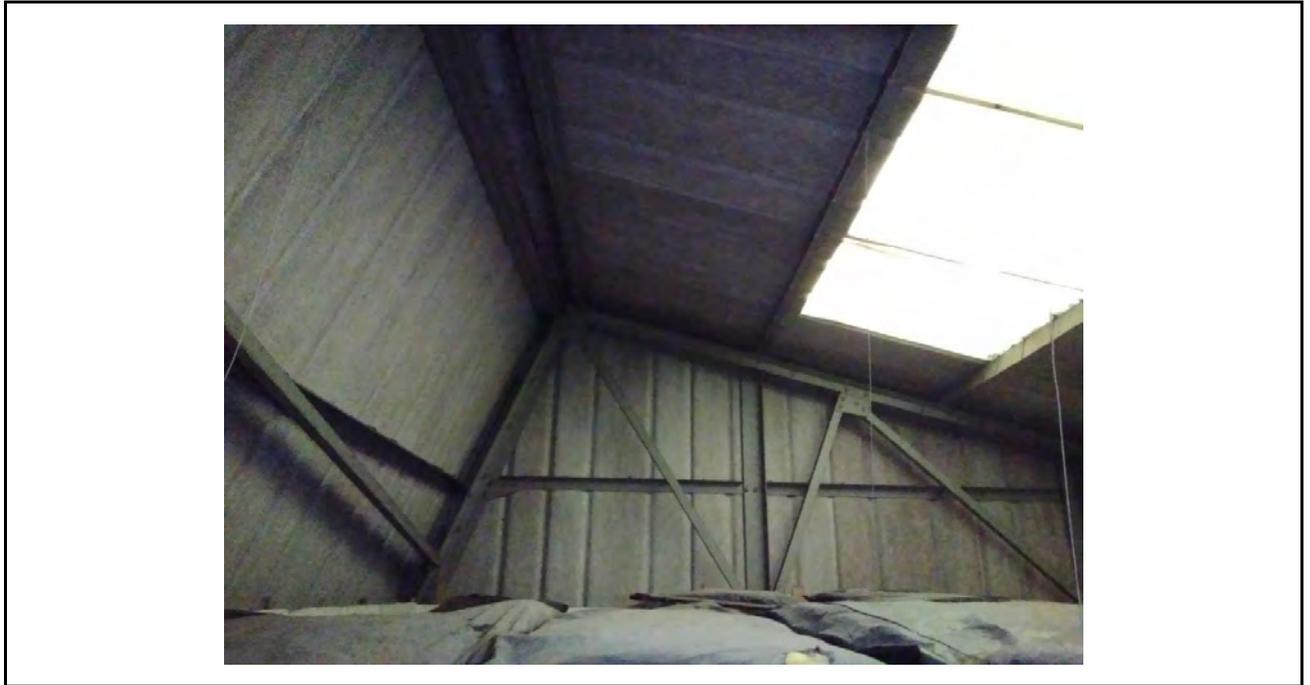
Description Wall panels . Visually consistent with Sample 1.
