Asbestos Management Survey

Mole Street Depot, B11 1XA

Report No	D-11066	Report Issue Date	7 April 2025
Client Name & Address	Property Services Place, Prosperity & Sustainability Directorate Birmingham City Council PO Box 16255 Birmingham B2 2WT	Site Address	Mole Street Depot, Mole Street, Birmingham, B11 1XA
Order Placed By	Phil Andrews	Instruction Date	12 March 2025
Order Number	B1-AV056-2Z09-E00-JZZZZZ-TV2GN- JZZZ-JXXX	Project Reference	IPBL001826
Survey Date(s)	Between 14/03/2025 and 26/03/2025	Lead Surveyor	Luke Murphy

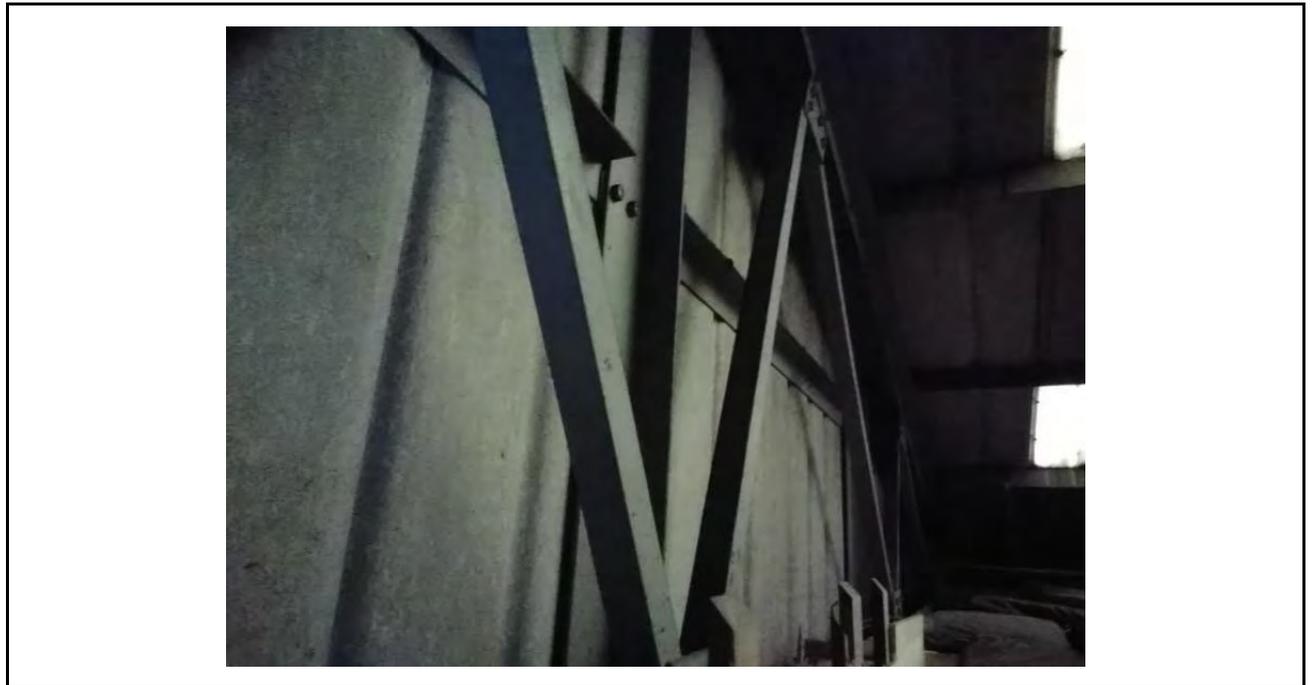
Description Wall panels . Visually consistent with Sample 1.

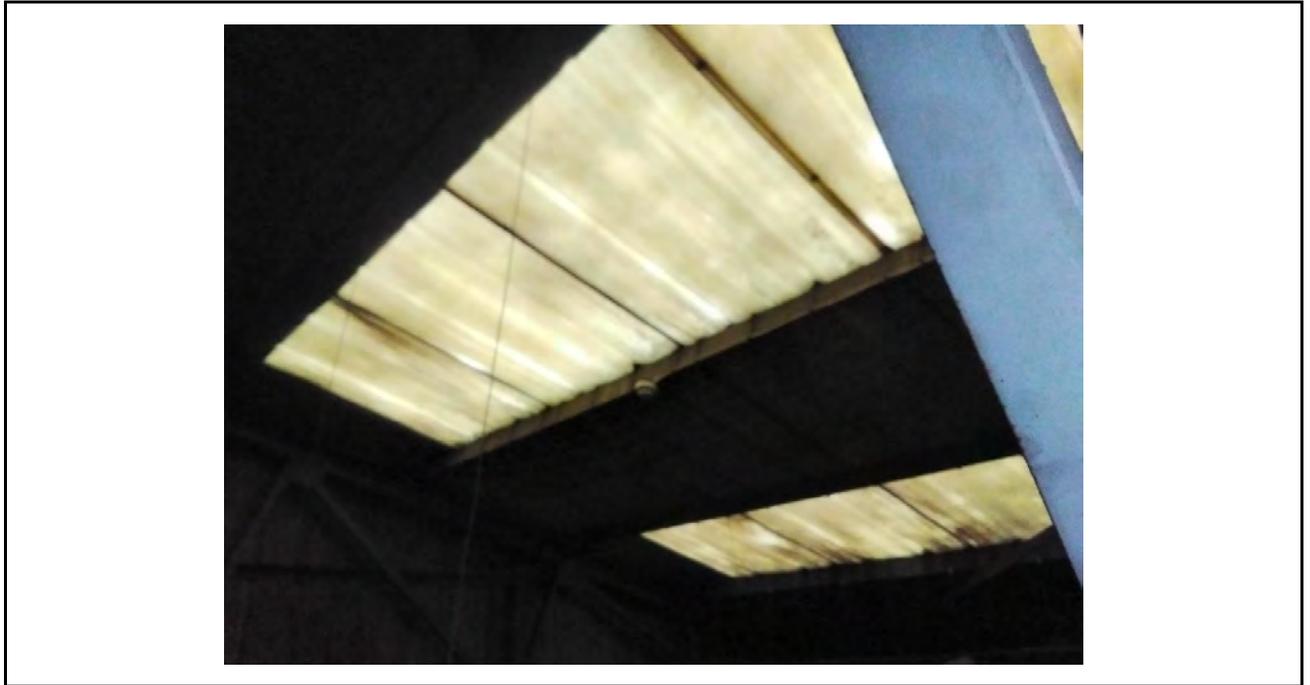
Description Roof sheets . Visually consistent with Sample 1.

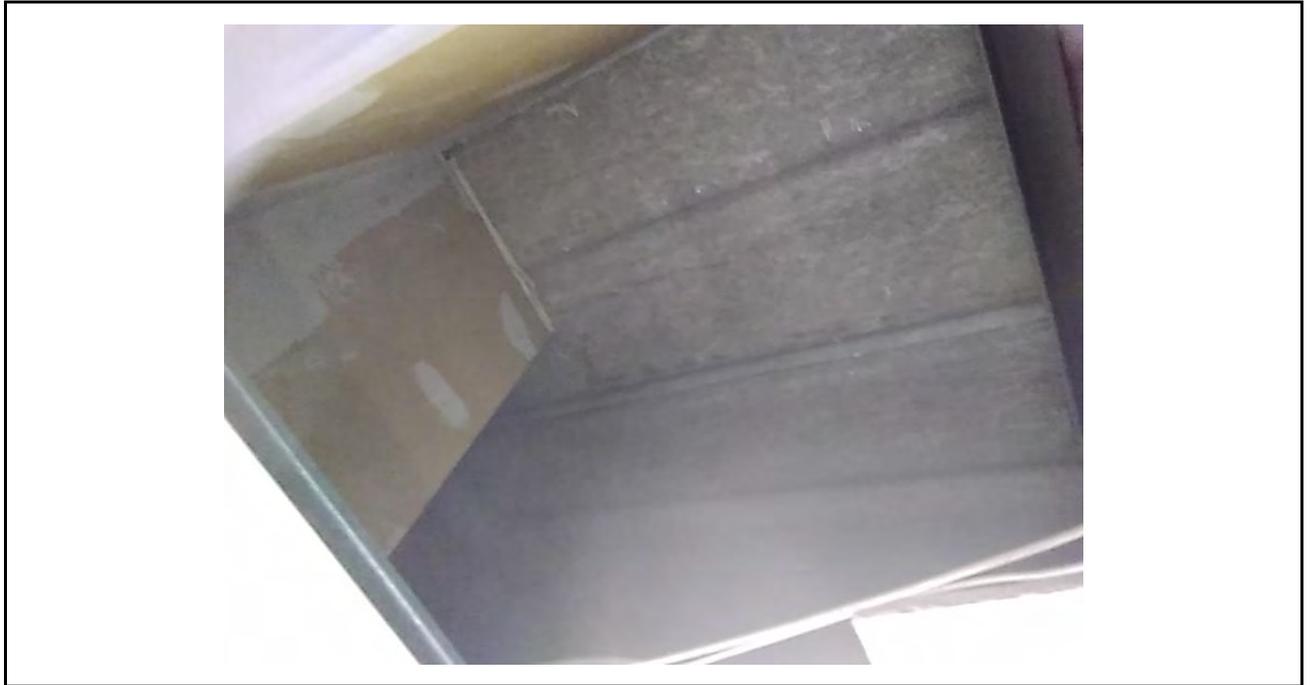
Description Roof sheets . Visually consistent with Sample 1.

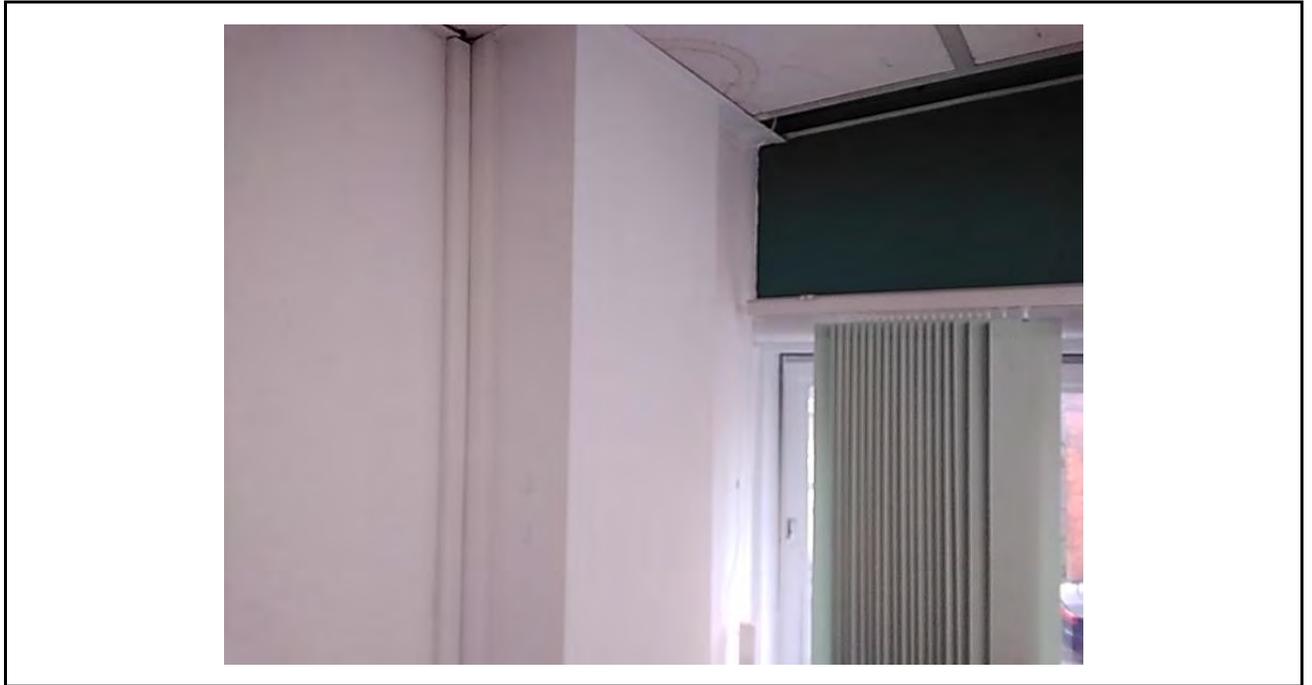
Description Behind boxing .

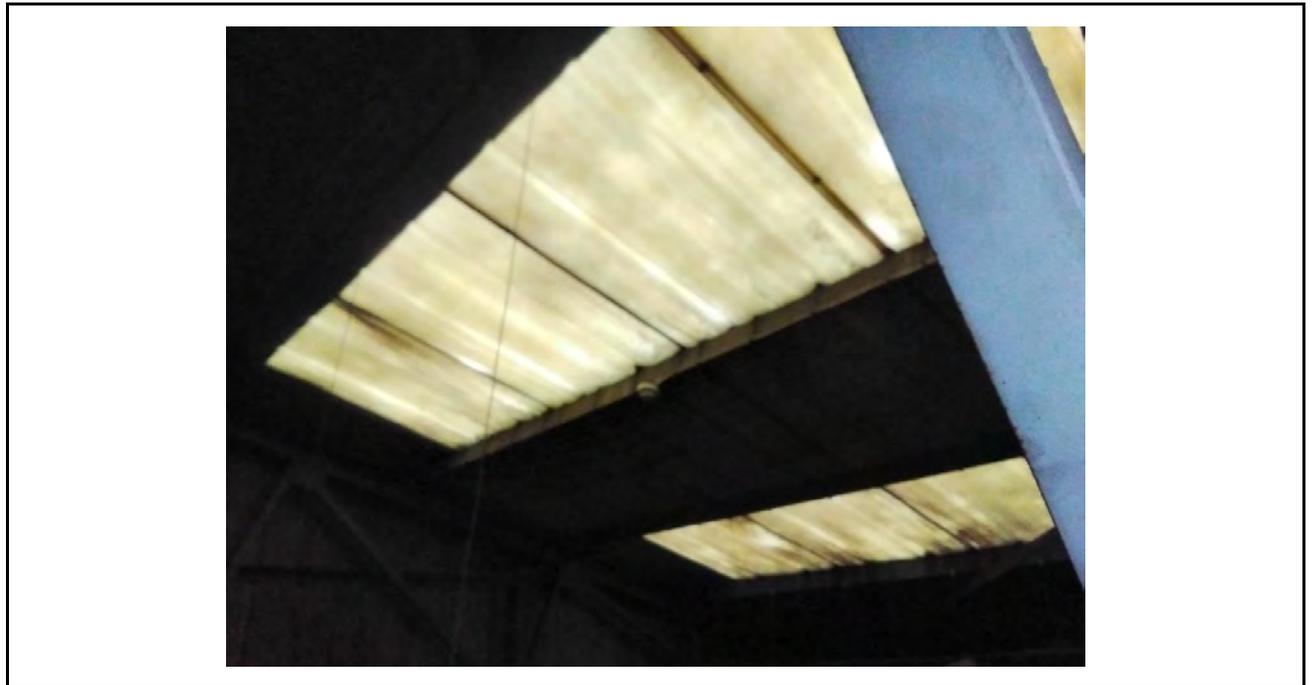
Description Roof sheets . Visually consistent with Sample 1.

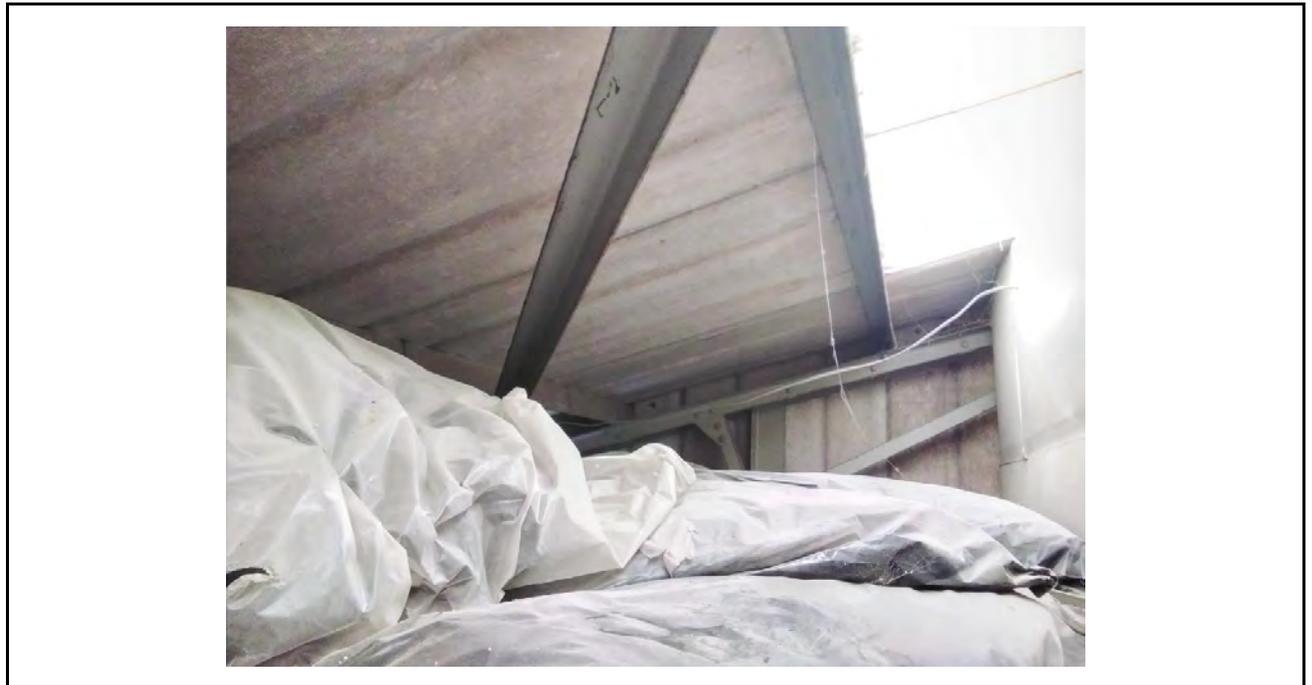
Description Wall panels . Visually consistent with Sample 1.

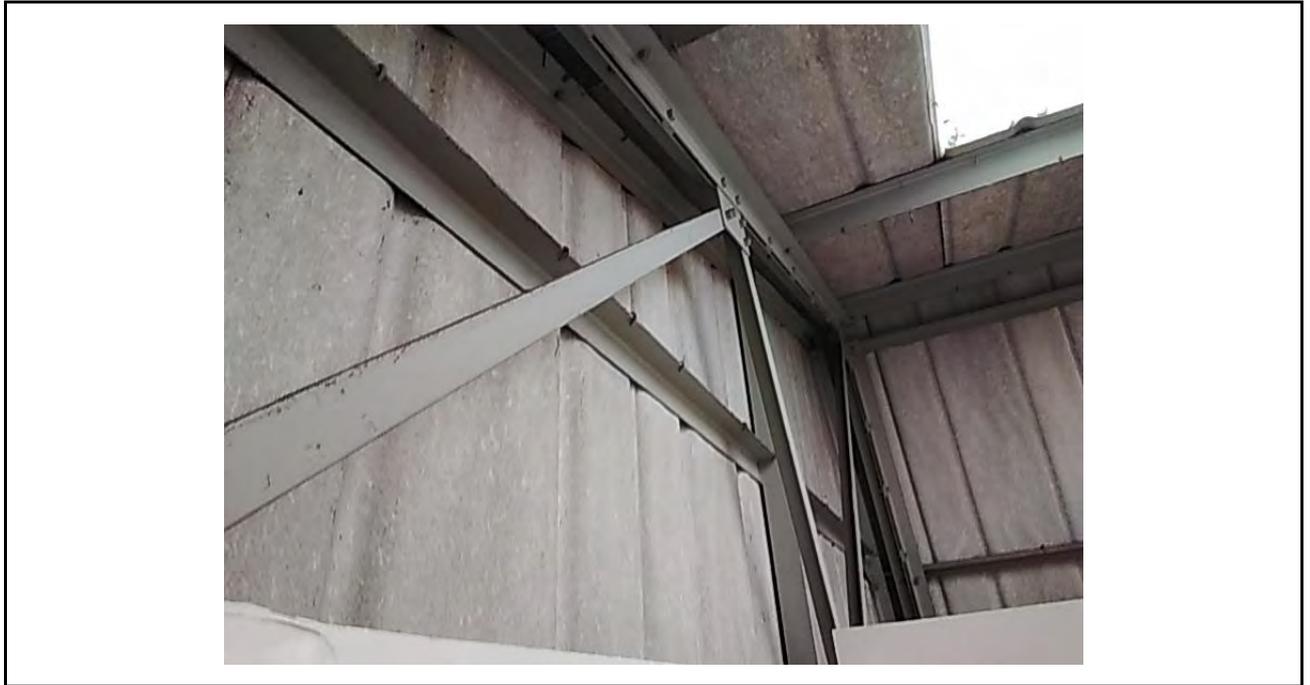
Description Wall panels . Visually consistent with Sample 1.

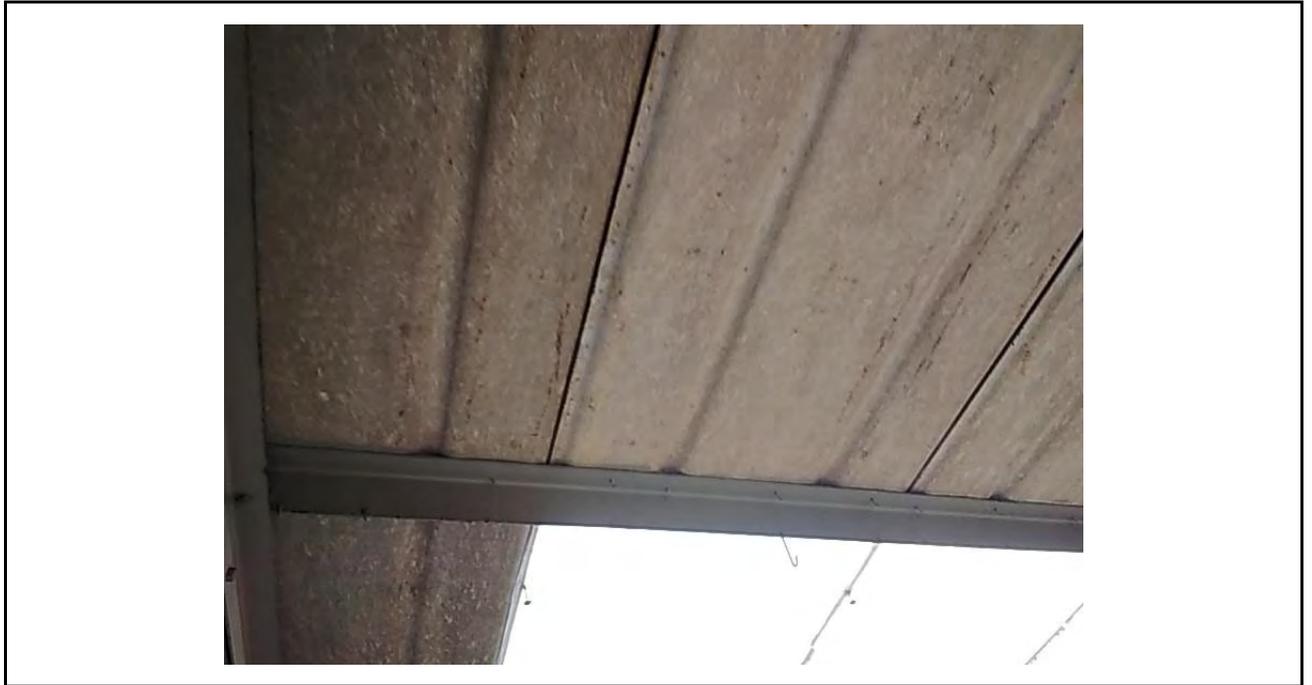
Description Roof sheets . Visually consistent with Sample 1.

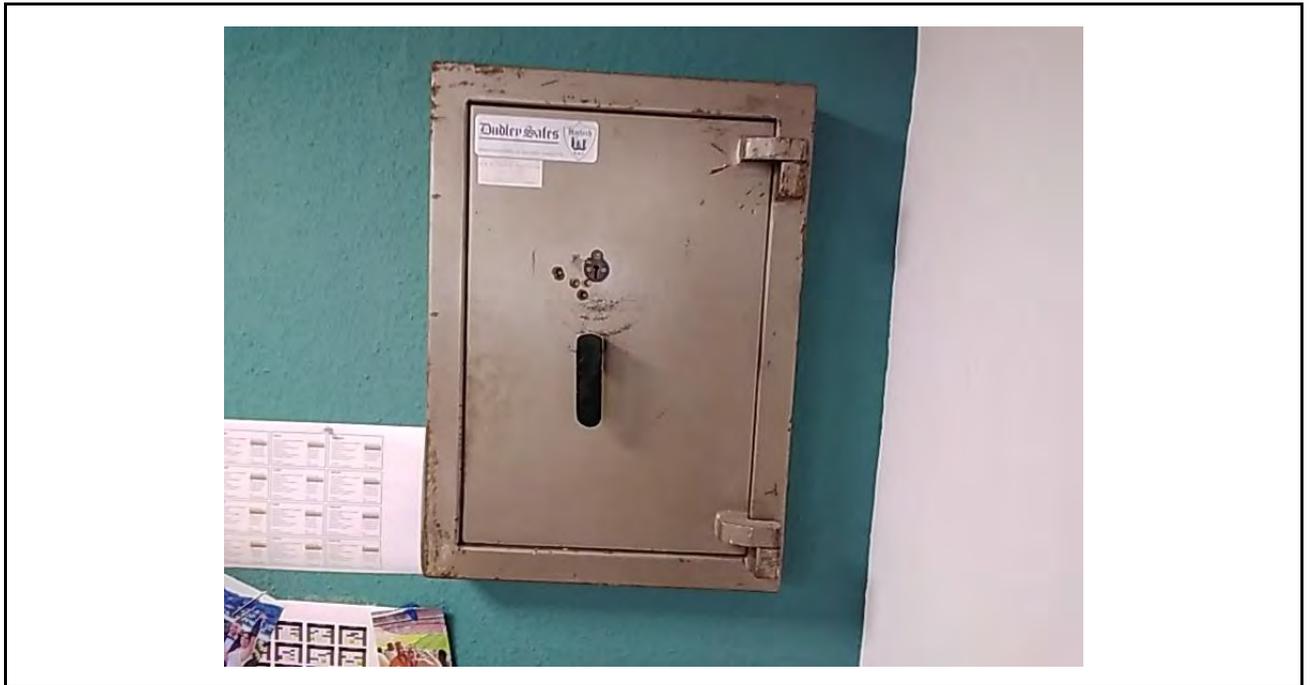
Description Internally to safe lining .

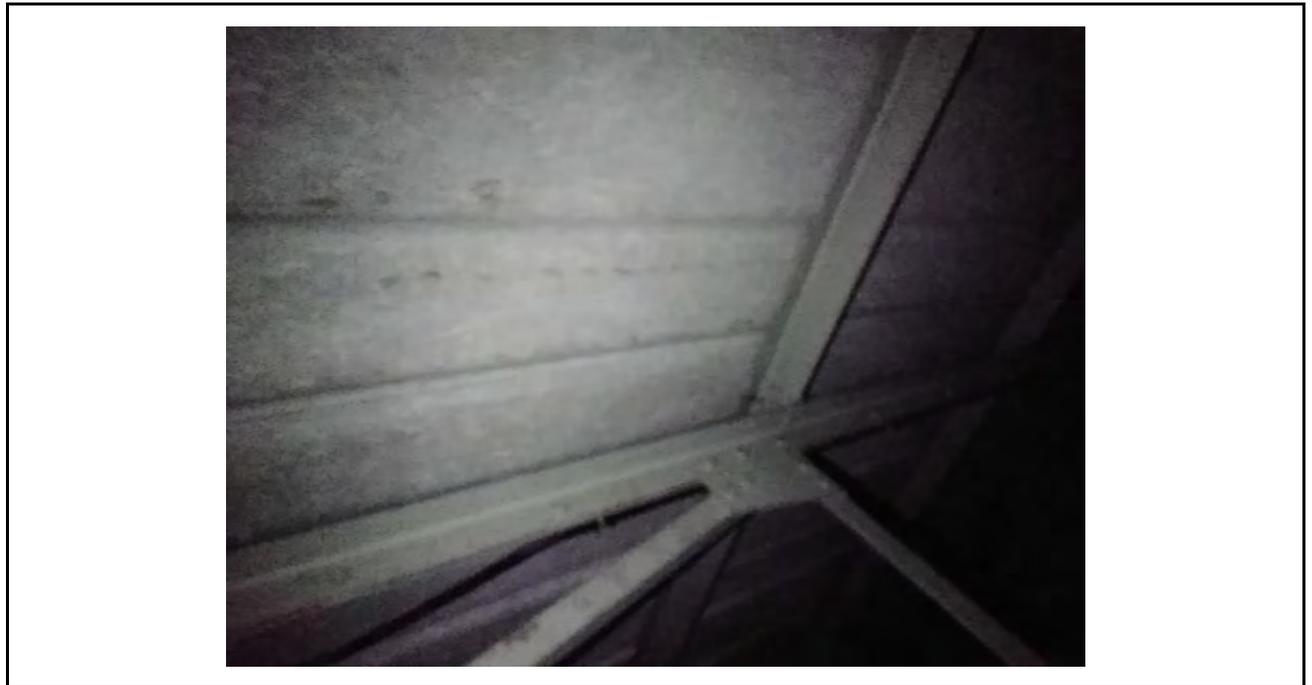
Description Roof sheets . Visually consistent with Sample 1.

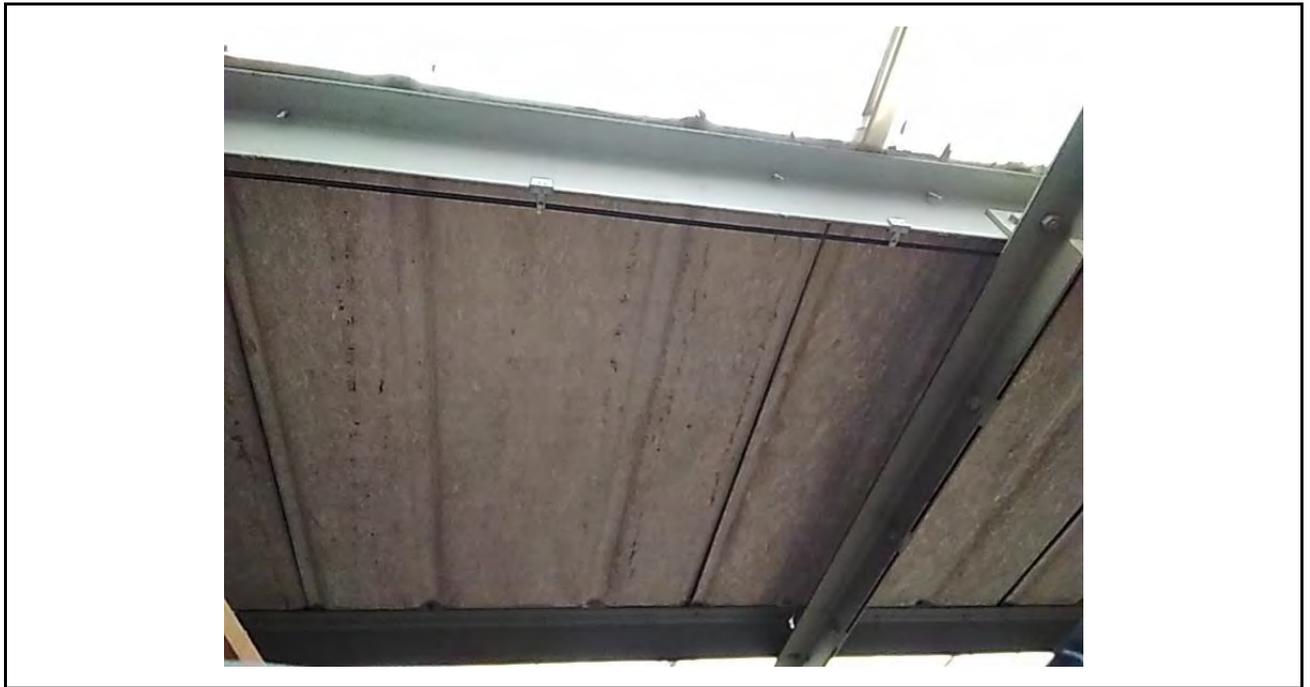
Description Roof sheets . Visually consistent with Sample 1.

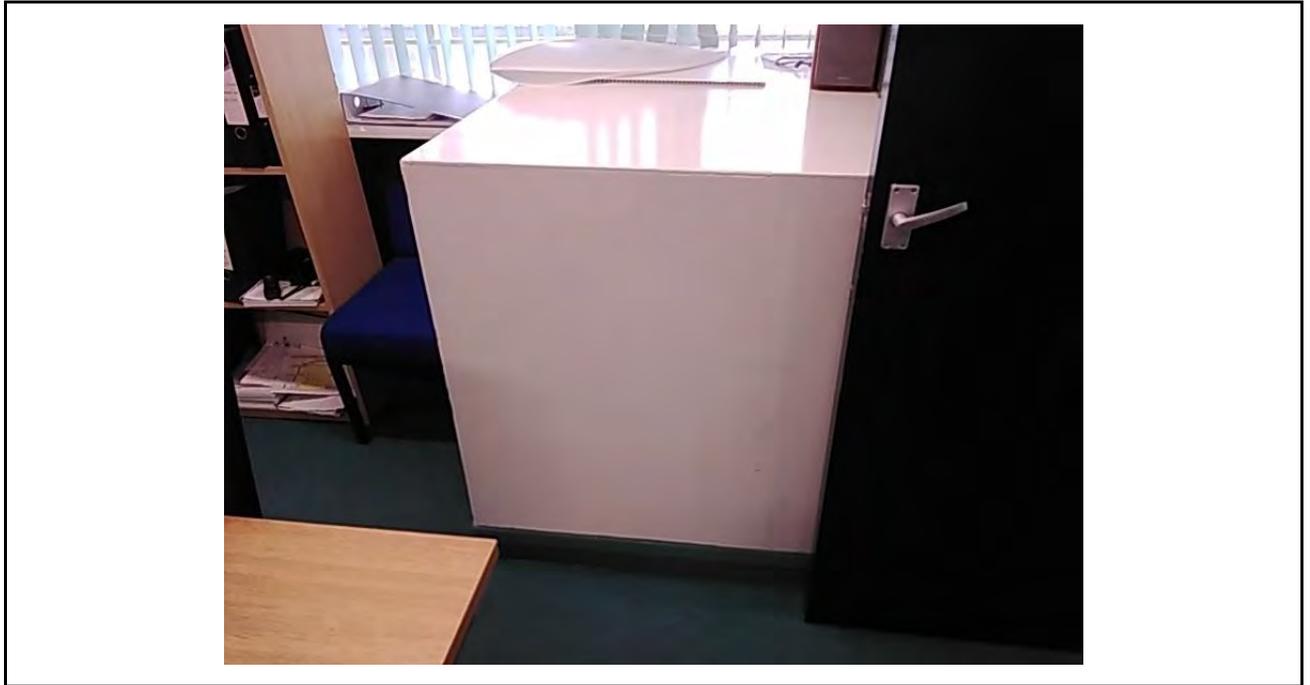
Description Behind boxing .

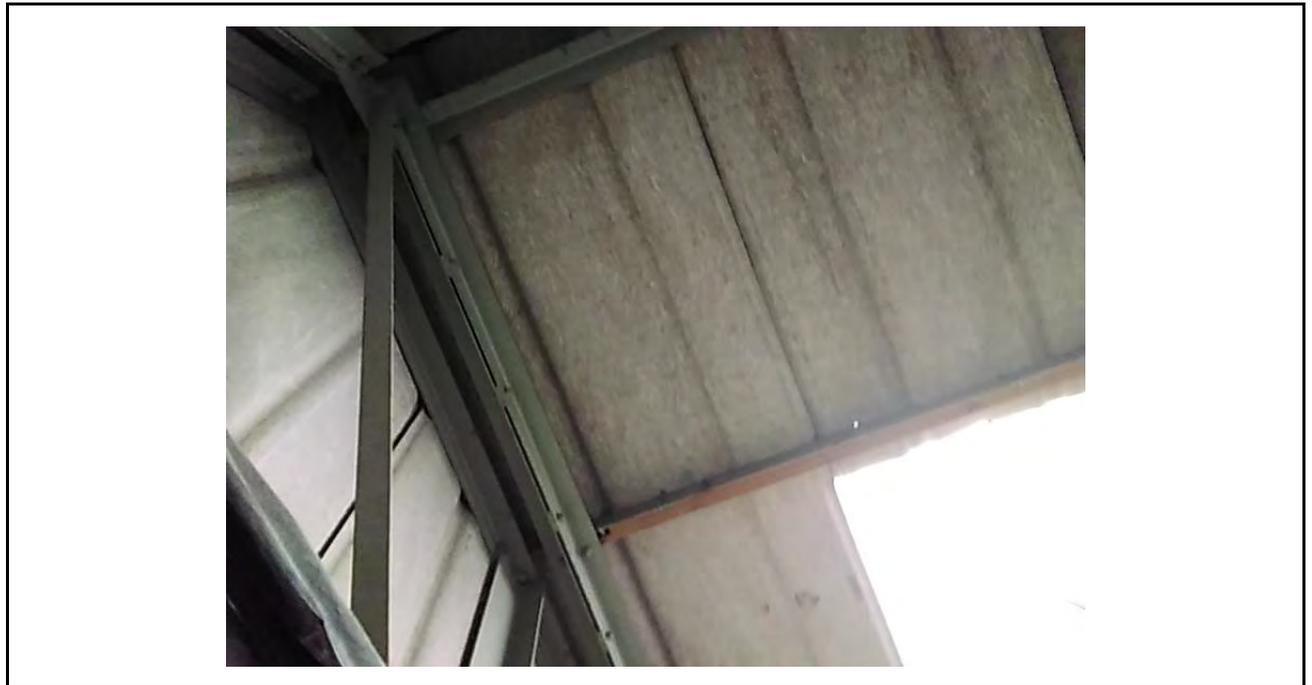
Description Roof sheets . Visually consistent with Sample 1.

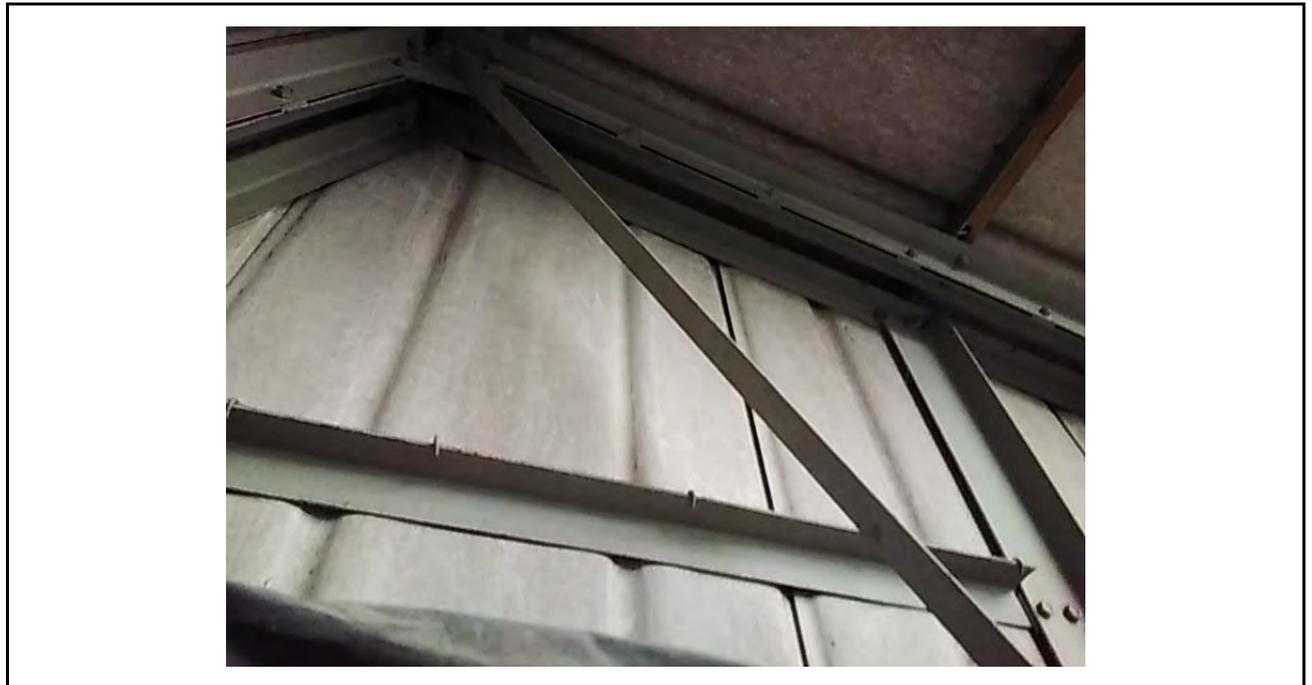
Description Wall panels . Visually consistent with Sample 1.

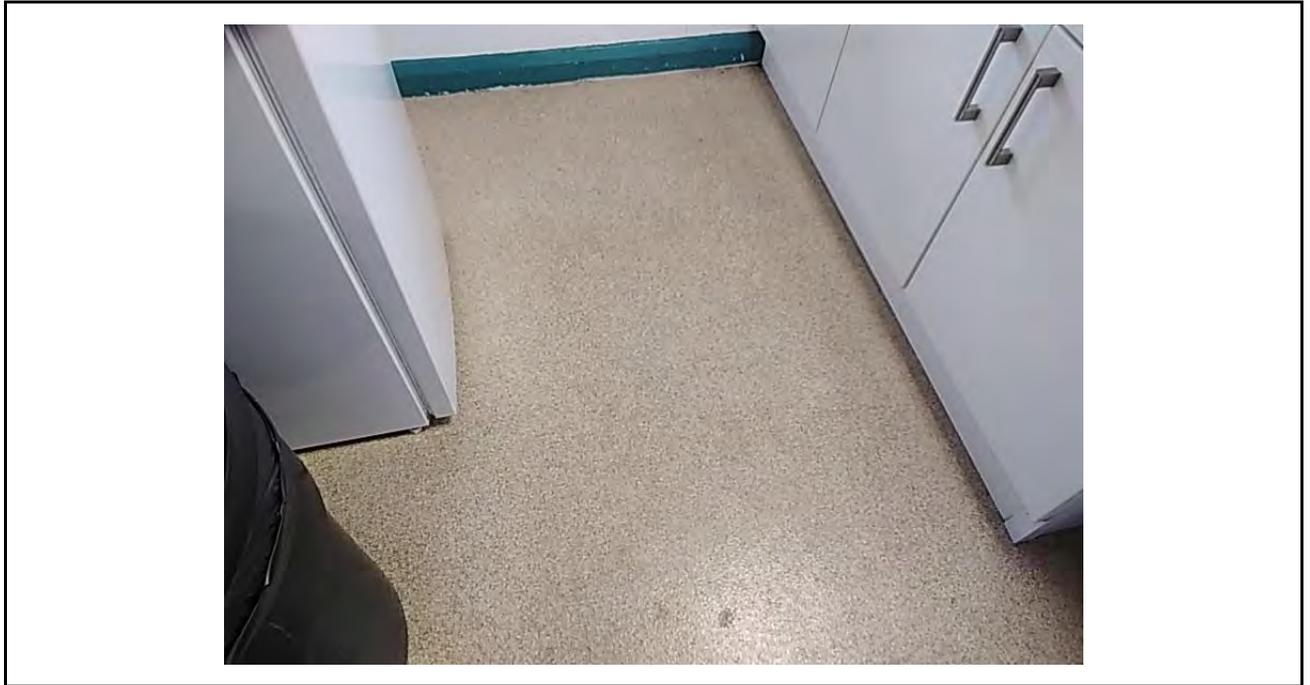
Description Floor tiles .

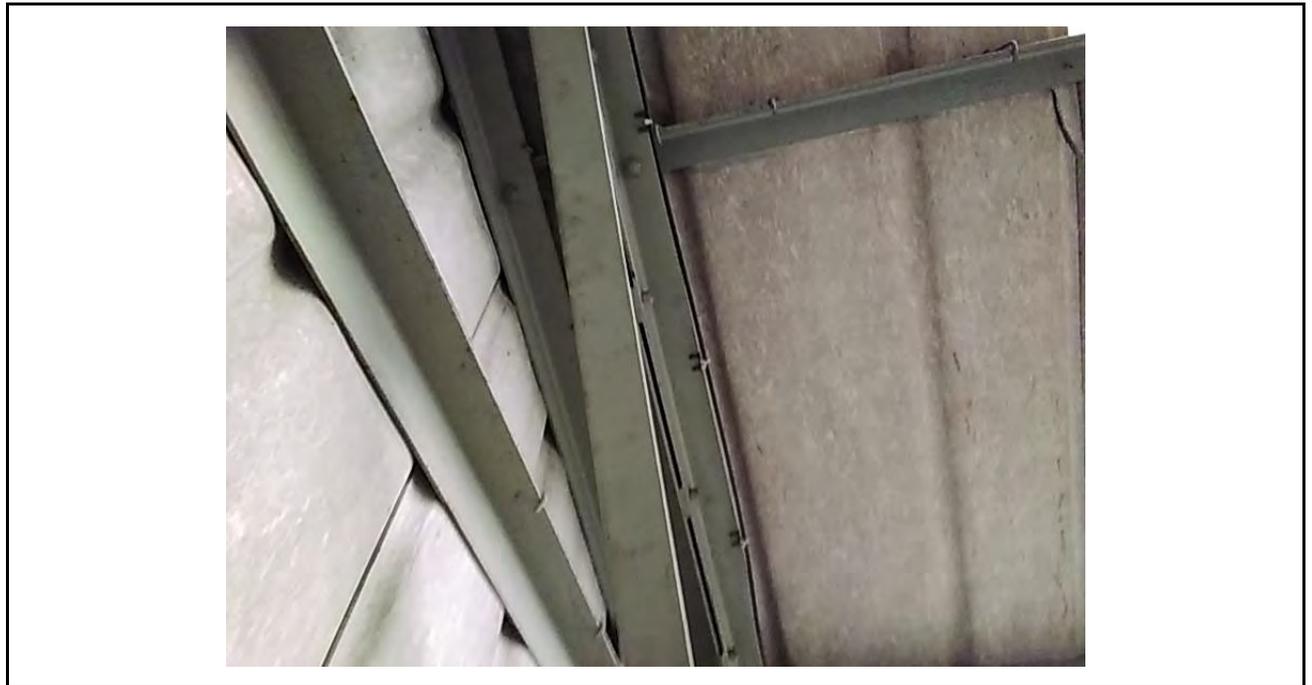
Description Roof sheets . Visually consistent with Sample 1.

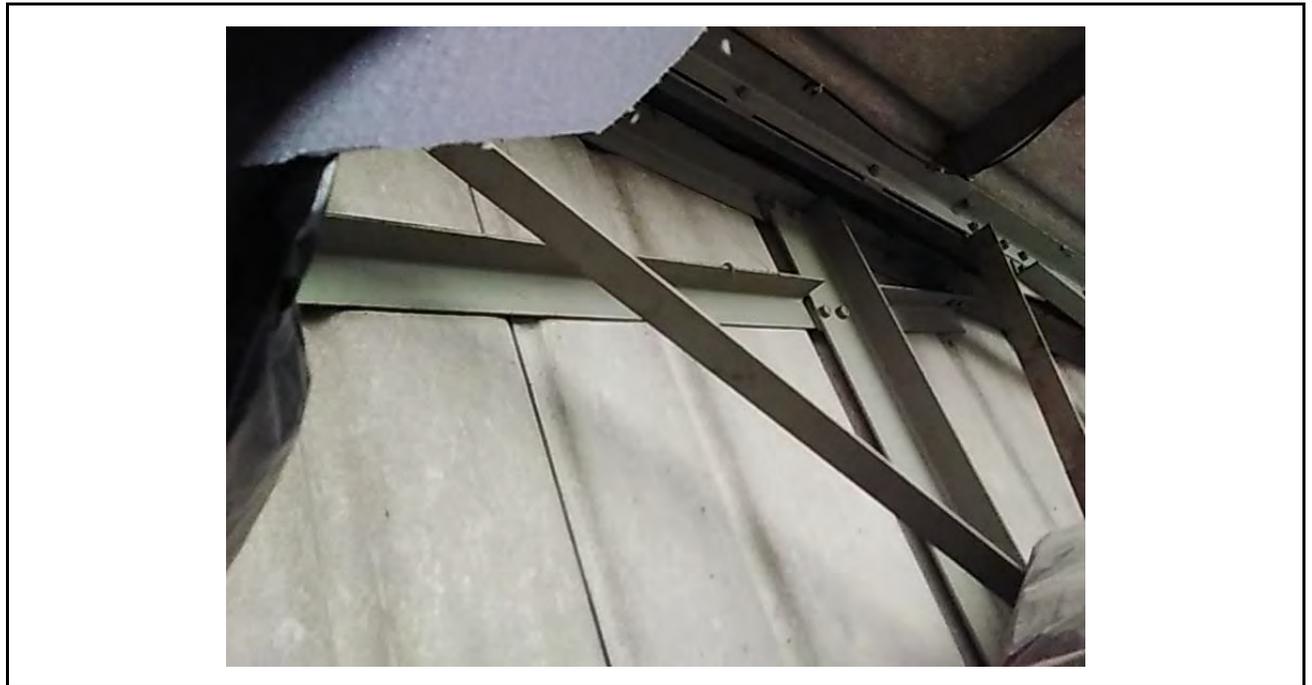
Description Wall panels . Visually consistent with Sample 1.

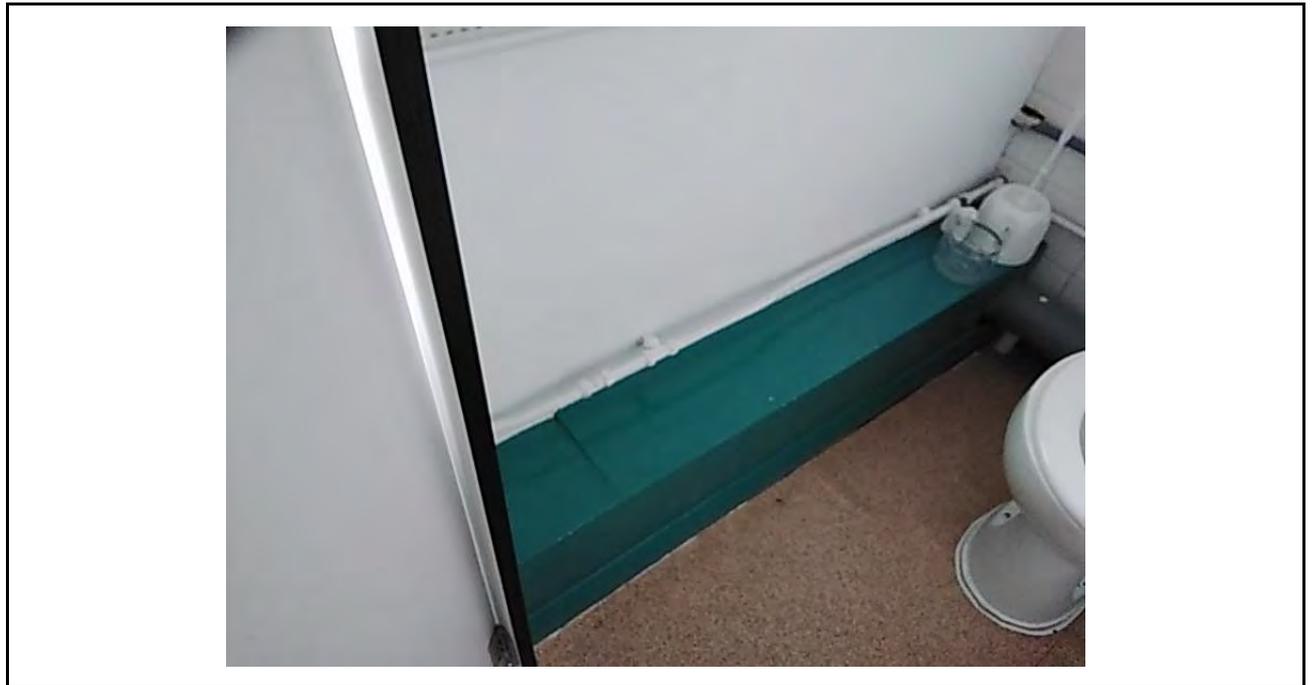
Description Behind boxing .

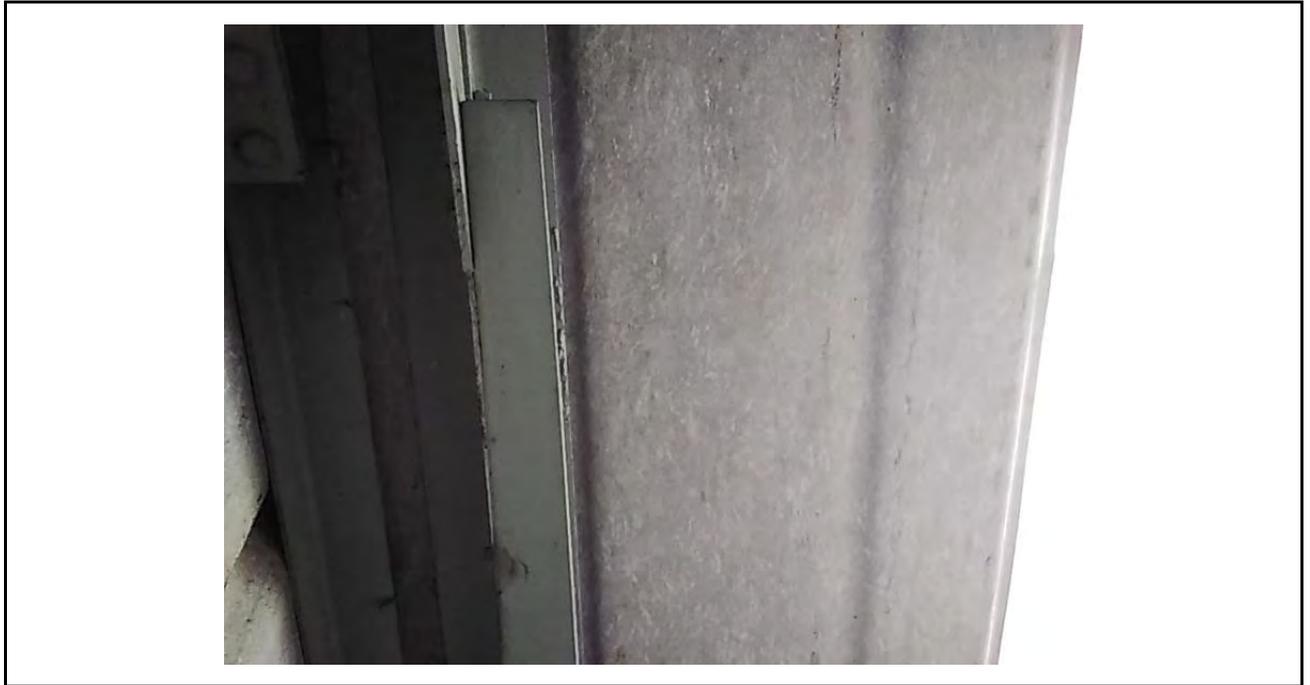
Description Roof sheets . Visually consistent with Sample 1.

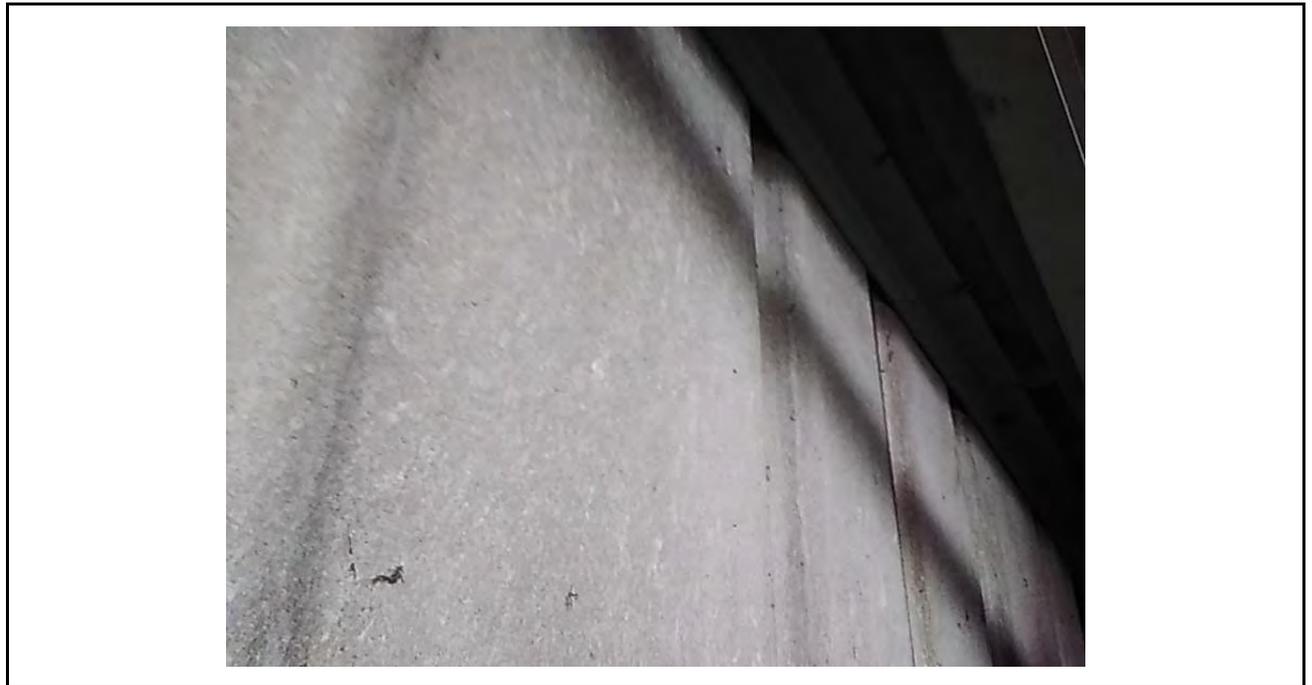
Description Wall panels . Visually consistent with Sample 1.

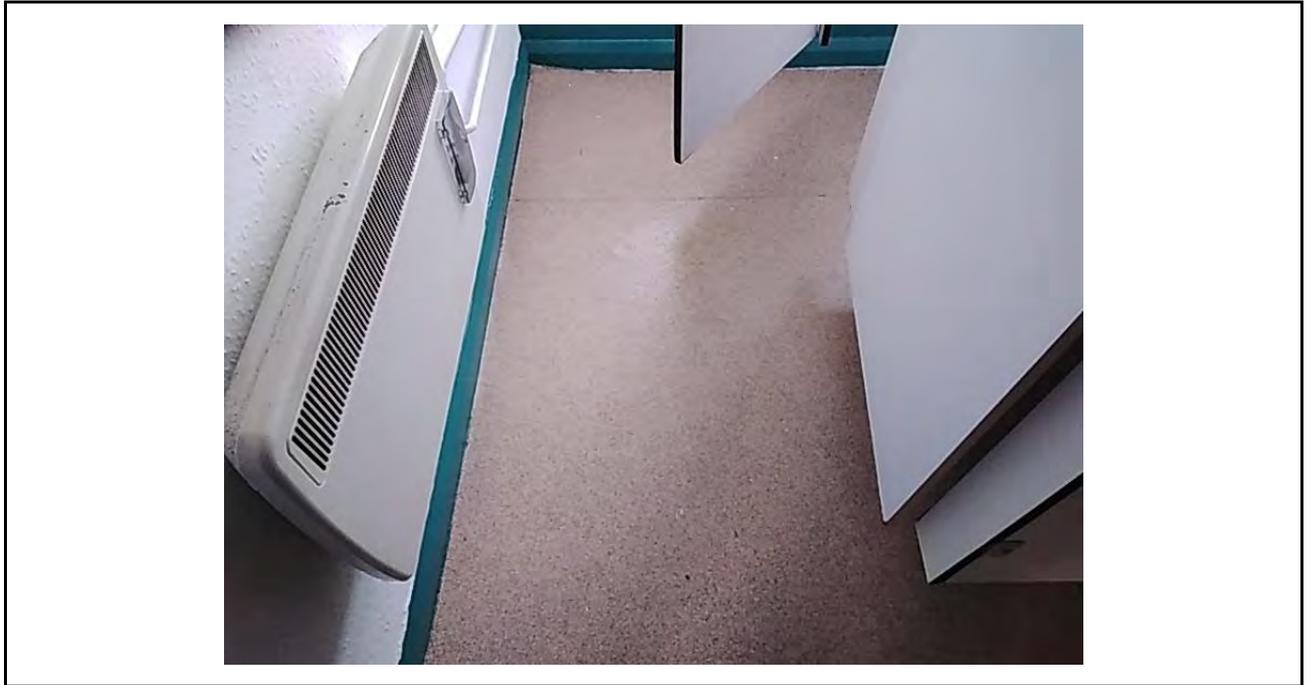
Description Floor tiles . Visually consistent with Sample 20.

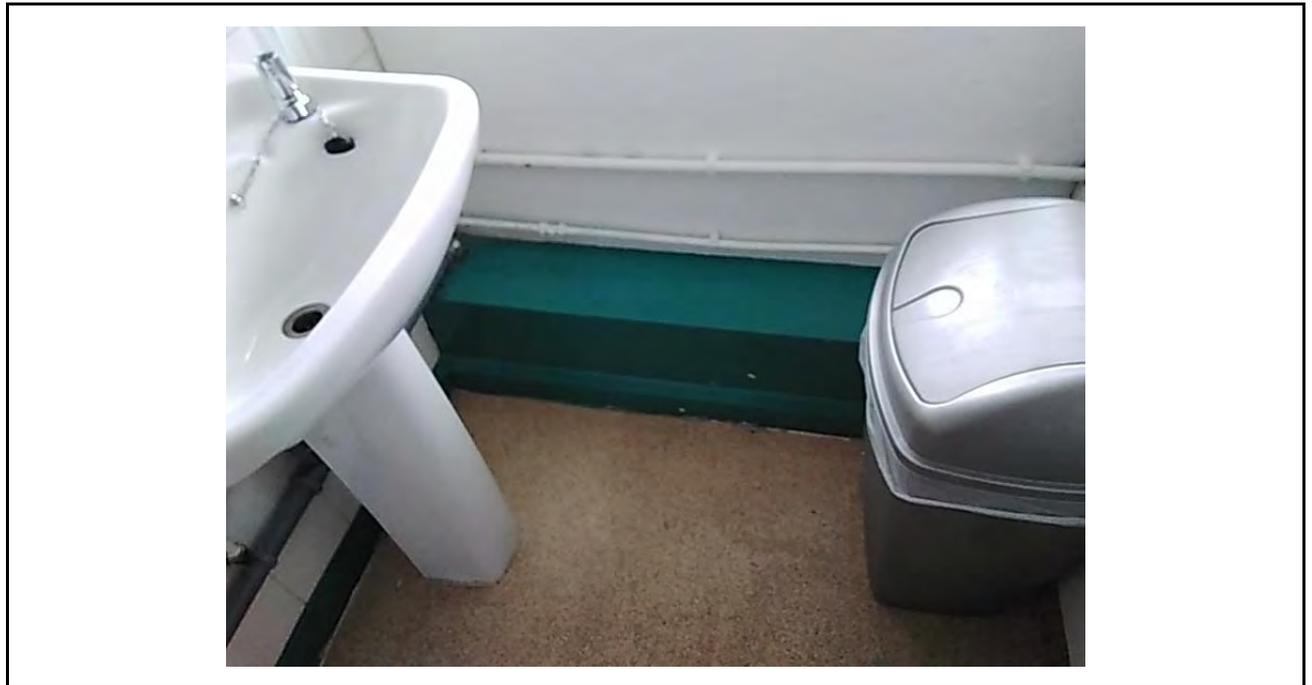
Description Behind boxing .

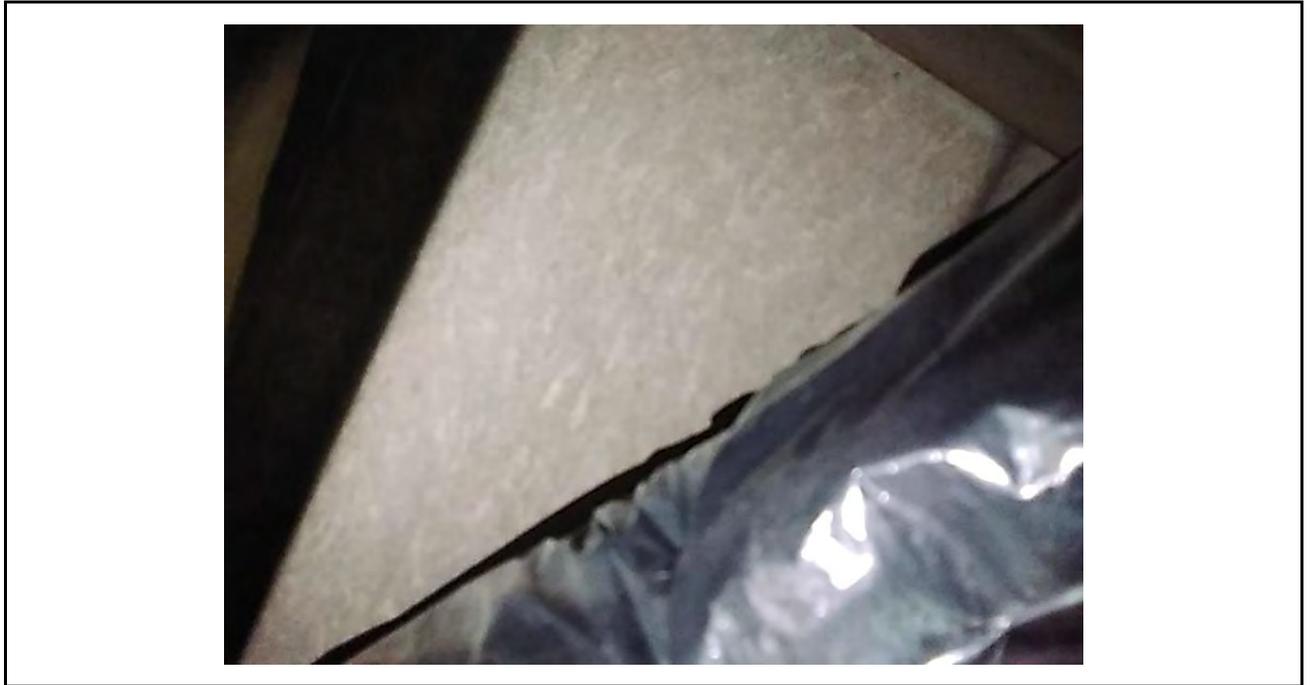
Description Roof sheets . Visually consistent with Sample 1.

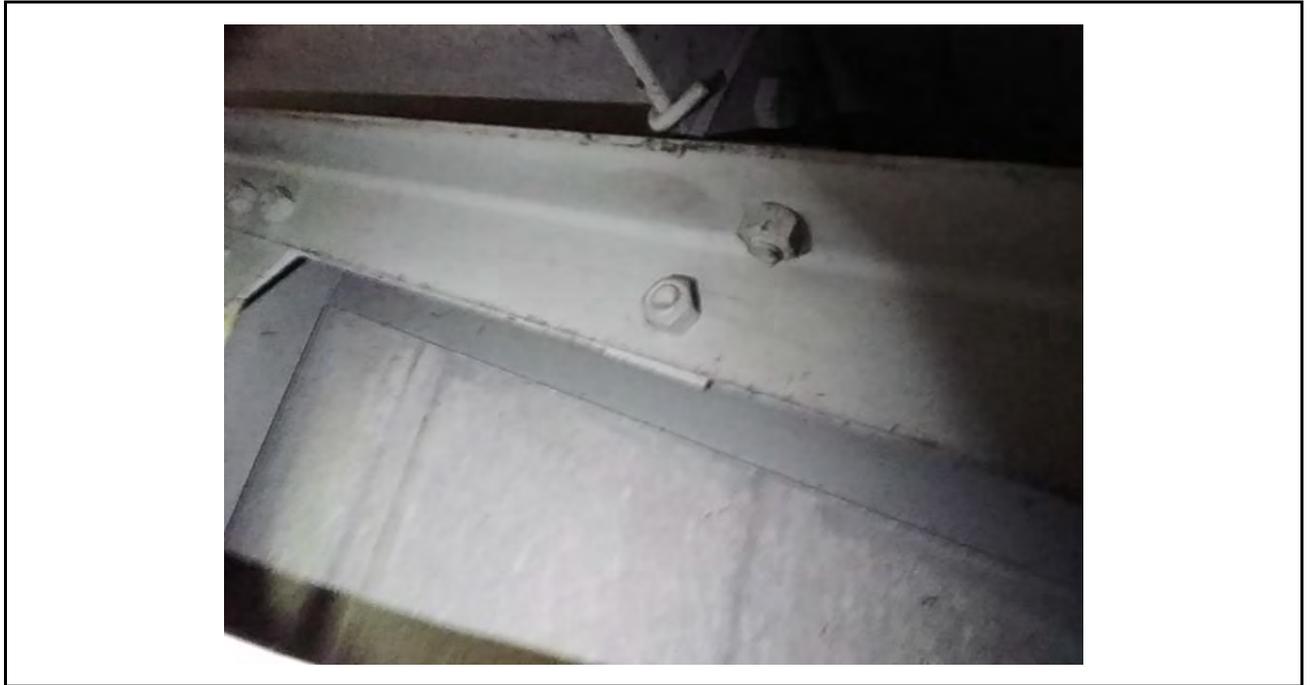
Description Wall panels . Visually consistent with Sample 1.

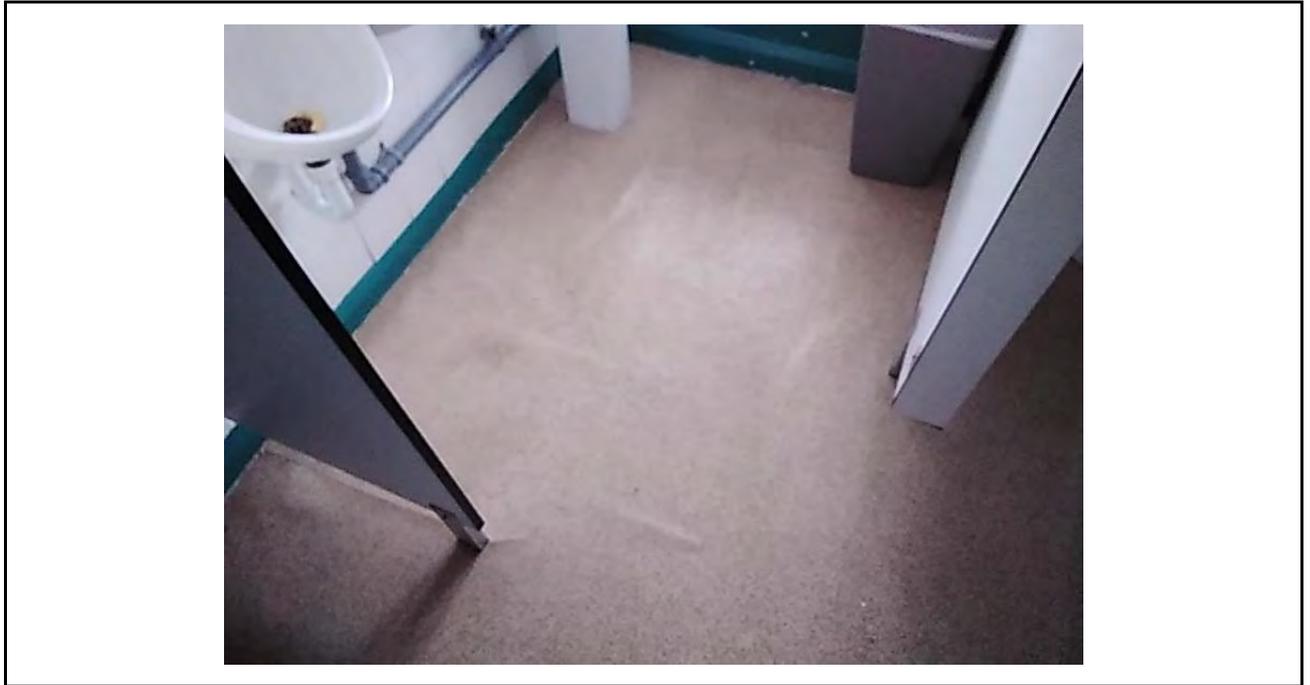
Description Floor tiles . Visually consistent with Sample 20.
