Asbestos Management Survey

Mole Street Depot, B11 1XA

Report No	D-11066	Report Issue Date	7 April 2025
Client Name & Address	Property Services Place, Prosperity & Sustainability Directorate Birmingham City Council PO Box 16255 Birmingham B2 2WT	Site Address	Mole Street Depot, Mole Street, Birmingham, B11 1XA
Order Placed By	Phil Andrews	Instruction Date	12 March 2025
Order Number	B1-AV056-2Z09-E00-JZZZZZ-TV2GN- JZZZ-JXXX	Project Reference	IPBL001826
Survey Date(s)	Between 14/03/2025 and 26/03/2025	Lead Surveyor	Luke Murphy

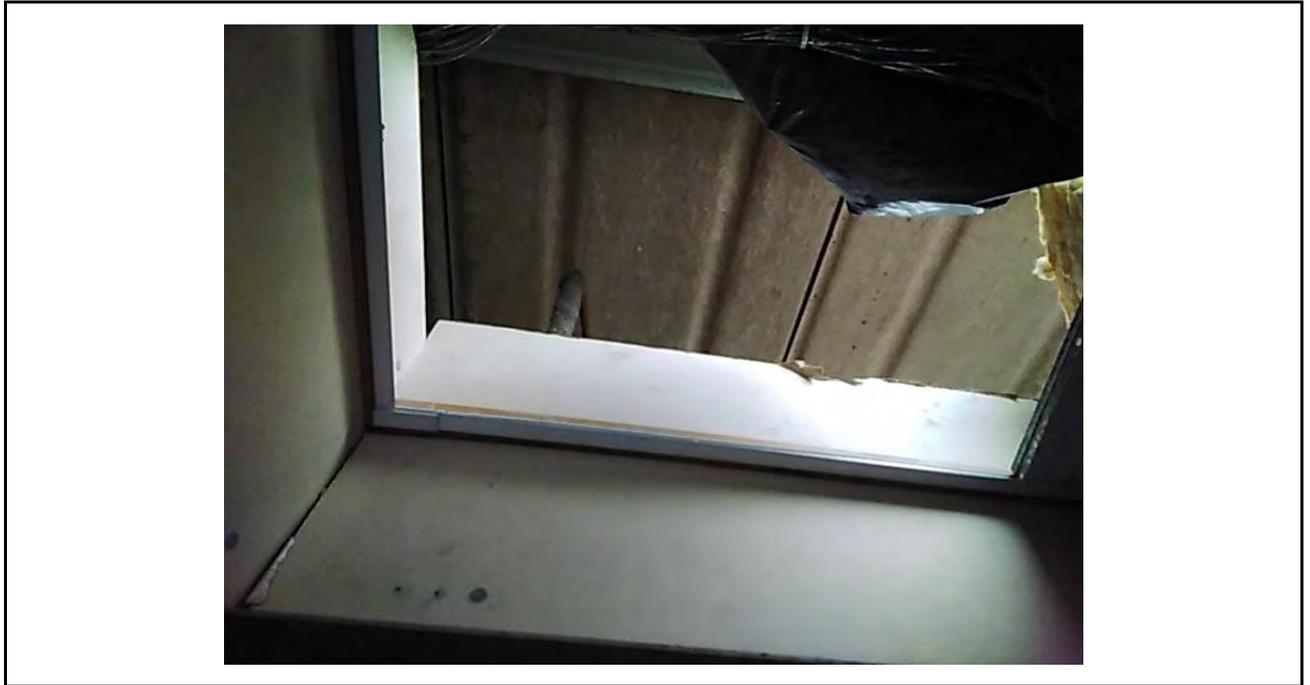
Description Roof sheets . Visually consistent with Sample 1.

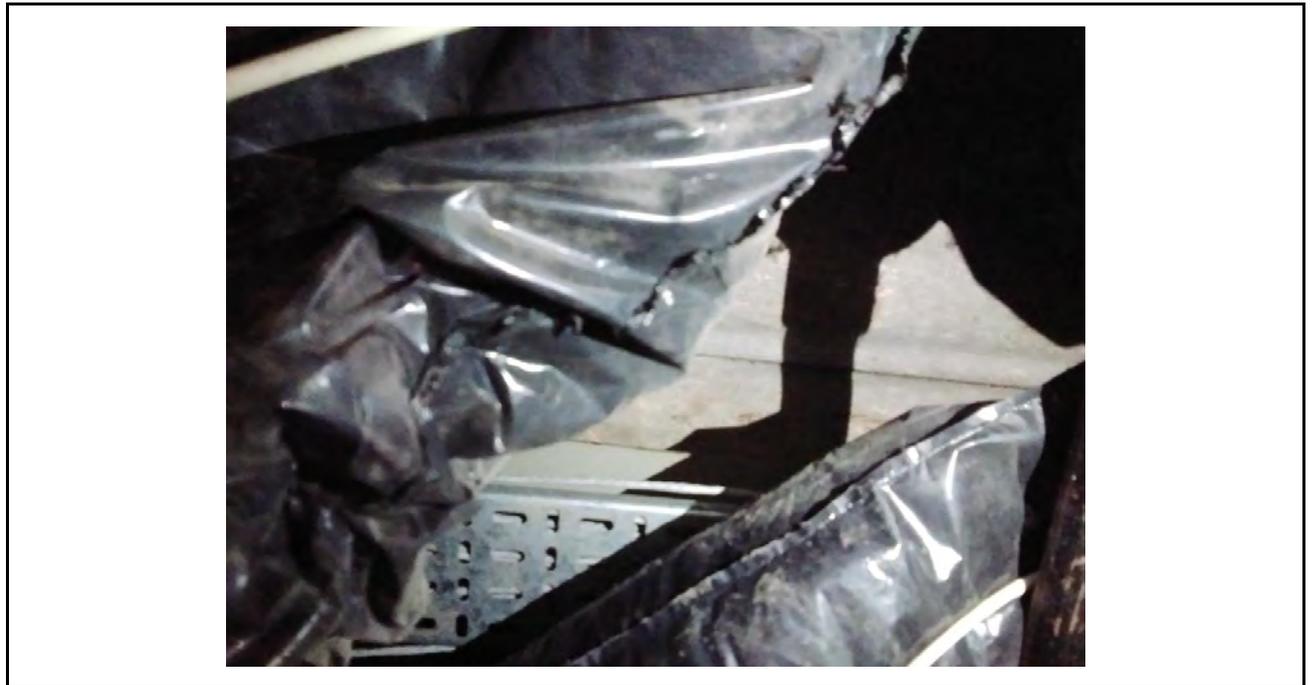
Description Roof sheets . Visually consistent with Sample 1.

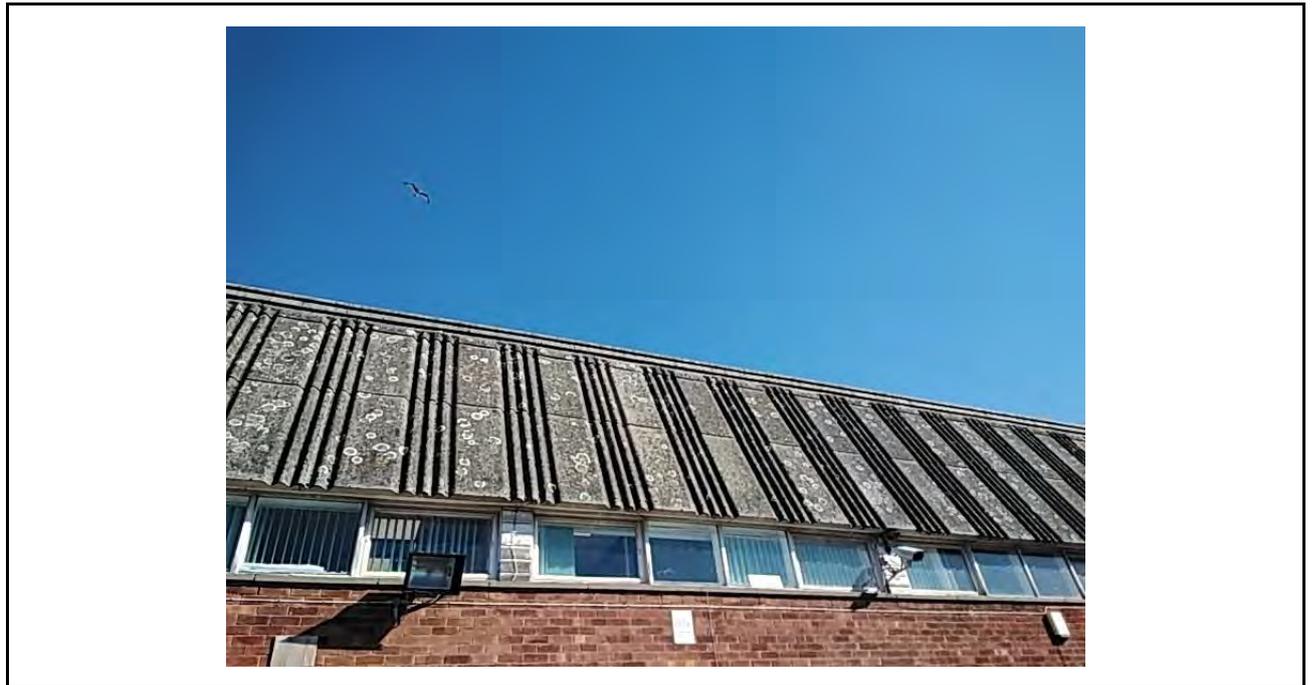
Description Roof sheets .

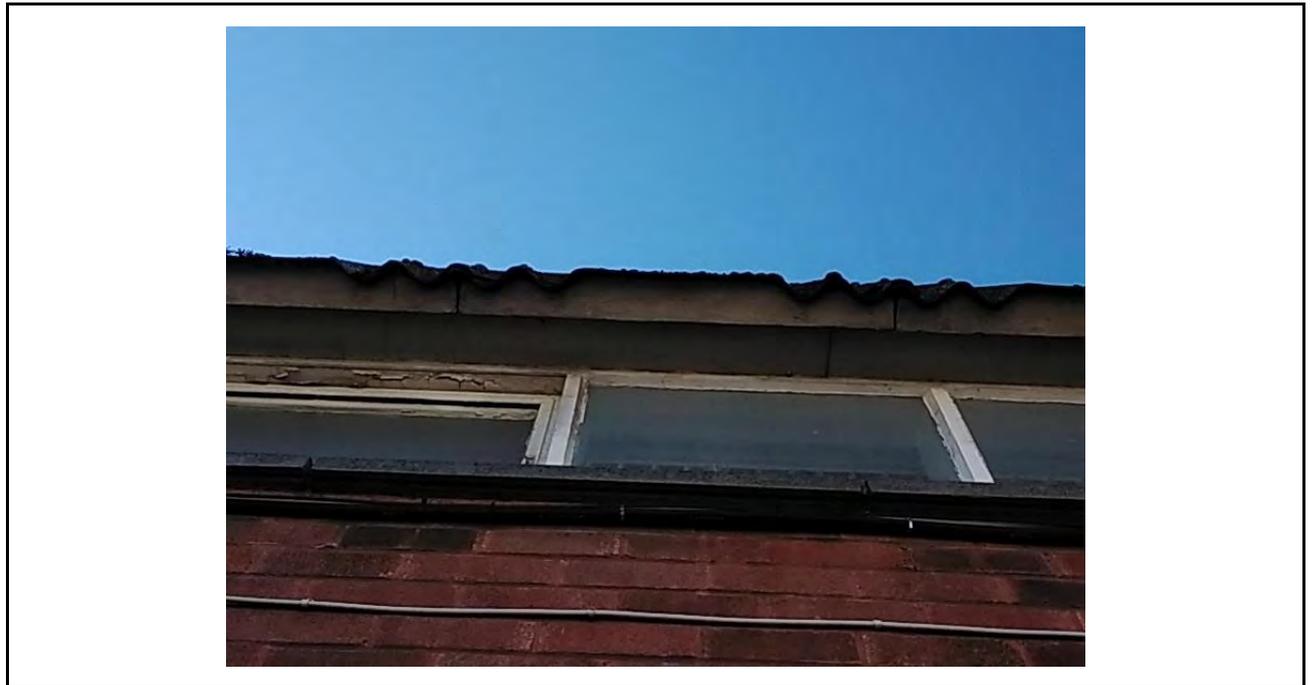
Description Soffits .

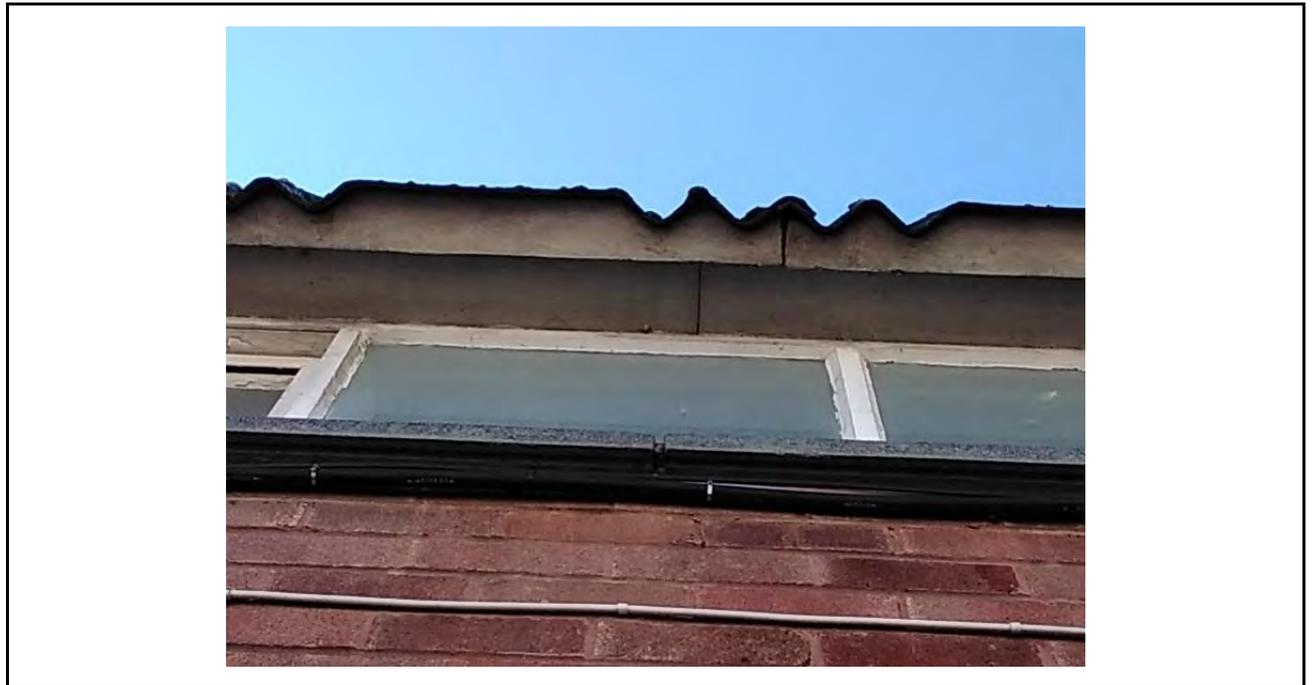
Description Soffits .

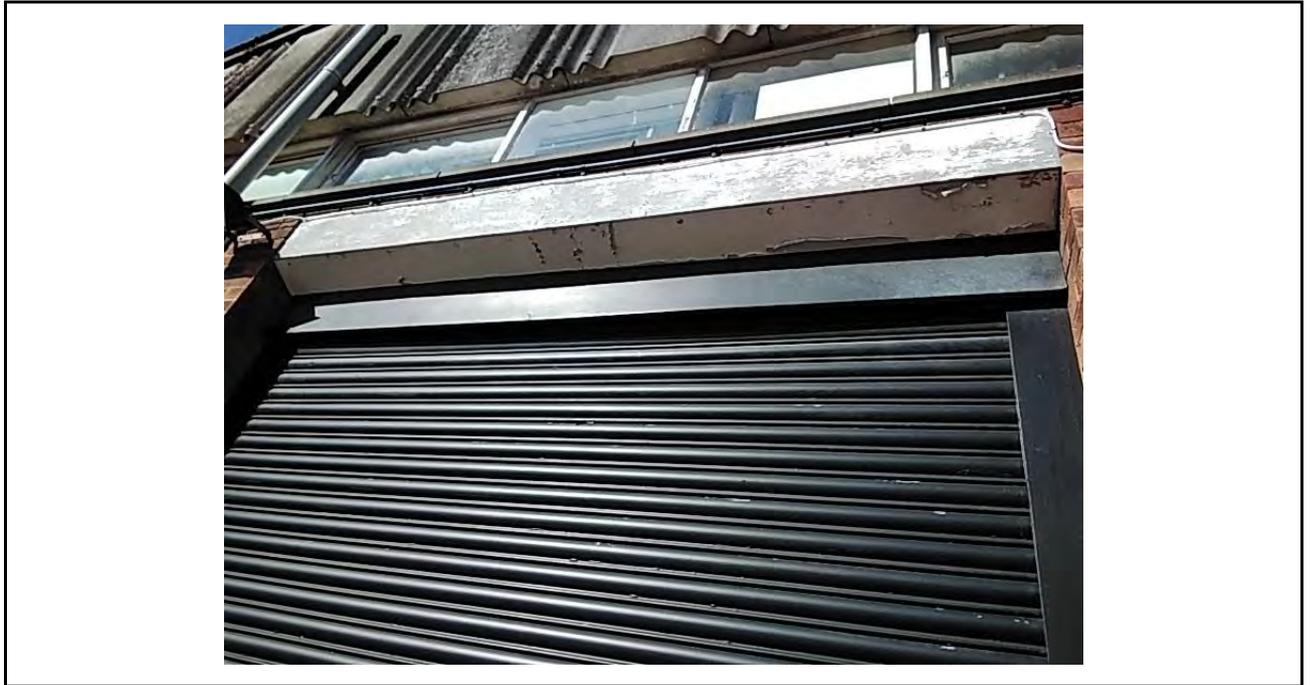
Description Soffit above roller shutter.

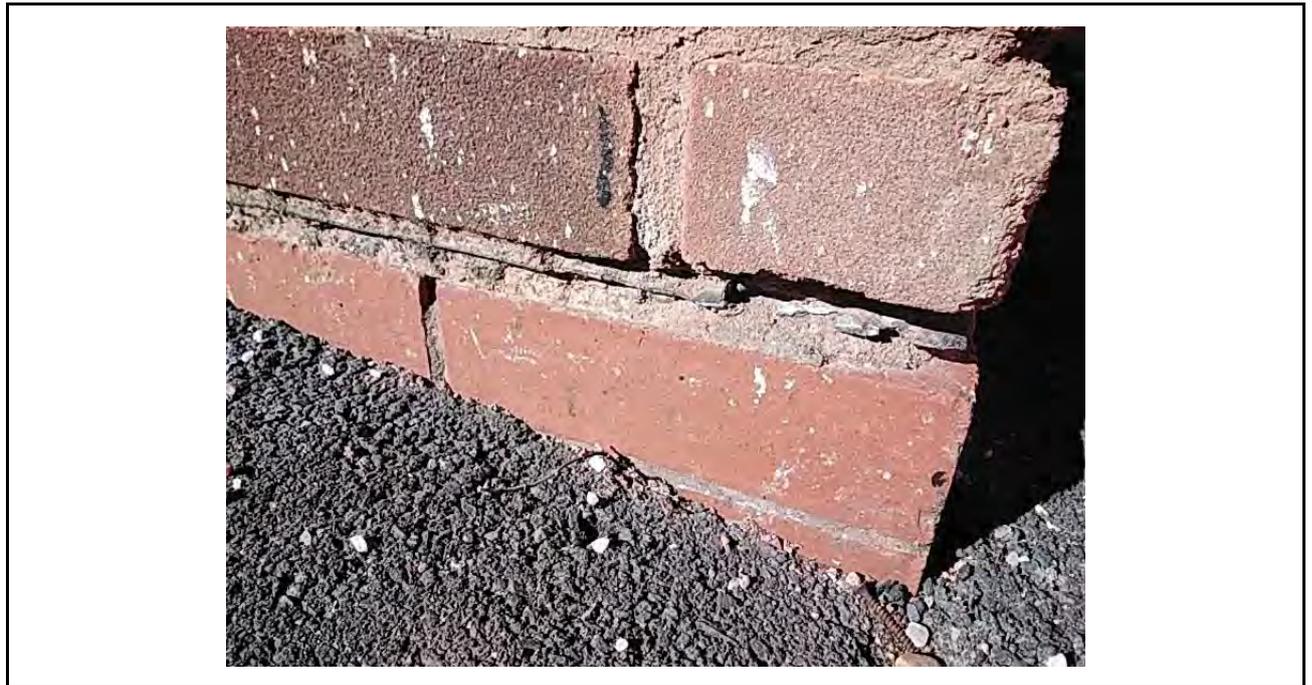
Description Damp proofing.

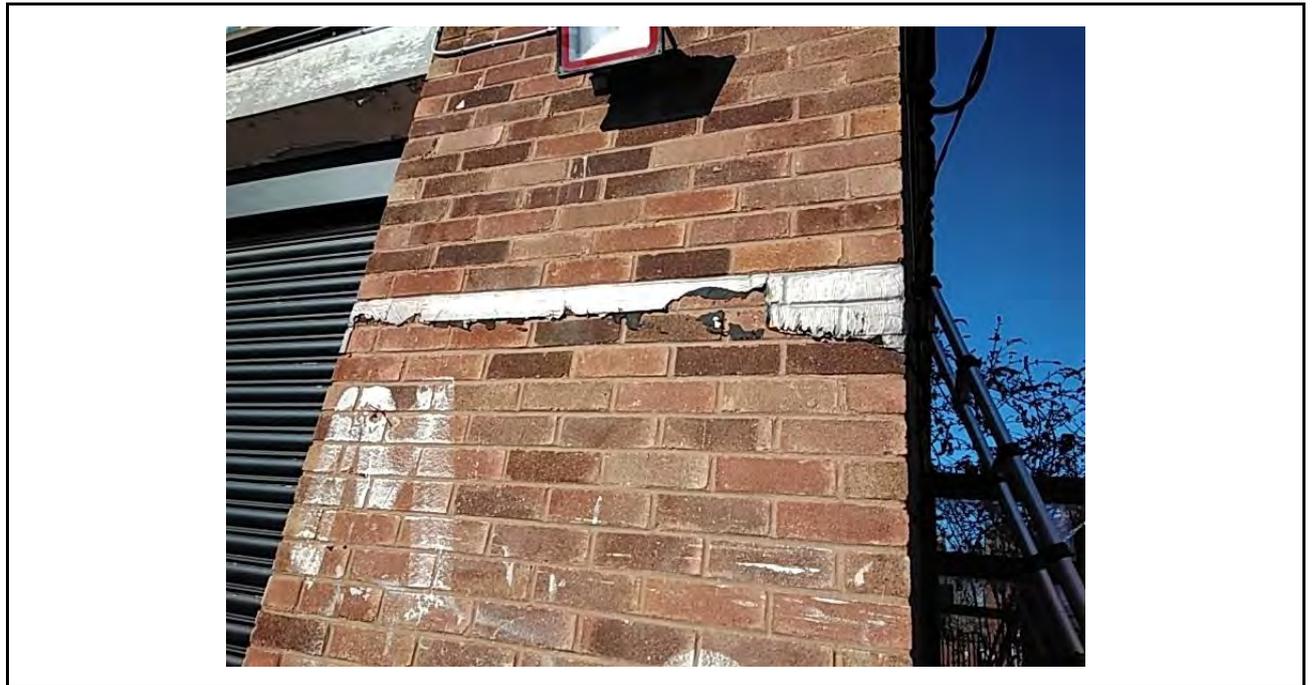
Description Adhesive tape .

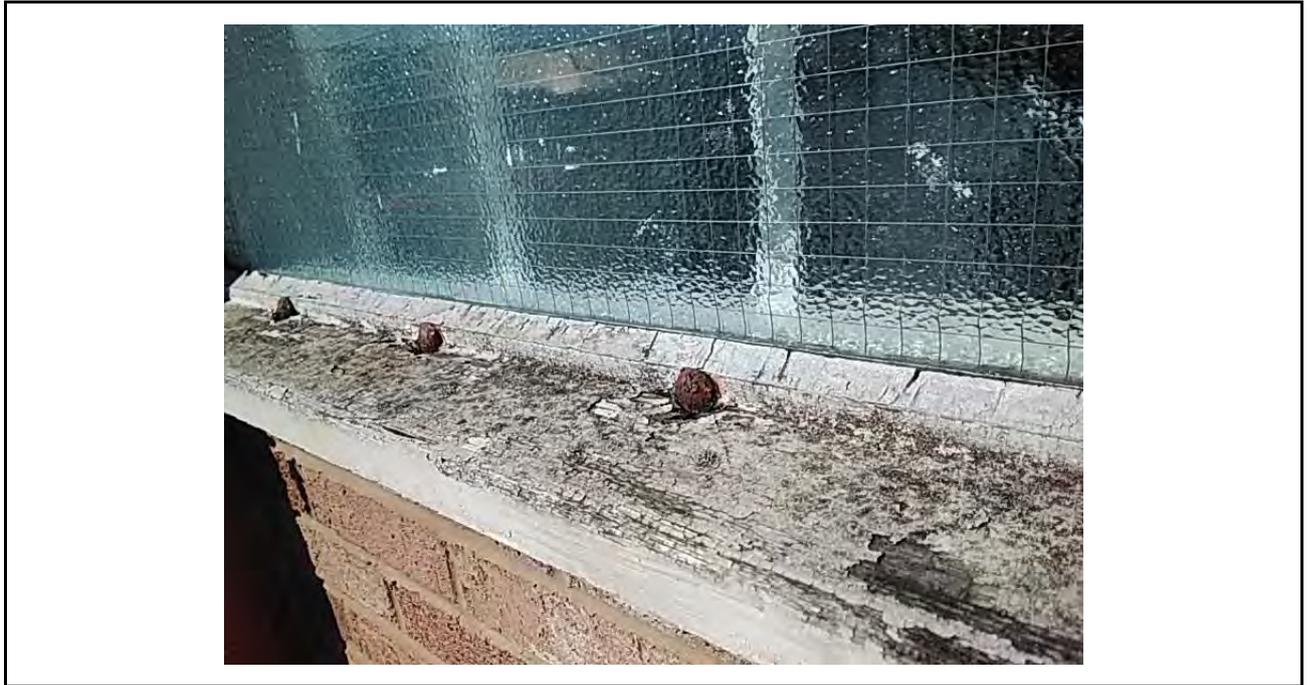
Description Seals to window frames.

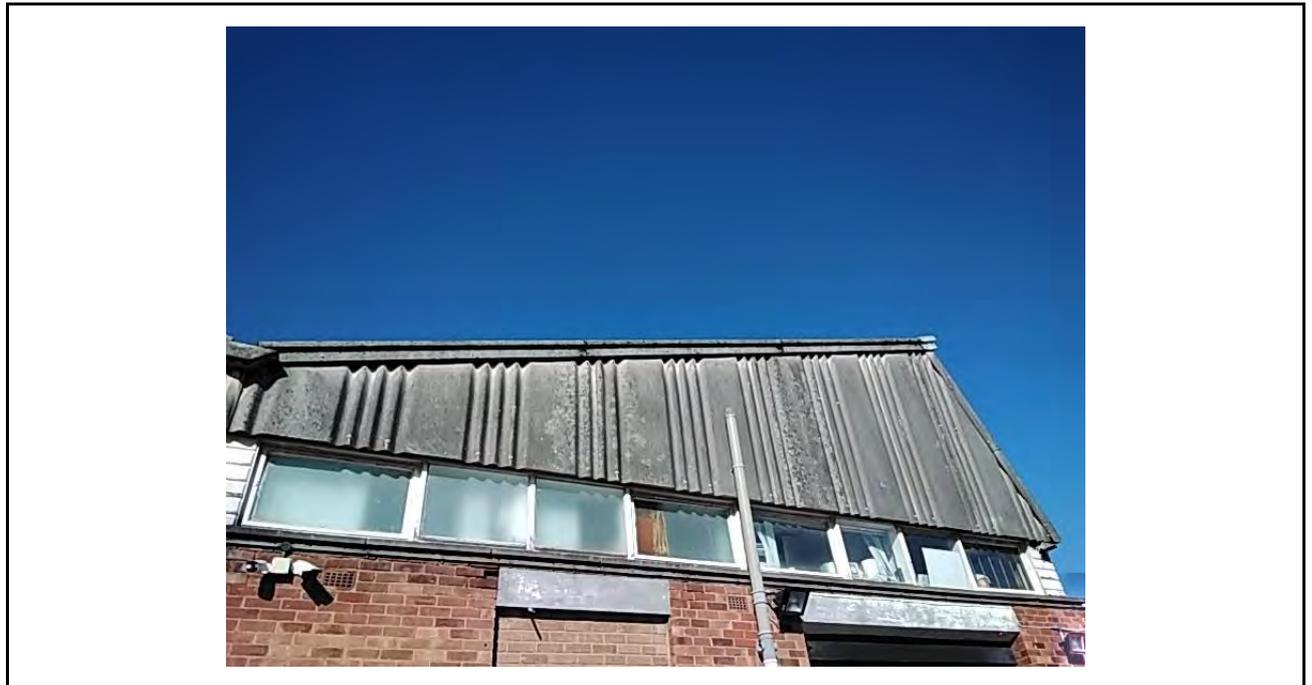
Description Wall panels . Visually consistent with Sample 23.

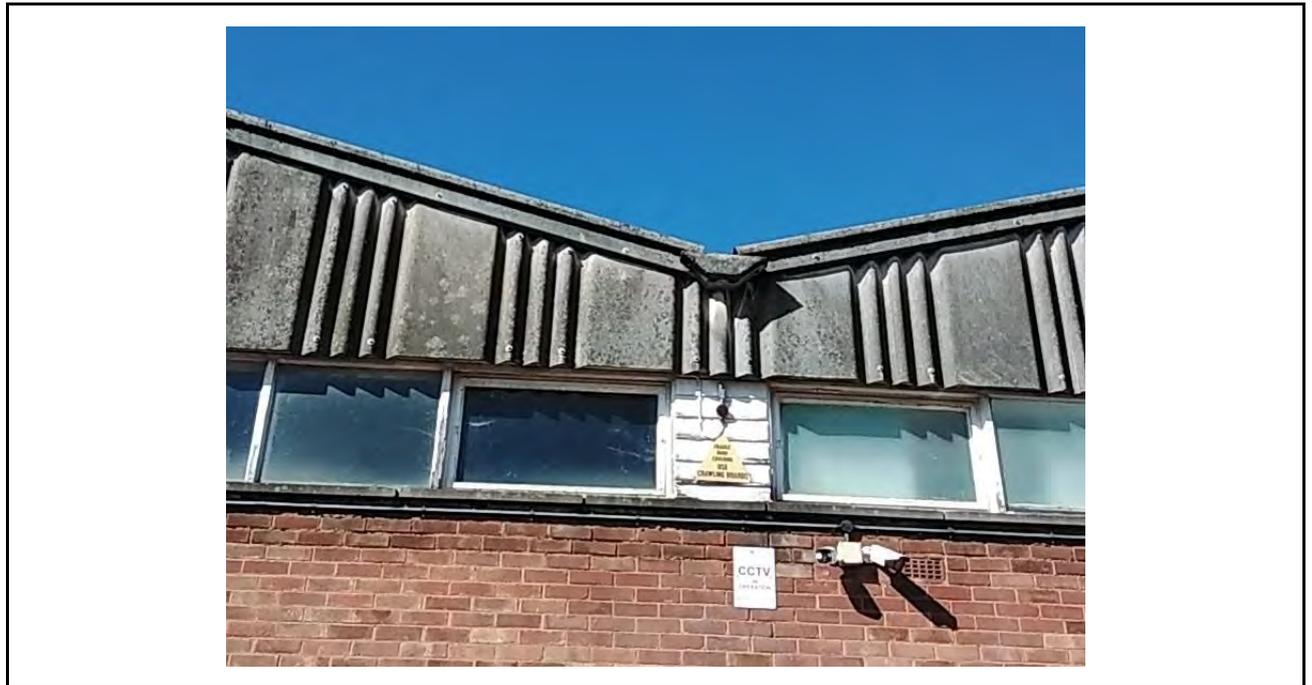
Description Gully / trough . Visually consistent with Sample 23.

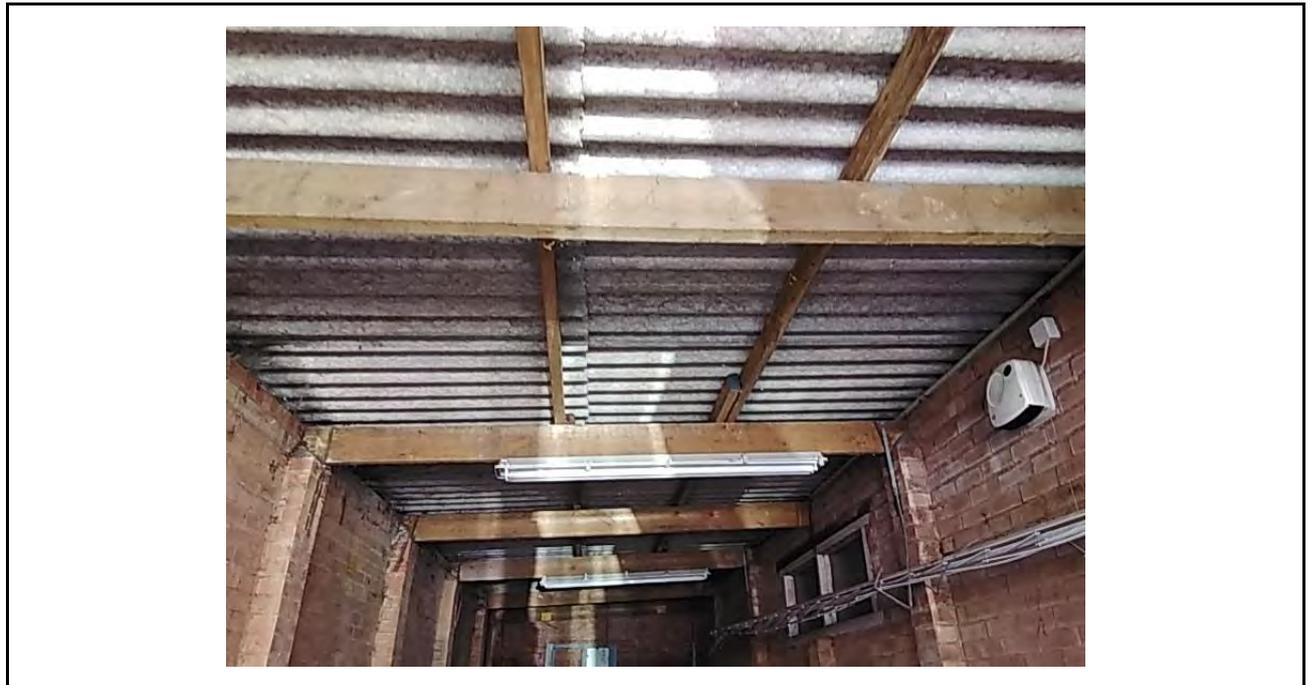
Description Roof sheets . Visually consistent with Sample 33.

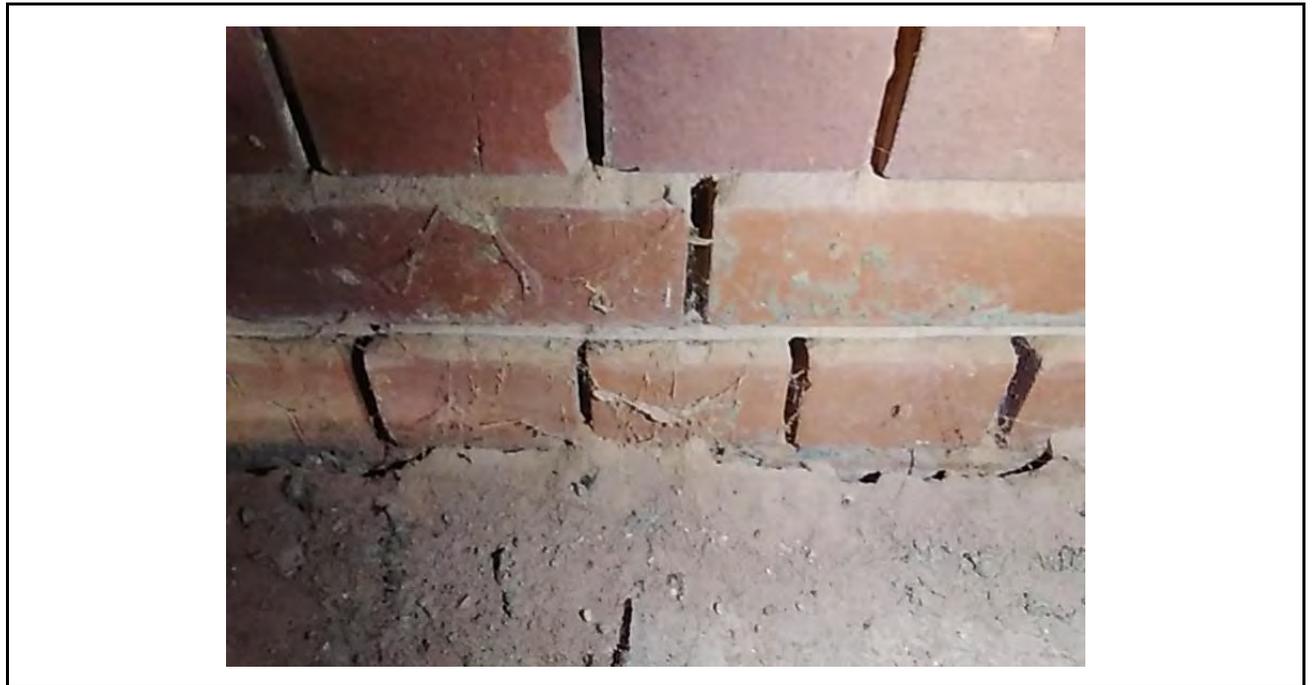
Description Damp proofing . Visually consistent with Sample 34.

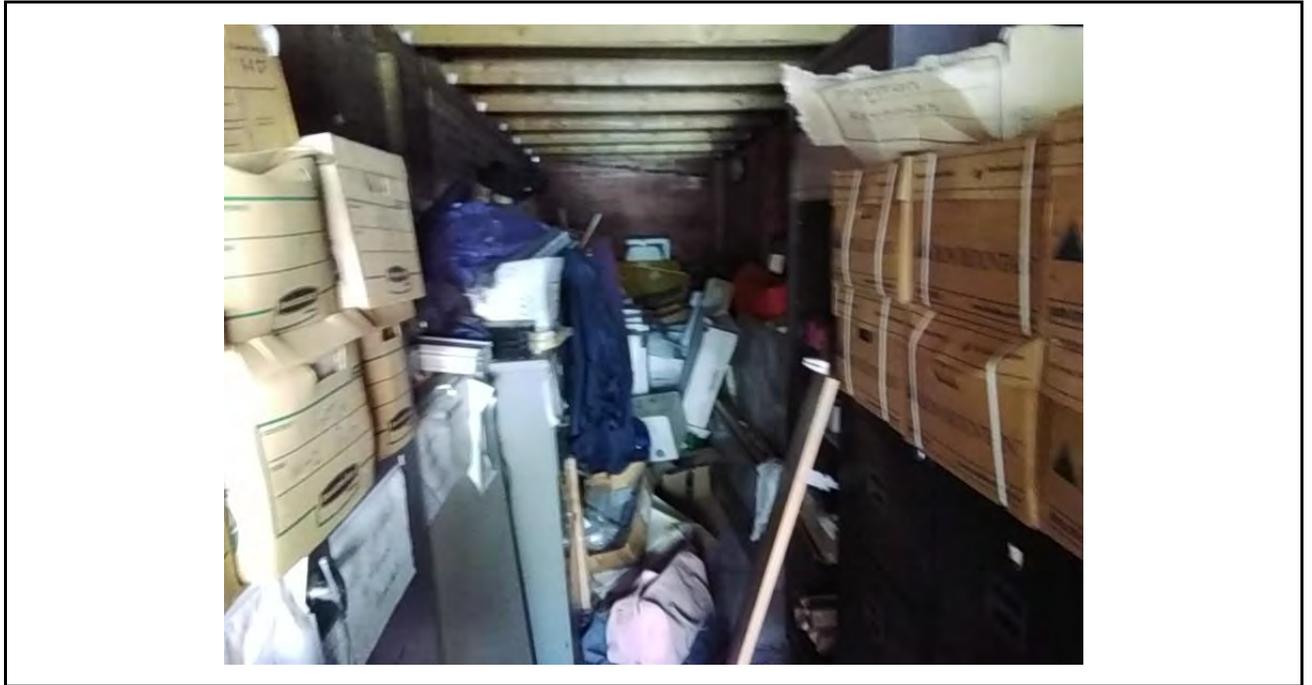
Description No access .

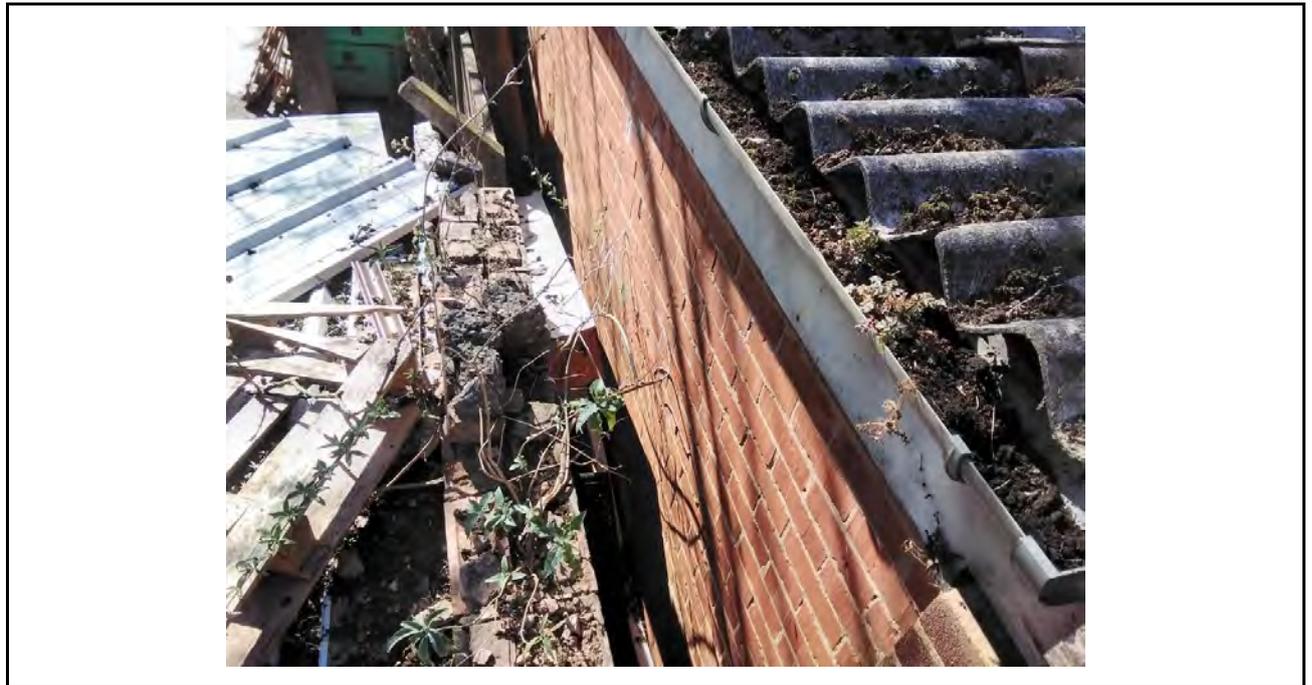
Description Side of structure .

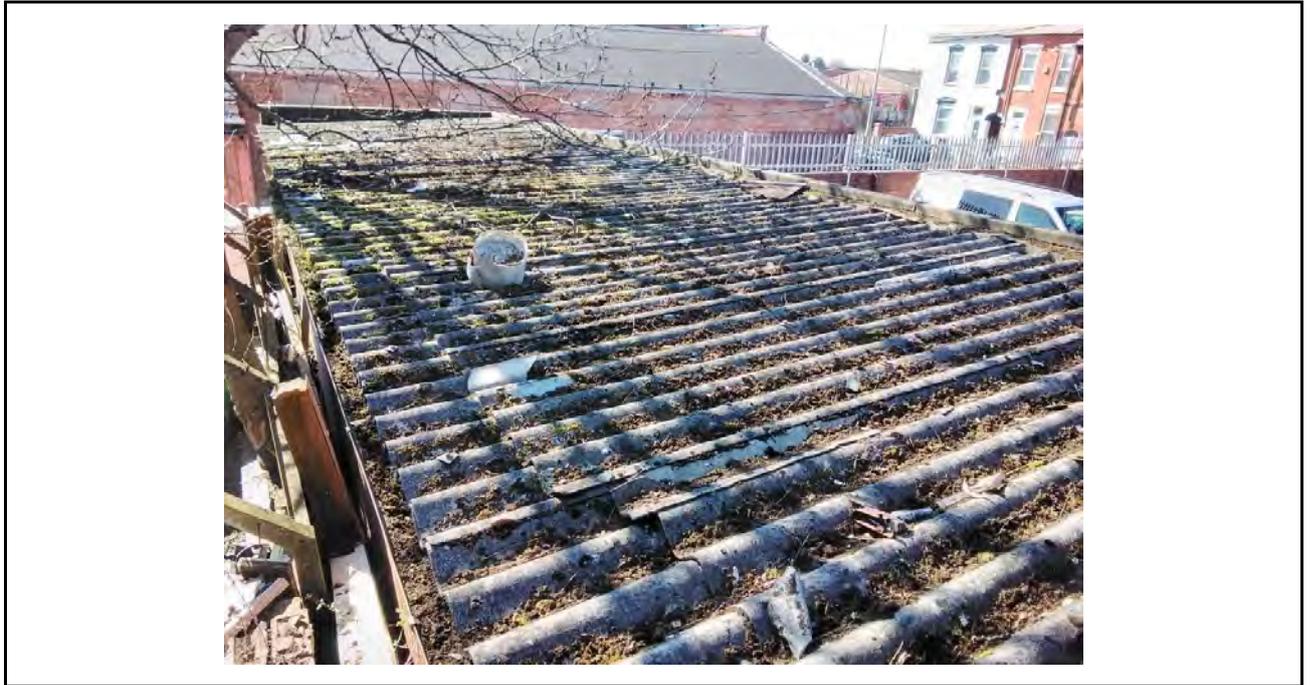
Description Roof sheets .

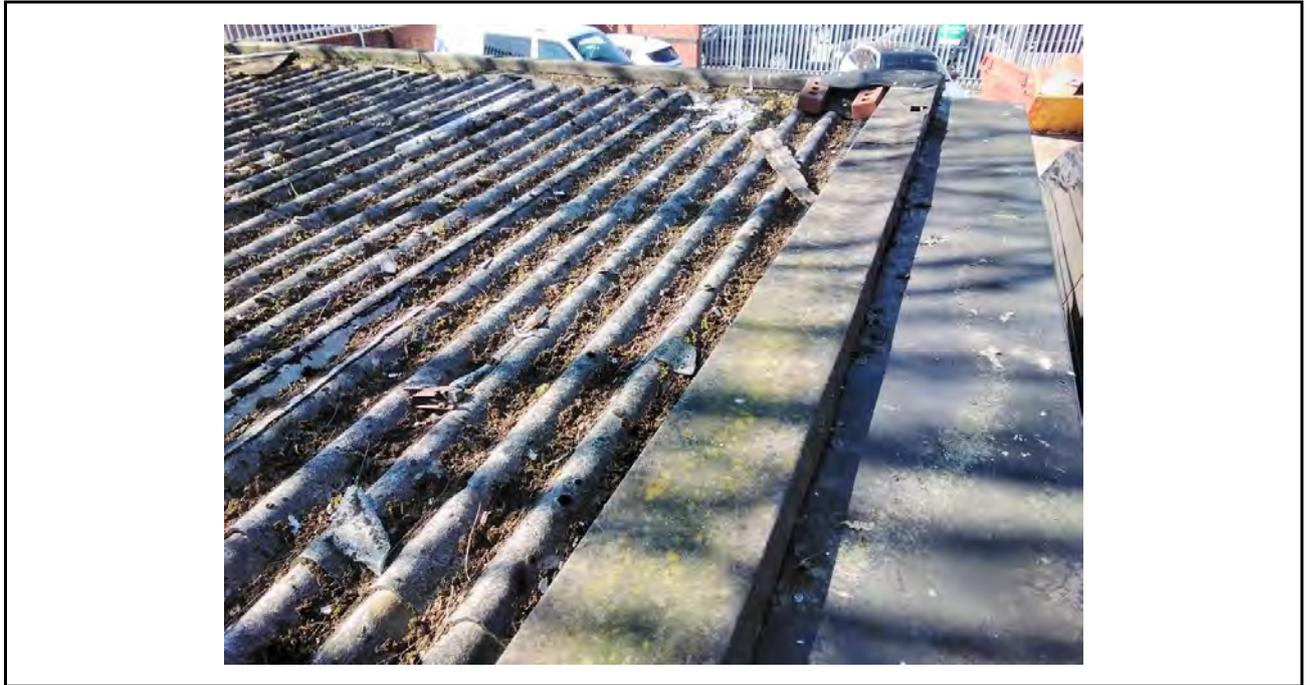
Description Flashing .

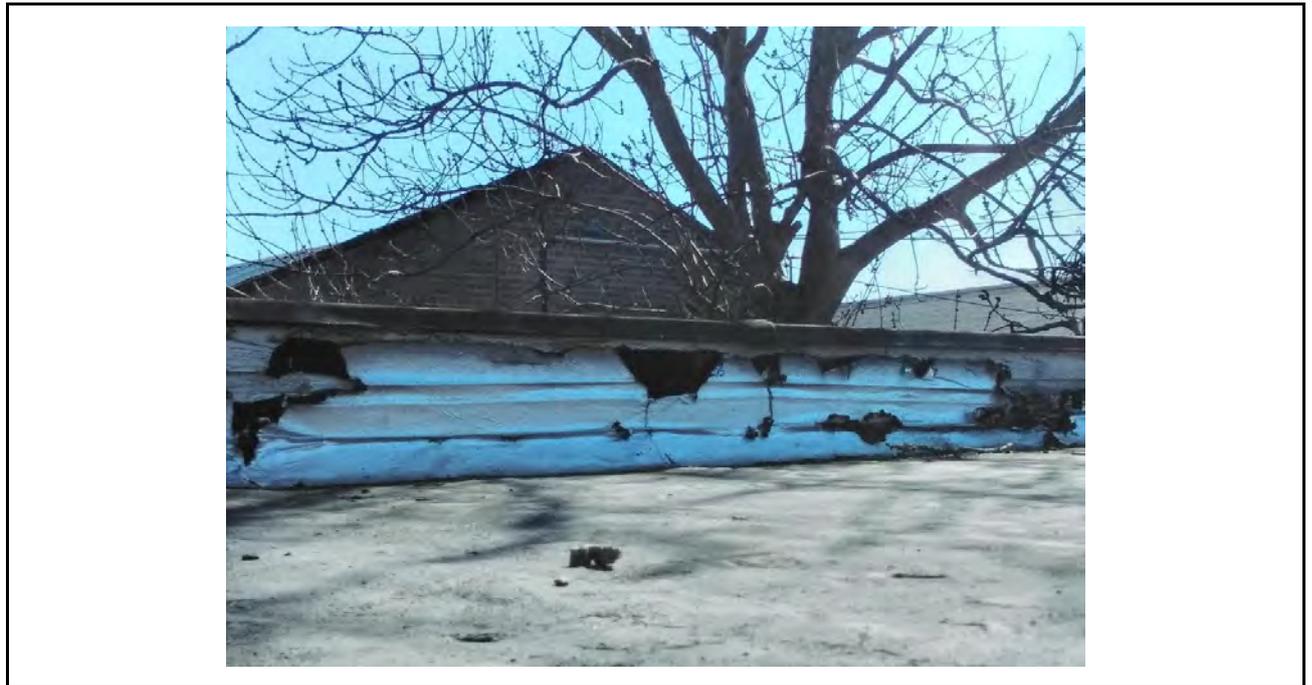
Description Adhesive tape .

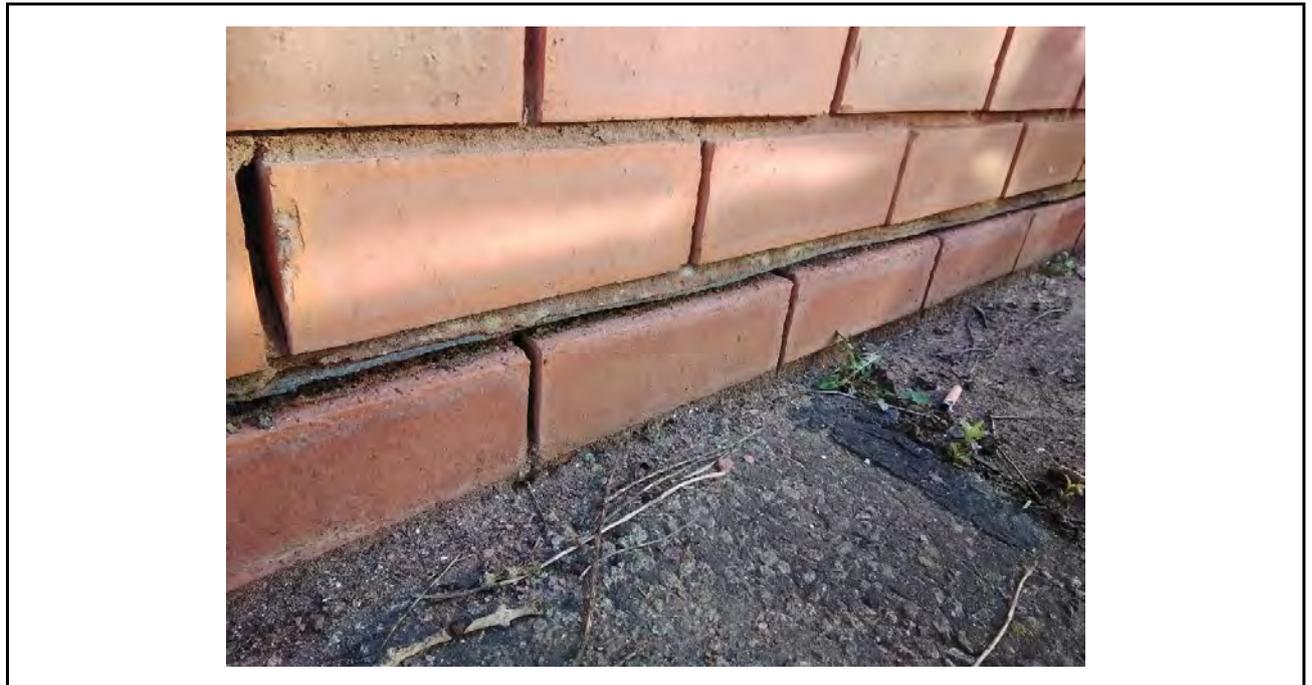
Description Damp proofing .

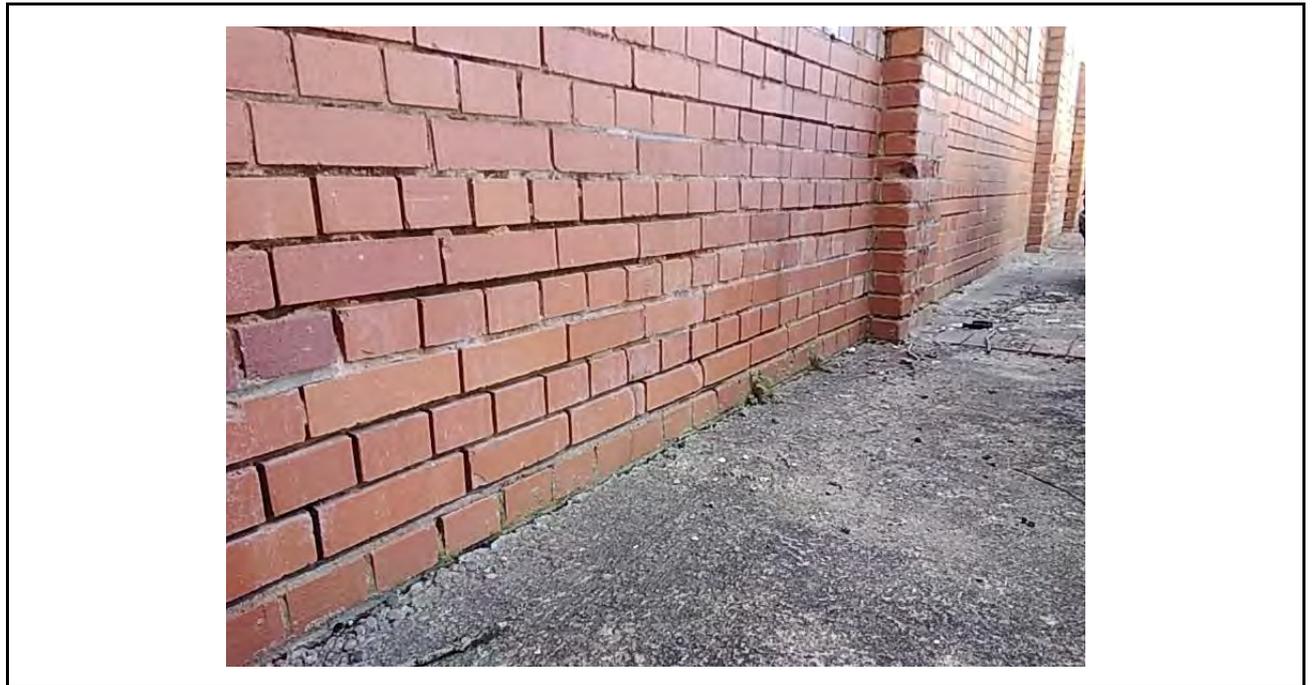
Description Damp proofing . Visually consistent with Sample 36.
