Asbestos Reinspection Survey

Mole Street Housing Office, B11 1XA

Report No	R-11330	Report Issue Date	19 November 2025
Client Name & Address	Asset Management & Maintenance Division Mole Street Centre Mole Street Sparkbrook Birmingham B11 1XA	Site Address	Mole Street Housing Office, Mole Street, Birmingham, B11 1XA
Order Placed By	Claire Lennon	Instruction Date	1 September 2025
Order Number	B1-AV0N4-2Z09-EH1-JZZZZZ-TV5EB- JZZZ-JXXX	Project Reference	IPBL001924
Reinspection Report Date	07/10/2026	Lead Surveyor	Luke Murphy

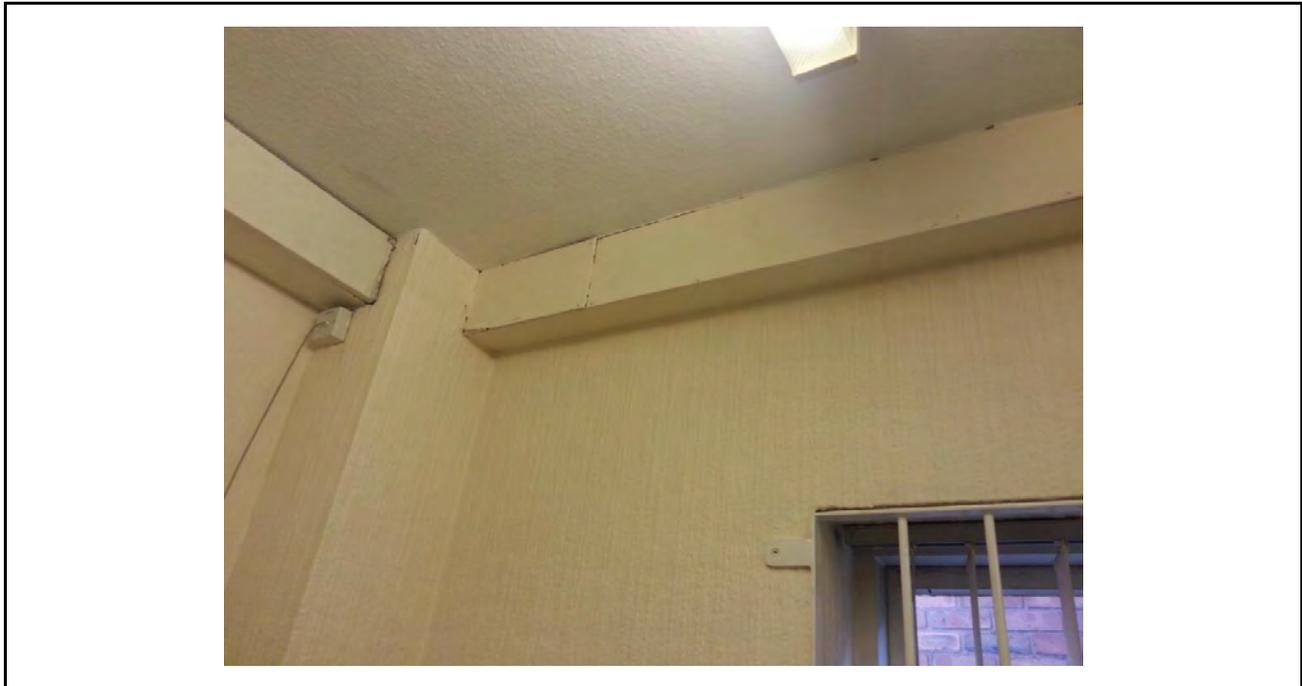
Surveyor	Luke Murphy	Building	Main Building
Survey Type	Re-Inspection	Floor	0
Survey Date	07/10/2025	Location/ Room	001 - Store 001
Next Inspection	07/10/2026	Sample No	P001
Level of Identification	Presumed	Inspection Ref	1075671 Original Ref: 340247

Description Behind boxing.
All boxing throughout.

Score
Asbestos Type	Presumed Asbestos	-
Product Type		-
Extent of Damage		-
Surface Treatment		-
Estimated Amount		
Accessibility		
Risk Score		12

Recommendation	Inspection Required
Notes	Unable to access the room at the time of the reinspection due to the room being used for private meetings during operational hours. The item has been presumed to remain in-situ. The original photograph has been retained to provide clarity to the report.

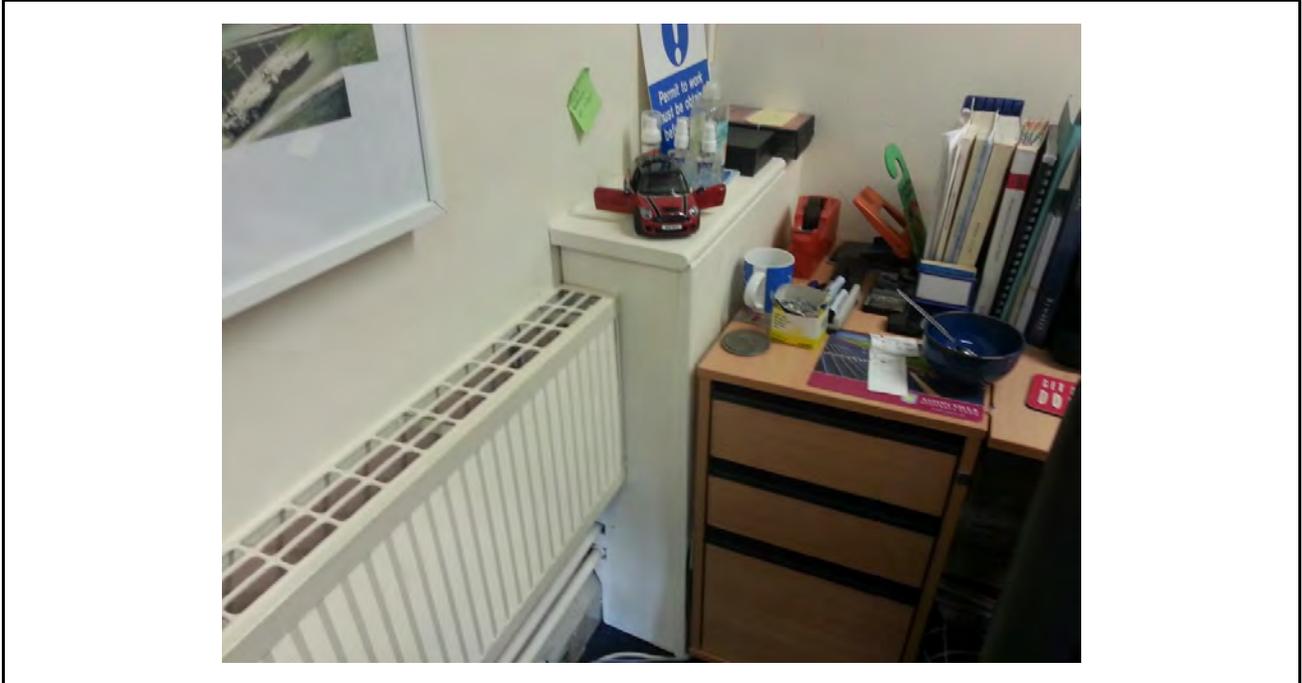
Surveyor	Luke Murphy	Building	Main Building
Survey Type	Re-Inspection	Floor	0
Survey Date	07/10/2025	Location/ Room	002 - Office 002
Next Inspection	07/10/2026	Sample No	P002
Level of Identification	Presumed	Inspection Ref	1075670 Original Ref: 340261

Description Behind boxing.

Score
Asbestos Type	Presumed Asbestos	-
Product Type		-
Extent of Damage		-
Surface Treatment		-
Estimated Amount		
Accessibility		
Risk Score		12

Recommendation	Inspection Required
Notes	Unable to access the room at the time of the reinspection due to the room being used for private meetings during operational hours. The item has been presumed to remain in-situ. The original photograph has been retained to provide clarity to the report.

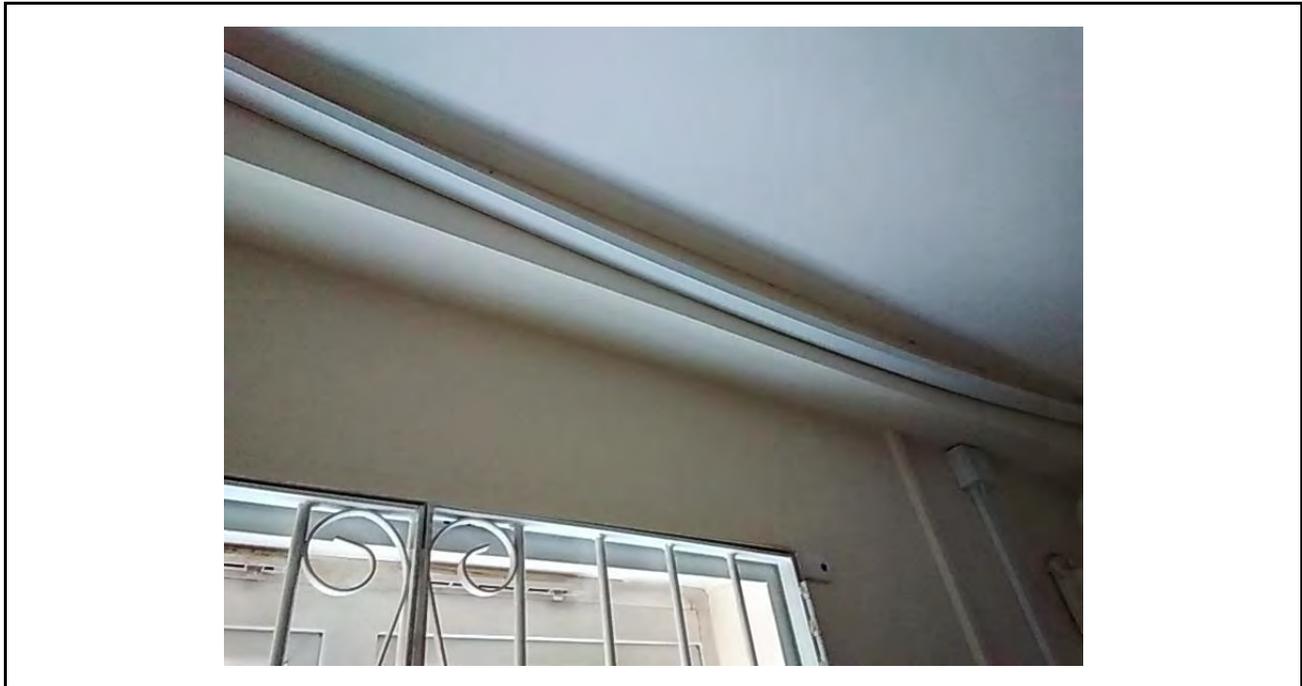
Surveyor	Luke Murphy	Building	Main Building
Survey Type	Re-Inspection	Floor	0
Survey Date	07/10/2025	Location/ Room	003 - Meeting room 003
Next Inspection	07/10/2026	Sample No	P005
Level of Identification	Presumed	Inspection Ref	1075655 Original Ref: 340283

Description Behind boxing.
All boxing throughout.

Score
Asbestos Type	Presumed Asbestos	-
Product Type		-
Extent of Damage		-
Surface Treatment		-
Estimated Amount		
Accessibility		
Risk Score		12

Recommendation	Inspection Required
Notes	Unable to remove due to damage limitation. The building/area is in use on a daily basis. No change.

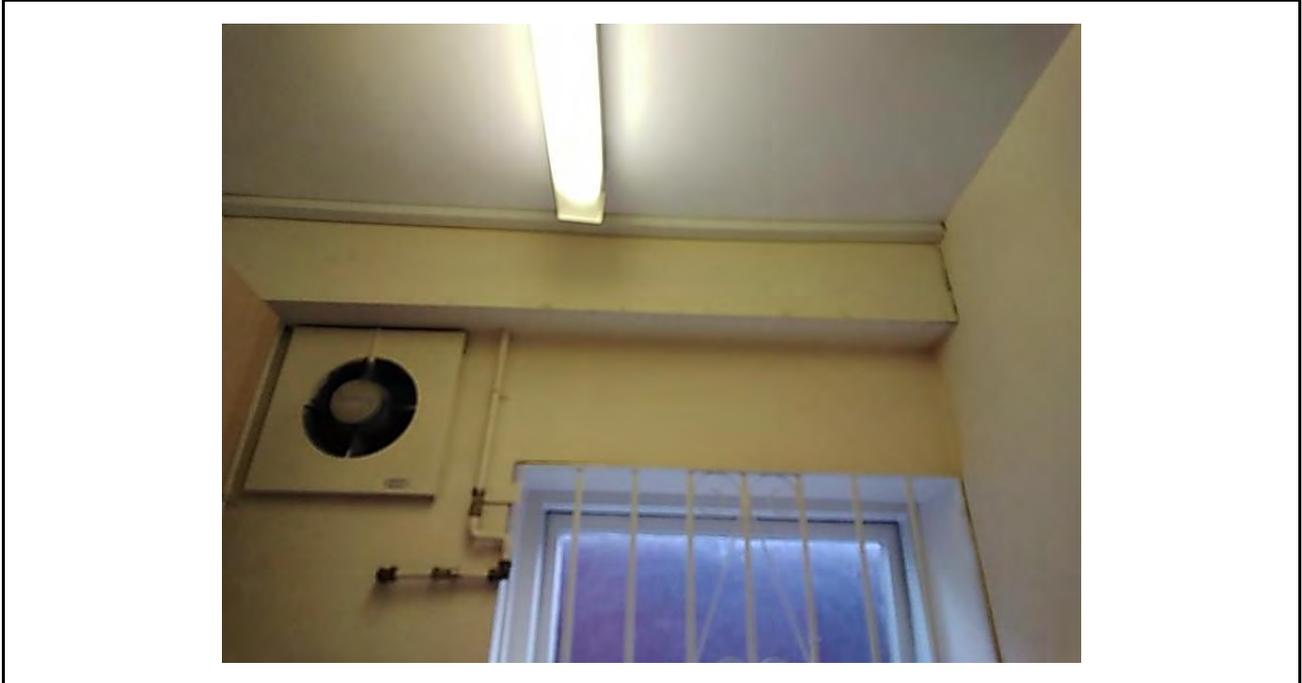
Surveyor	Luke Murphy	Building	Main Building
Survey Type	Re-Inspection	Floor	0
Survey Date	07/10/2025	Location/ Room	004 - Kitchen 004
Next Inspection	07/10/2026	Sample No	P004
Level of Identification	Presumed	Inspection Ref	1075653 Original Ref: 340275

Description Behind boxing.

Score
Asbestos Type	Presumed Asbestos	-
Product Type		-
Extent of Damage		-
Surface Treatment		-
Estimated Amount		
Accessibility		
Risk Score		12

Recommendation	Inspection Required
Notes	Unable to remove due to damage limitation. The building/area is in use on a daily basis. No change.

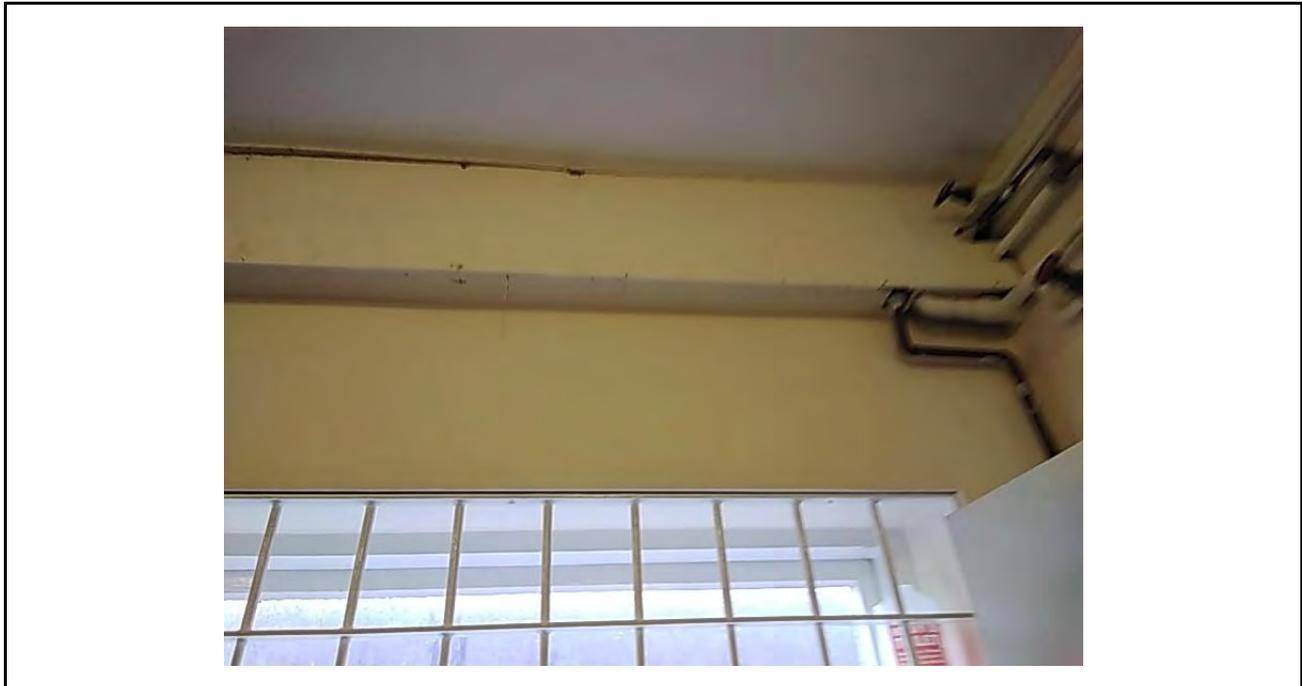
Surveyor	Luke Murphy	Building	Main Building
Survey Type	Re-Inspection	Floor	0
Survey Date	07/10/2025	Location/ Room	005 - W/C 005
Next Inspection	07/10/2026	Sample No	P008
Level of Identification	Presumed	Inspection Ref	1075652 Original Ref: 340300

Description Behind boxing.
All boxing throughout.

Score
Asbestos Type	Presumed Asbestos	-
Product Type		-
Extent of Damage		-
Surface Treatment		-
Estimated Amount		
Accessibility		
Risk Score		12

Recommendation	Inspection Required
Notes	Unable to remove due to damage limitation. The building/area is in use on a daily basis. No change.

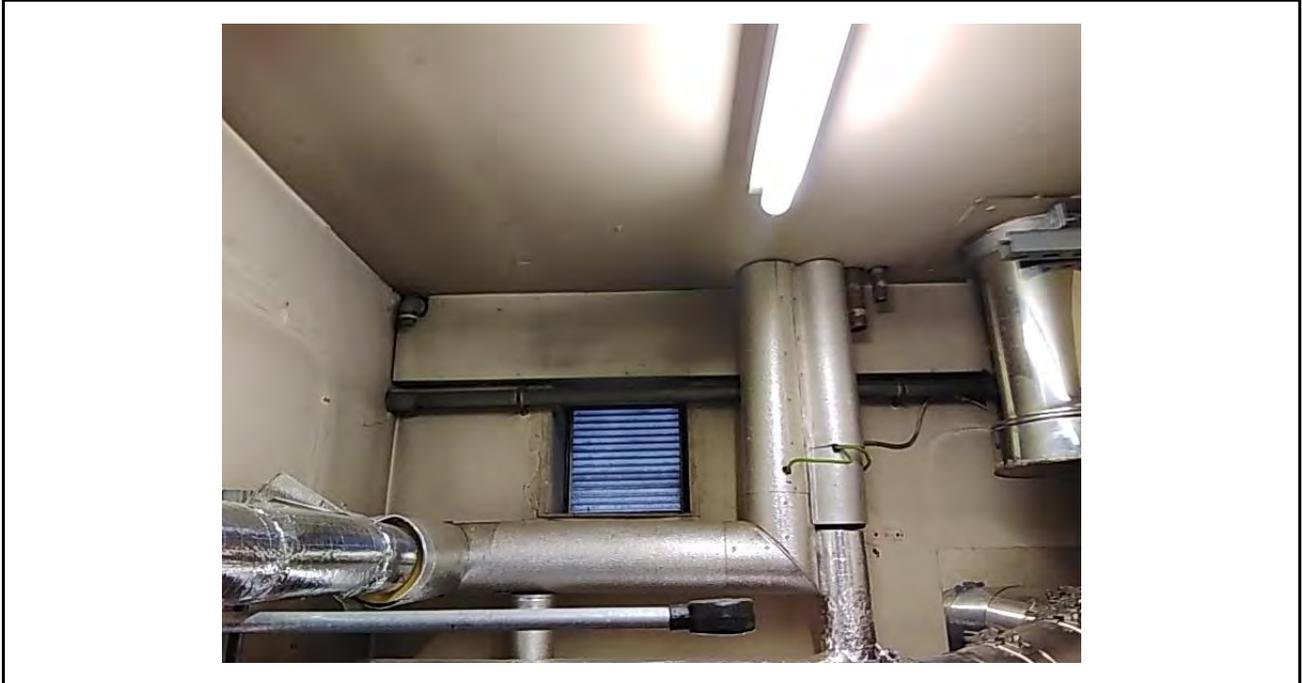
Surveyor	Luke Murphy	Building	Main Building
Survey Type	Re-Inspection	Floor	0
Survey Date	07/10/2025	Location/ Room	006 - Boiler room 006
Next Inspection	07/10/2026	Sample No	P010
Level of Identification	Presumed	Inspection Ref	1075668 Original Ref: 340318

Description Behind boxing.

Score
Asbestos Type	Presumed Asbestos	-
Product Type		-
Extent of Damage		-
Surface Treatment		-
Estimated Amount		
Accessibility		
Risk Score		12

Recommendation	Inspection Required
Notes	Unable to remove due to damage limitation. The building/area is in use on a daily basis. No change.

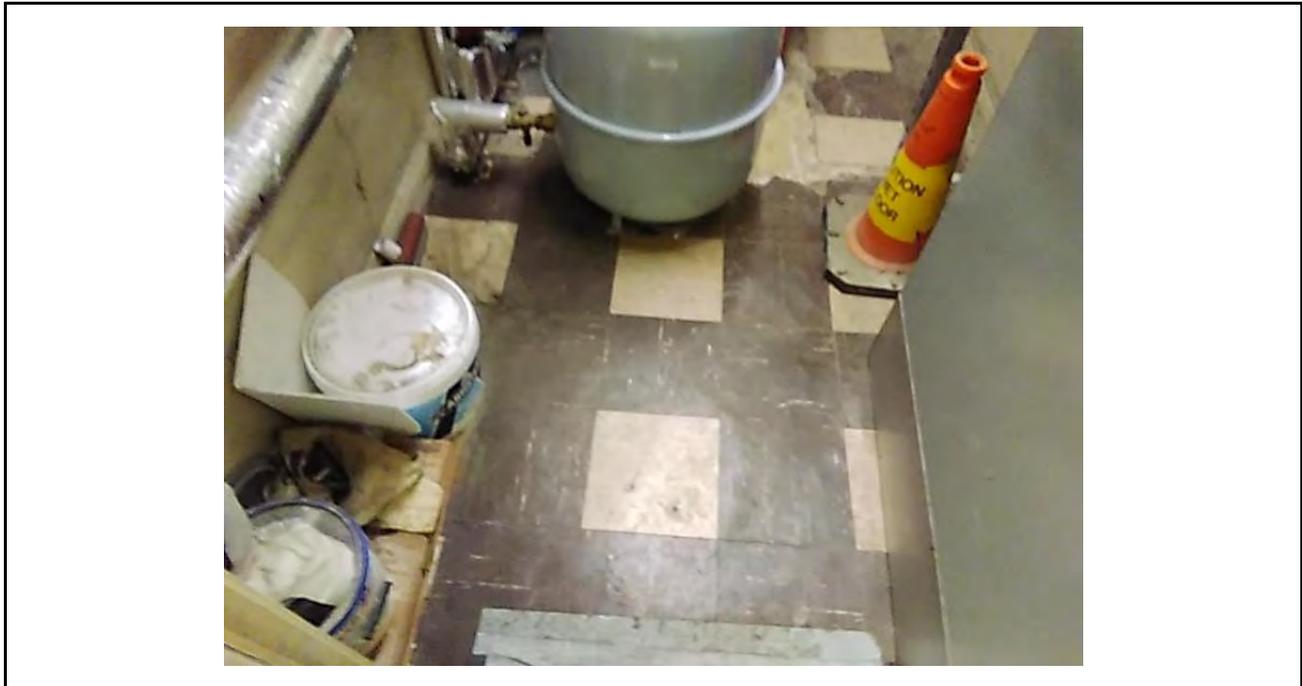
Surveyor	Luke Murphy	Building	Main Building
Survey Type	Re-Inspection	Floor	0
Survey Date	07/10/2025	Location/ Room	006 - Boiler room 006
Next Inspection	07/10/2026	Sample No	PS009
Level of Identification	Previously Sampled	Inspection Ref	1075651 Original Ref: 340309

Description Floor.

Score
Asbestos Type	CHRYSTILE (Chrysotile present in adhesive only.)	1
Product Type	Floor Tiles & Adhesive	1
Extent of Damage	Low Damage	1
Surface Treatment	Composite, reinforced or bonded	0
Estimated Amount	5 m ²	
Accessibility	Easily Disturbed	
Risk Score		3

Recommendation	Manage & Re-inspect
Notes	No change.

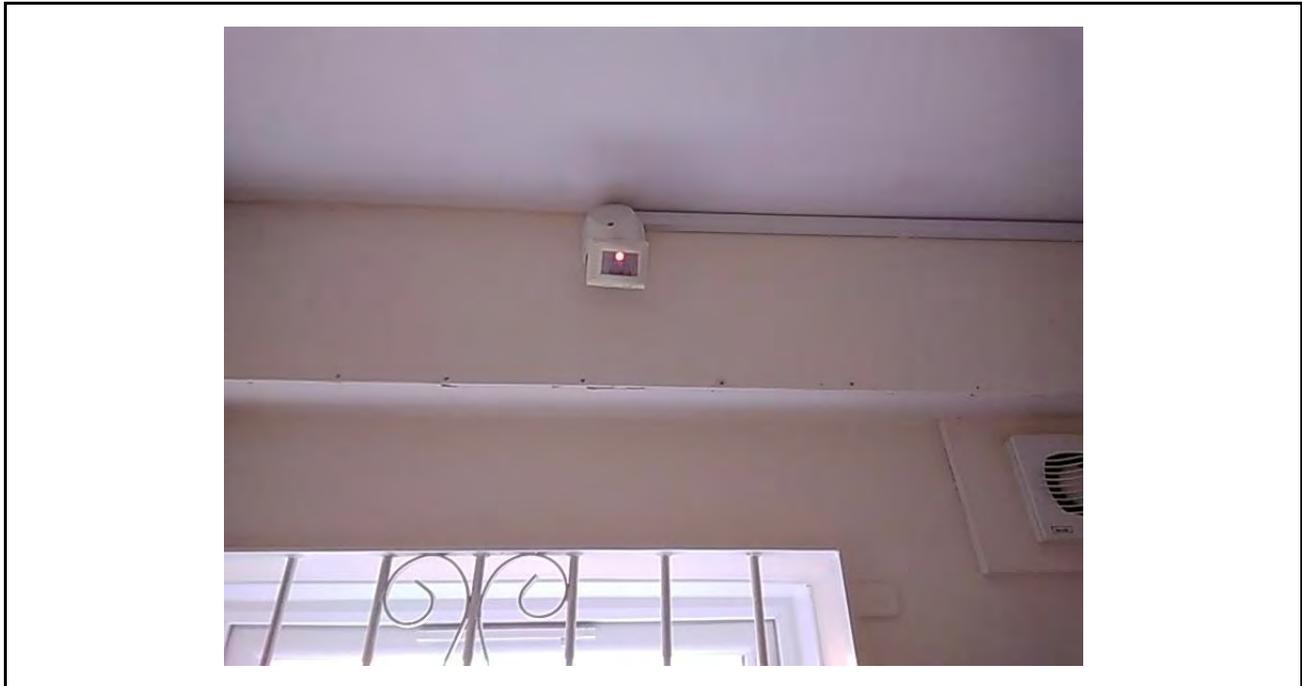
Surveyor	Luke Murphy	Building	Main Building
Survey Type	Re-Inspection	Floor	0
Survey Date	07/10/2025	Location/ Room	007 - W/C 007
Next Inspection	07/10/2026	Sample No	P015
Level of Identification	Presumed	Inspection Ref	1075650 Original Ref: 340327

Description Behind boxing.

Score
Asbestos Type	Presumed Asbestos	-
Product Type		-
Extent of Damage		-
Surface Treatment		-
Estimated Amount		
Accessibility		
Risk Score		12

Recommendation	Inspection Required
Notes	Unable to remove due to damage limitation. The building/area is in use on a daily basis. No change.

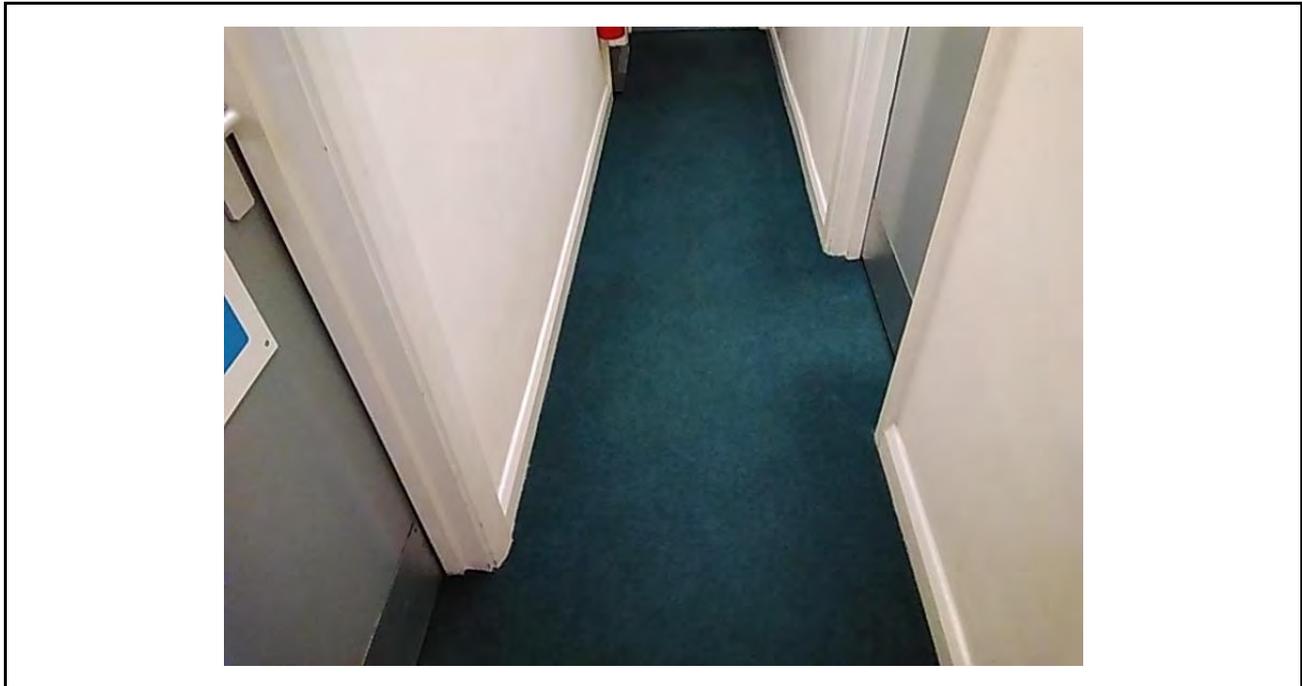
Surveyor	Luke Murphy	Building	Main Building
Survey Type	Re-Inspection	Floor	0
Survey Date	07/10/2025	Location/ Room	008 - Circulation 008
Next Inspection	07/10/2026	Sample No	PS012
Level of Identification	Previously Sampled	Inspection Ref	1075647 Original Ref: 340322

Description Floor below Carpet.
Remaining adhesive.

Score
Asbestos Type	CHRYBOTILE	1
Product Type	Bitumen Products	1
Extent of Damage	Low Damage	1
Surface Treatment	Composite, reinforced or bonded	0
Estimated Amount	6 m ²	
Accessibility	Occasional Disturbance	
Risk Score		3

Recommendation	Manage & Re-inspect
Notes	Located beneath carpet. No change. No change.

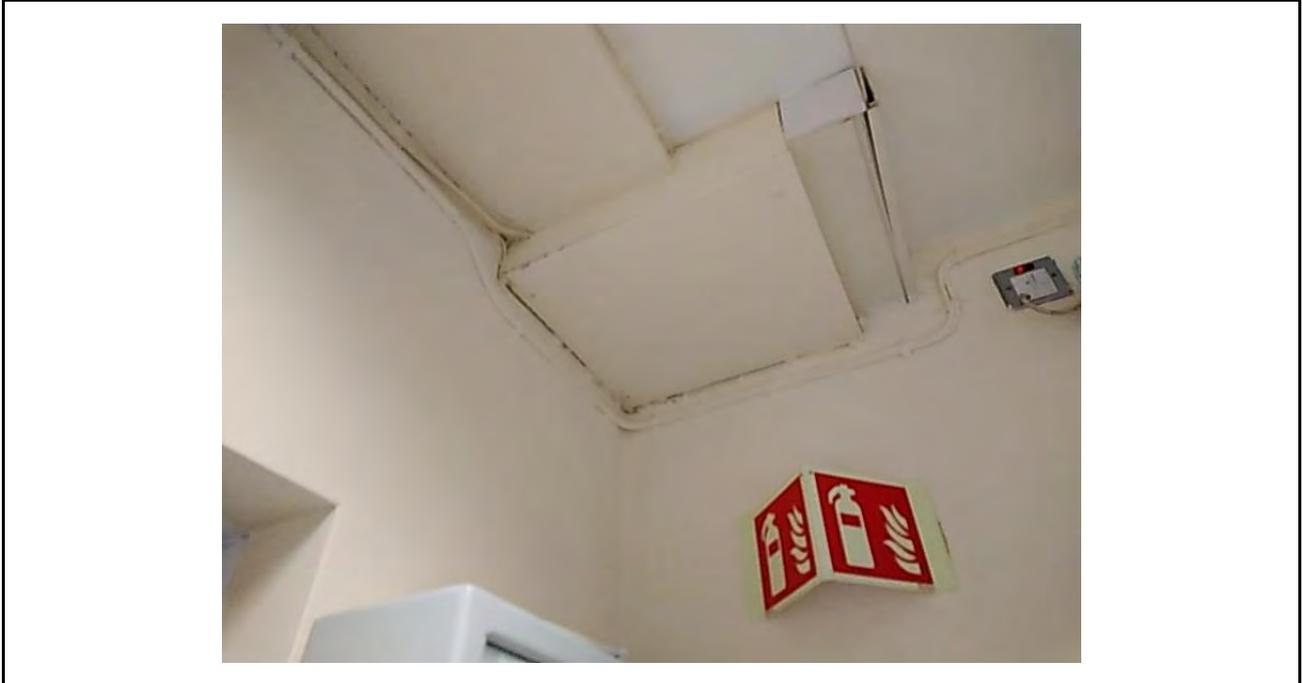
Surveyor	Luke Murphy	Building	Main Building
Survey Type	Re-Inspection	Floor	0
Survey Date	07/10/2025	Location/ Room	009 - Lobby/circulation 009
Next Inspection	07/10/2026	Sample No	P014
Level of Identification	Presumed	Inspection Ref	1075645 Original Ref: 340334

Description Behind boxing.

Score
Asbestos Type	Presumed Asbestos	-
Product Type		-
Extent of Damage		-
Surface Treatment		-
Estimated Amount		
Accessibility		
Risk Score		12

Recommendation	Inspection Required
Notes	Unable to remove due to damage limitation. The building/area is in use on a daily basis. No change.

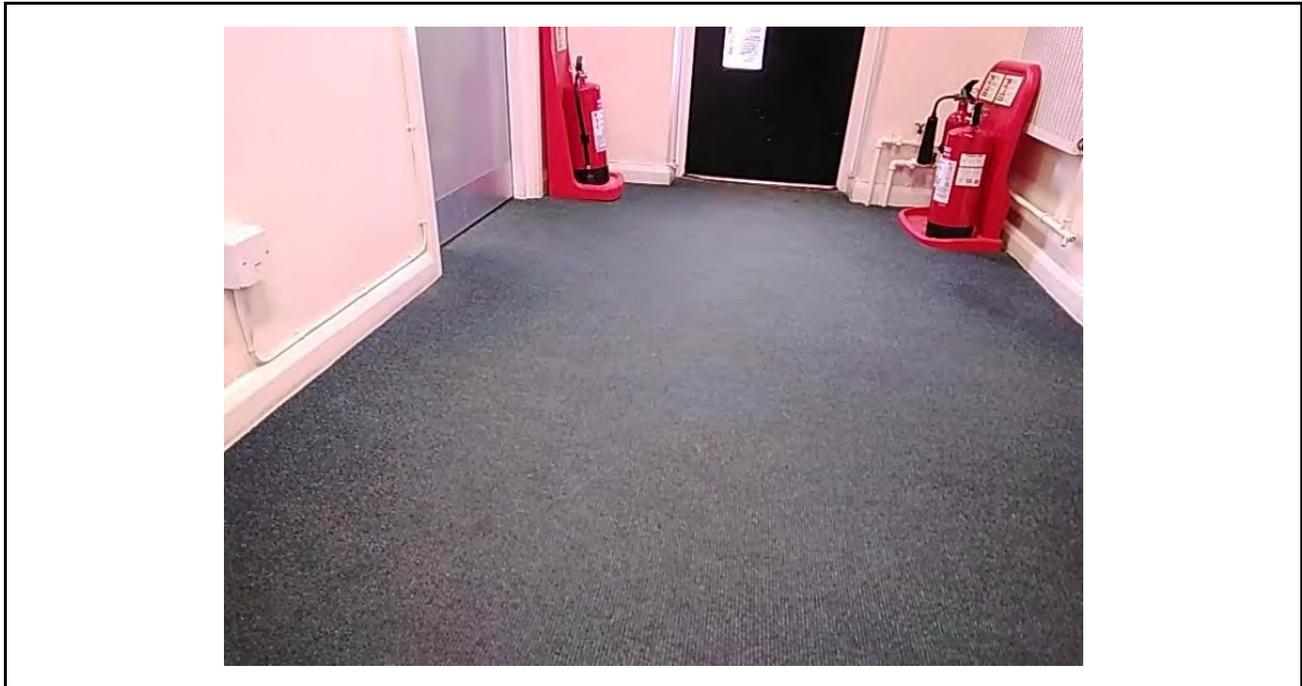
Surveyor	Luke Murphy	Building	Main Building
Survey Type	Re-Inspection	Floor	0
Survey Date	07/10/2025	Location/ Room	009 - Lobby/circulation 009
Next Inspection	07/10/2026	Sample No	X013
Level of Identification	Strongly Presumed	Inspection Ref	1075646 Original Ref: 340335

Description Floor below Carpet. Visually consistent with Sample 13.
Remaining adhesive.

Score
Asbestos Type	CHRYSTILE	1
Product Type	Bitumen Products	1
Extent of Damage	Low Damage	1
Surface Treatment	Composite, reinforced or bonded	0
Estimated Amount	15 m ²	
Accessibility	Occasional Disturbance	
Risk Score		3

Recommendation	Manage & Re-inspect
Notes	Located beneath carpet. No change. No change.

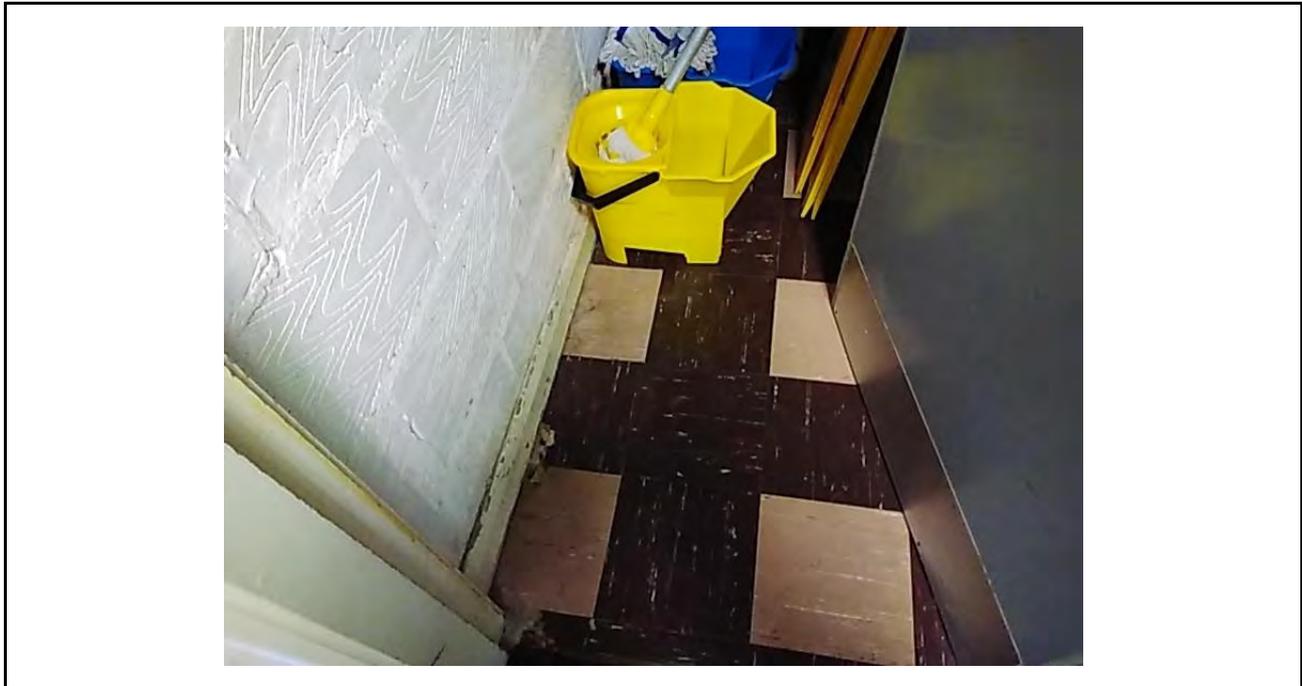
Surveyor	Luke Murphy	Building	Main Building
Survey Type	Re-Inspection	Floor	0
Survey Date	07/10/2025	Location/ Room	010 - Cleaners store 010
Next Inspection	07/10/2026	Sample No	PS013
Level of Identification	Previously Sampled	Inspection Ref	1075669 Original Ref: 340371

Description Floor.

Score
Asbestos Type	CHRYBOTILE	1
Product Type	Floor Tiles & Adhesive	1
Extent of Damage	Low Damage	1
Surface Treatment	Composite, reinforced or bonded	0
Estimated Amount	5 m ²	
Accessibility	Easily Disturbed	
Risk Score		3

Recommendation	Manage & Re-inspect
Notes	No change.

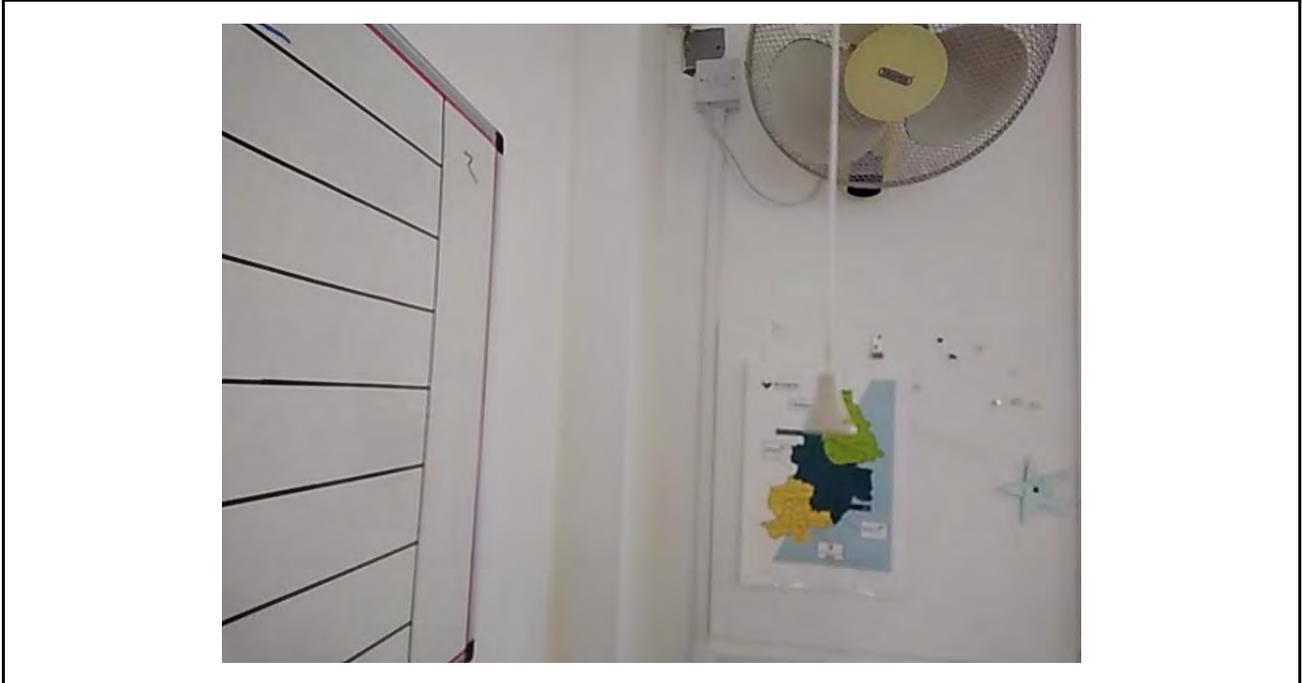
Surveyor	Luke Murphy	Building	Main Building
Survey Type	Re-Inspection	Floor	0
Survey Date	07/10/2025	Location/ Room	011 - Office 011
Next Inspection	07/10/2026	Sample No	P016
Level of Identification	Presumed	Inspection Ref	1075648 Original Ref: 340342

Description Behind boxing.

Score
Asbestos Type	Presumed Asbestos	-
Product Type		-
Extent of Damage		-
Surface Treatment		-
Estimated Amount		
Accessibility		
Risk Score		12

Recommendation	Inspection Required
Notes	Unable to remove due to damage limitation. The building/area is in use on a daily basis. No change.

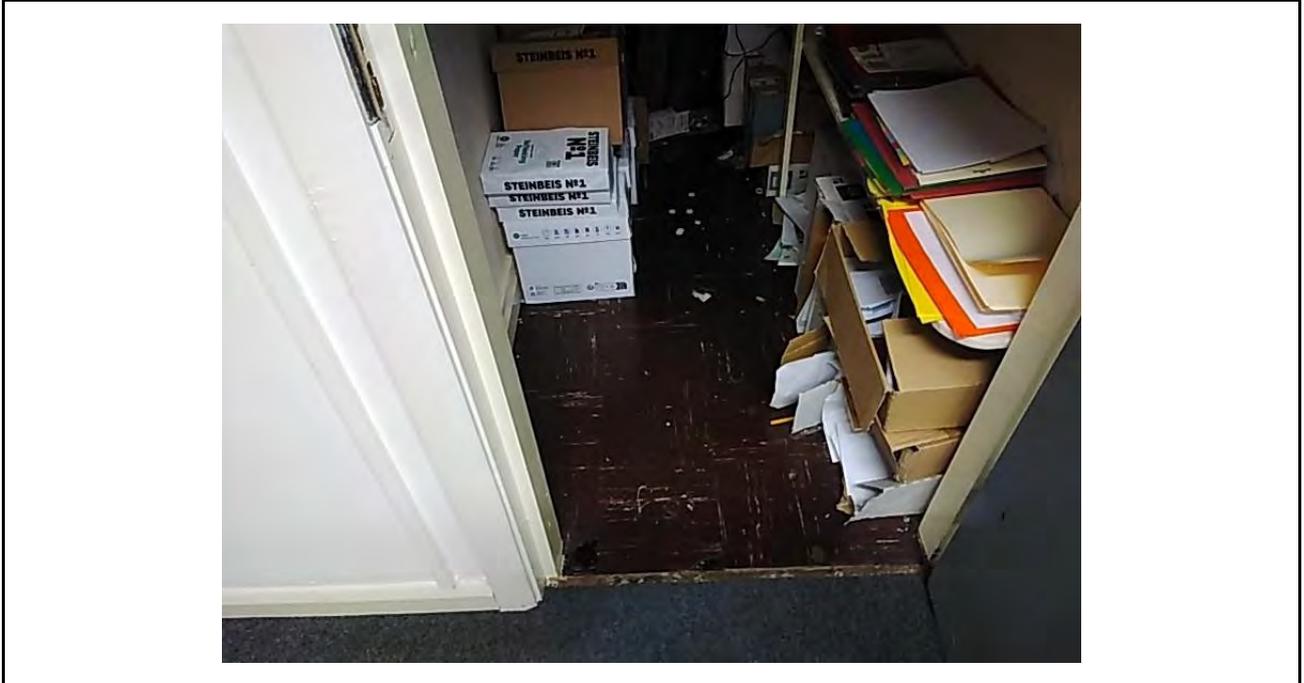
Surveyor	Luke Murphy	Building	Main Building
Survey Type	Re-Inspection	Floor	0
Survey Date	07/10/2025	Location/ Room	012 - Under stairs cupboard 012
Next Inspection	07/10/2026	Sample No	PS018
Level of Identification	Previously Sampled	Inspection Ref	1075649 Original Ref: 340376

Description Floor.

Score
Asbestos Type	CHRYSOTILE (Chrysotile present in adhesive only)	1
Product Type	Floor Tiles & Adhesive	1
Extent of Damage	Low Damage	1
Surface Treatment	Composite, reinforced or bonded	0
Estimated Amount	4 m ²	
Accessibility	Easily Disturbed	
Risk Score		3

Recommendation	Manage & Re-inspect
Notes	No change.

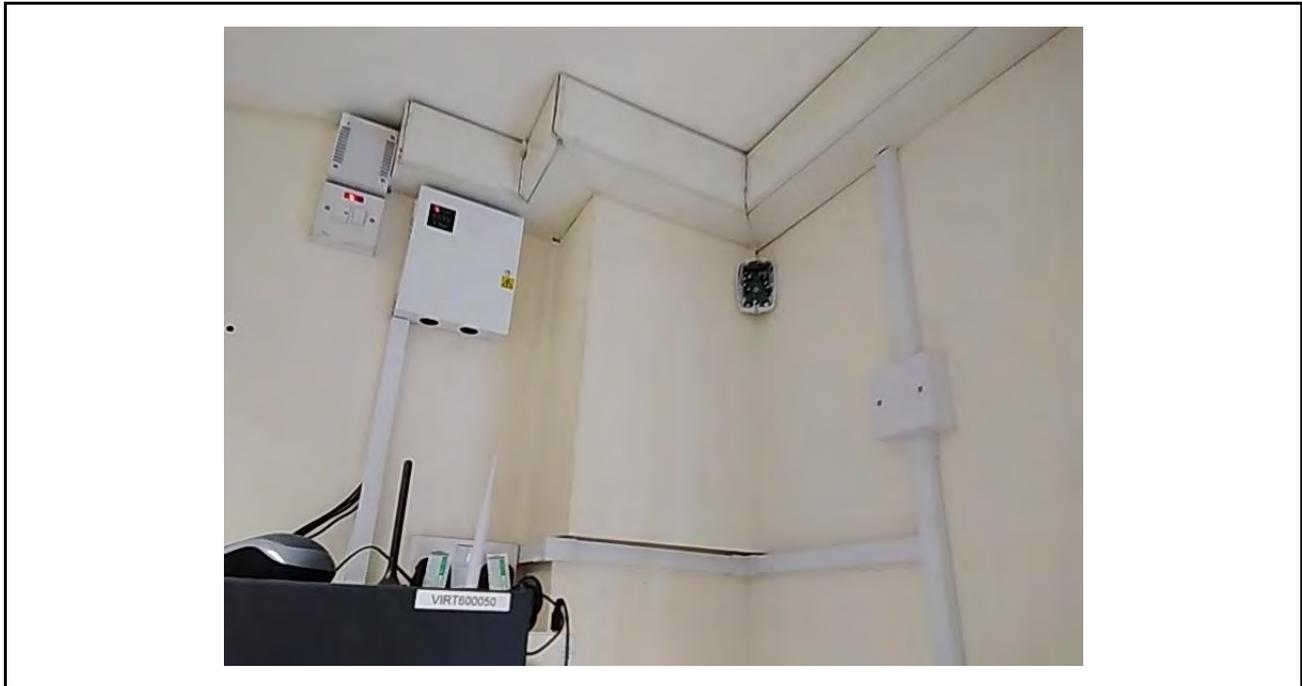
Surveyor	Luke Murphy	Building	Main Building
Survey Type	Re-Inspection	Floor	0
Survey Date	07/10/2025	Location/ Room	026 - Office 026
Next Inspection	07/10/2026	Sample No	P003
Level of Identification	Presumed	Inspection Ref	1075654 Original Ref: 340268

Description Behind boxing.

Score
Asbestos Type	Presumed Asbestos	-
Product Type		-
Extent of Damage		-
Surface Treatment		-
Estimated Amount		
Accessibility		
Risk Score		12

Recommendation	Inspection Required
Notes	Unable to remove due to damage limitation. The building/area is in use on a daily basis. No change.

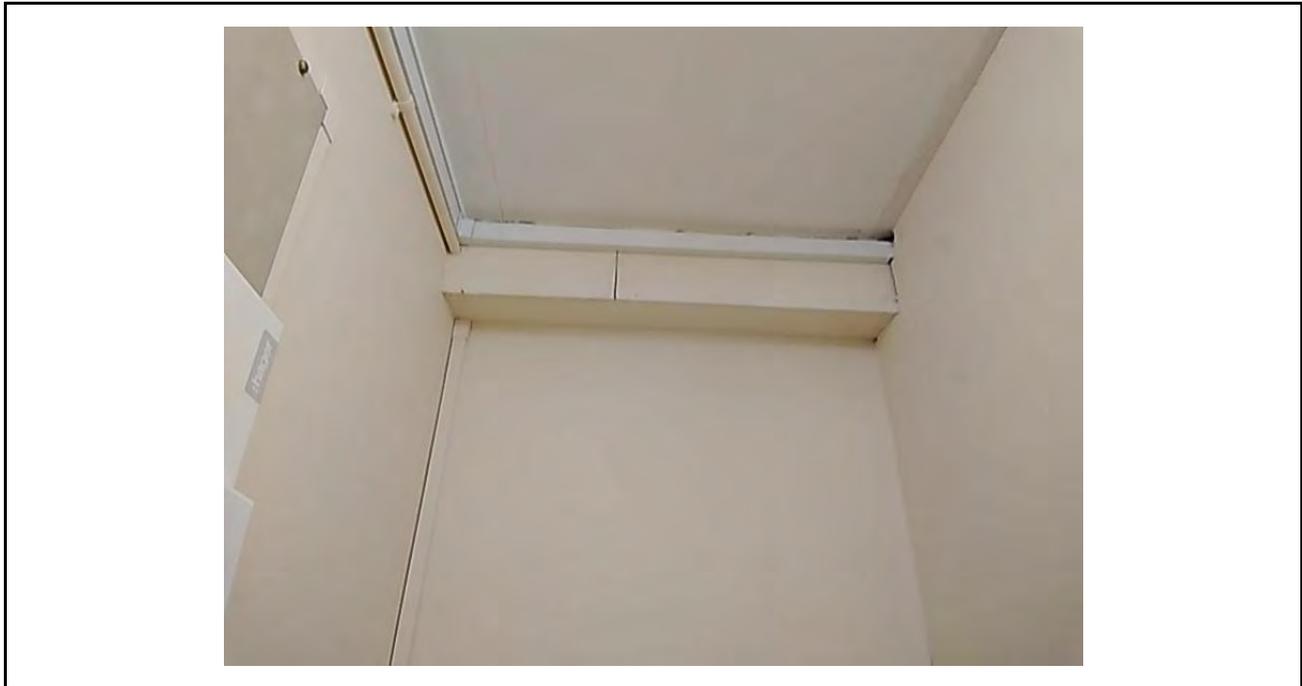
Surveyor	Luke Murphy	Building	Main Building
Survey Type	Re-Inspection	Floor	0
Survey Date	07/10/2025	Location/ Room	027 - Electric room 027
Next Inspection	07/10/2026	Sample No	P006
Level of Identification	Presumed	Inspection Ref	1075656 Original Ref: 340290

Description Behind boxing.
All boxing throughout.

Score
Asbestos Type	Presumed Asbestos	-
Product Type		-
Extent of Damage		-
Surface Treatment		-
Estimated Amount		
Accessibility		
Risk Score		12

Recommendation	Inspection Required
Notes	Unable to remove due to damage limitation. The building/area is in use on a daily basis. No change.

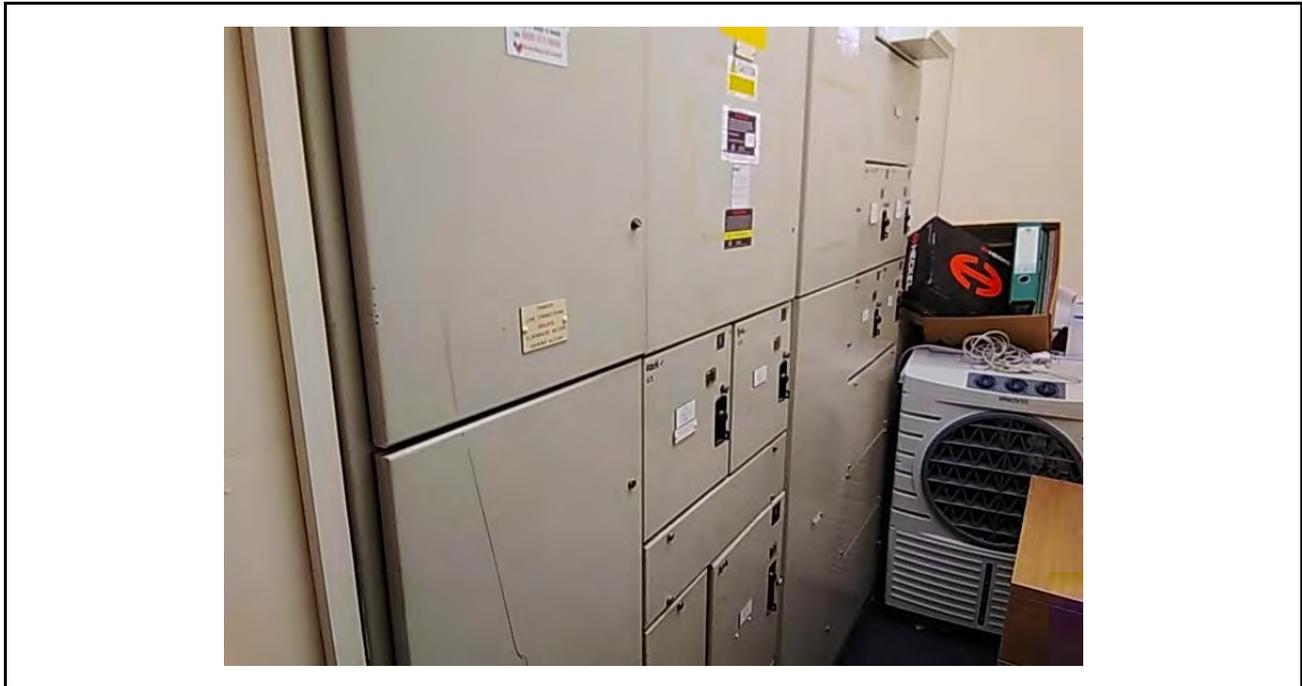
Surveyor	Luke Murphy	Building	Main Building
Survey Type	Re-Inspection	Floor	0
Survey Date	07/10/2025	Location/ Room	027 - Electric room 027
Next Inspection	07/10/2026	Sample No	P007
Level of Identification	Presumed	Inspection Ref	1075672 Original Ref: 340299

Description Electrics.

Score
Asbestos Type	Presumed Asbestos	-
Product Type		-
Extent of Damage		-
Surface Treatment		-
Estimated Amount		
Accessibility		
Risk Score		12

Recommendation	Inspection Required
Notes	Live unable to inspect. No change.

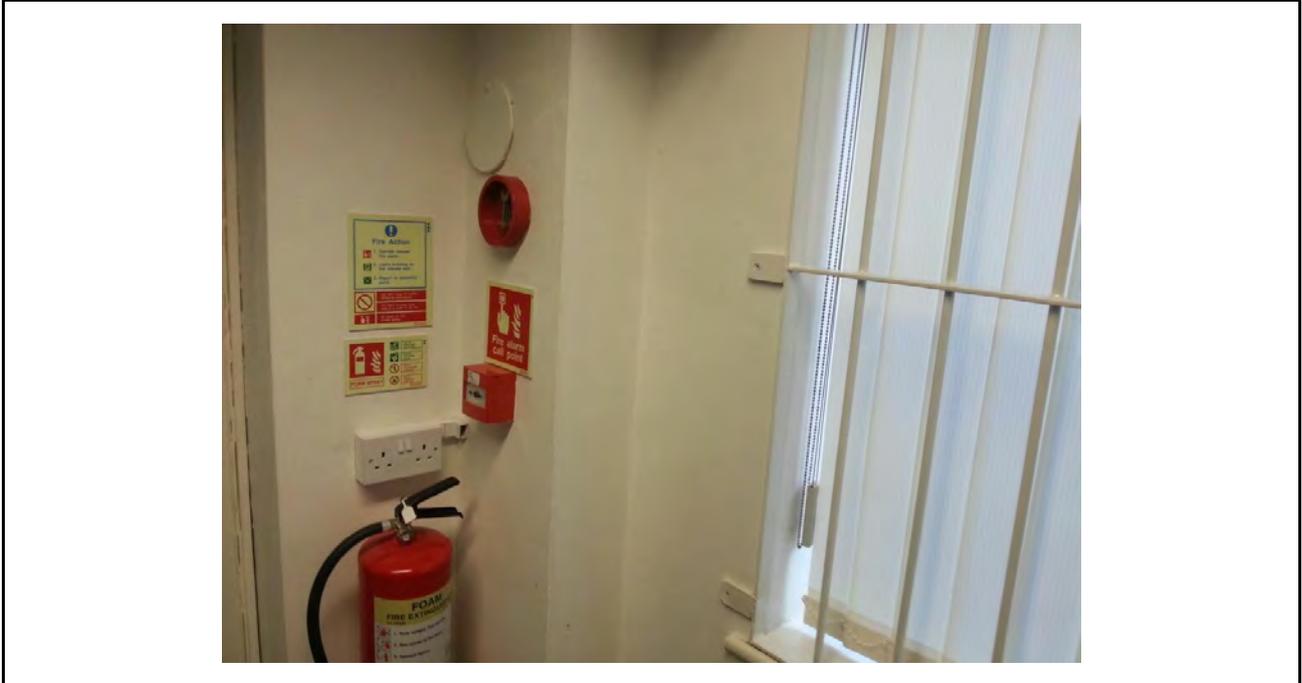
Surveyor	Luke Murphy	Building	Main Building
Survey Type	Re-Inspection	Floor	0
Survey Date	07/10/2025	Location/ Room	028 - Meeting room 028
Next Inspection	07/10/2026	Sample No	P017
Level of Identification	Presumed	Inspection Ref	1075660 Original Ref: 340349

Description Behind boxing.

Score
Asbestos Type	Presumed Asbestos	-
Product Type		-
Extent of Damage		-
Surface Treatment		-
Estimated Amount		
Accessibility		
Risk Score		12

Recommendation	Inspection Required
Notes	Unable to remove due to damage limitation. The building/area is in use on a daily basis. No change.

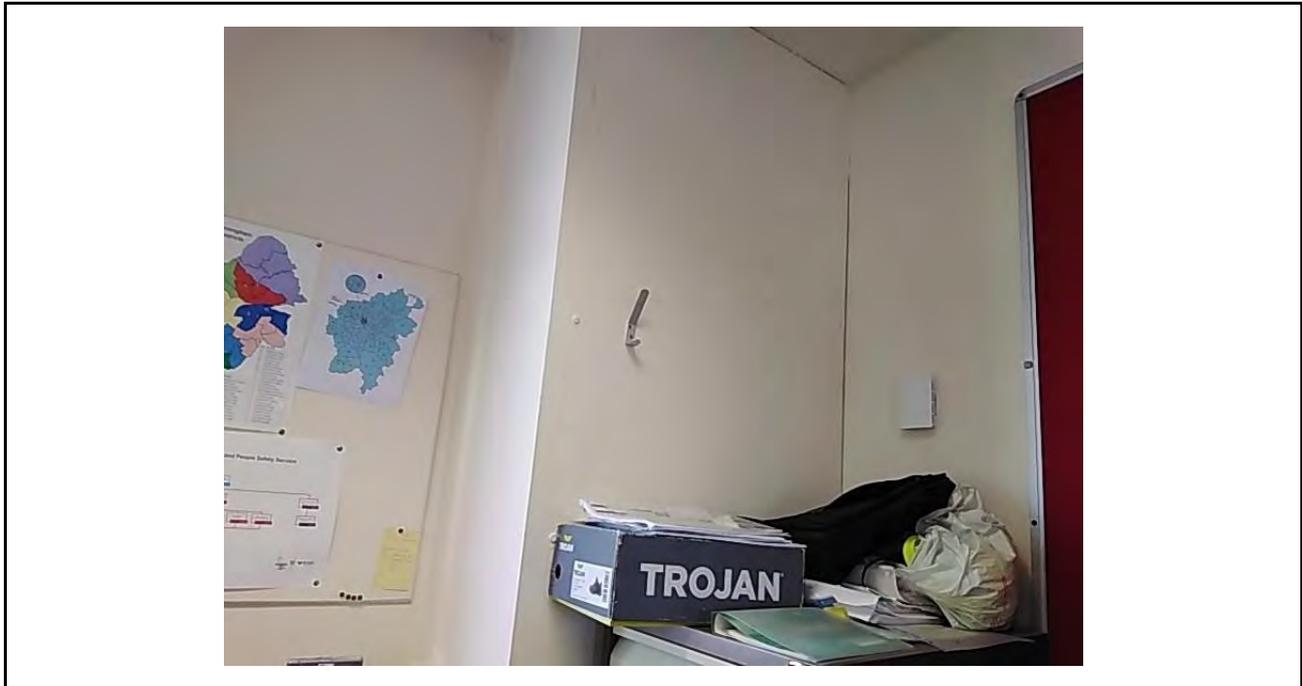
Surveyor	Luke Murphy	Building	Main Building
Survey Type	Re-Inspection	Floor	1
Survey Date	07/10/2025	Location/ Room	017 - Office 017
Next Inspection	07/10/2026	Sample No	P019
Level of Identification	Presumed	Inspection Ref	1075661 Original Ref: 340429

Description Behind boxing.

Score
Asbestos Type	Presumed Asbestos	-
Product Type		-
Extent of Damage		-
Surface Treatment		-
Estimated Amount		
Accessibility		
Risk Score		12

Recommendation	Inspection Required
Notes	Unable to remove due to damage limitation. The building/area is in use on a daily basis. No change.

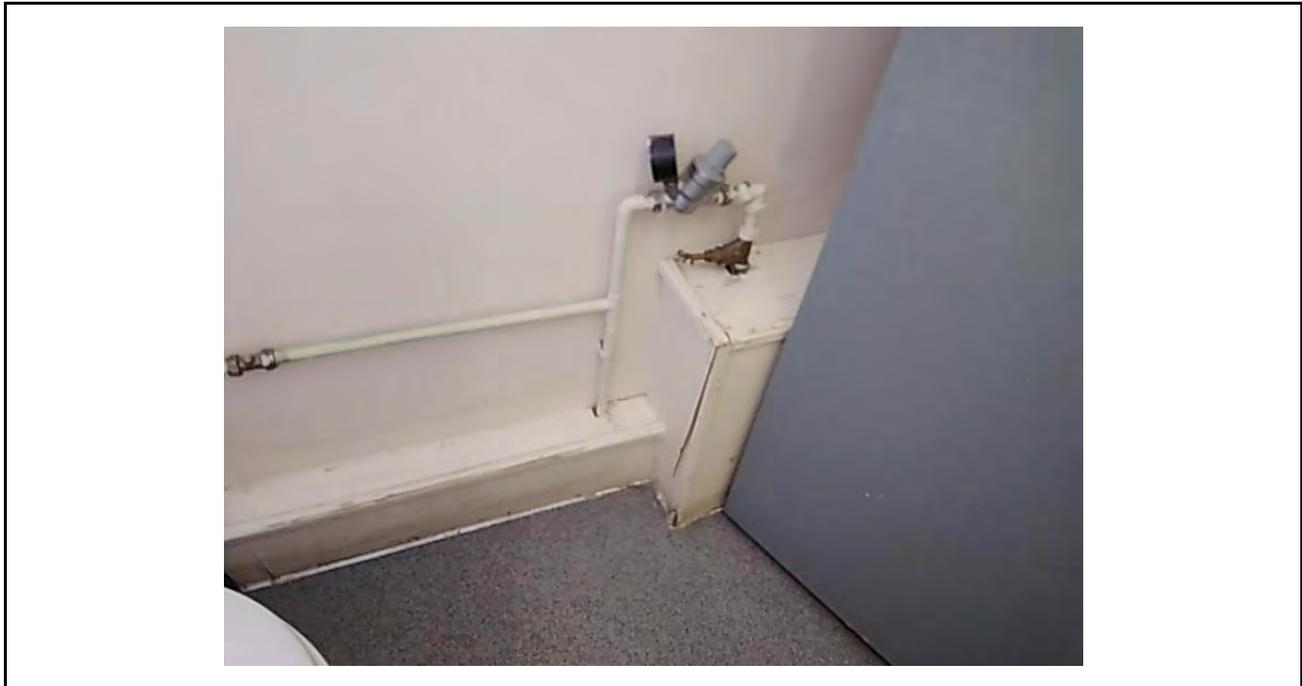
Surveyor	Luke Murphy	Building	Main Building
Survey Type	Re-Inspection	Floor	1
Survey Date	07/10/2025	Location/ Room	018 - W/C 018
Next Inspection	07/10/2026	Sample No	P020
Level of Identification	Presumed	Inspection Ref	1075658 Original Ref: 340389

Description Behind boxing.

Score
Asbestos Type	Presumed Asbestos	-
Product Type		-
Extent of Damage		-
Surface Treatment		-
Estimated Amount		
Accessibility		
Risk Score		12

Recommendation	Inspection Required
Notes	Unable to remove due to damage limitation. The building/area is in use on a daily basis. No change.

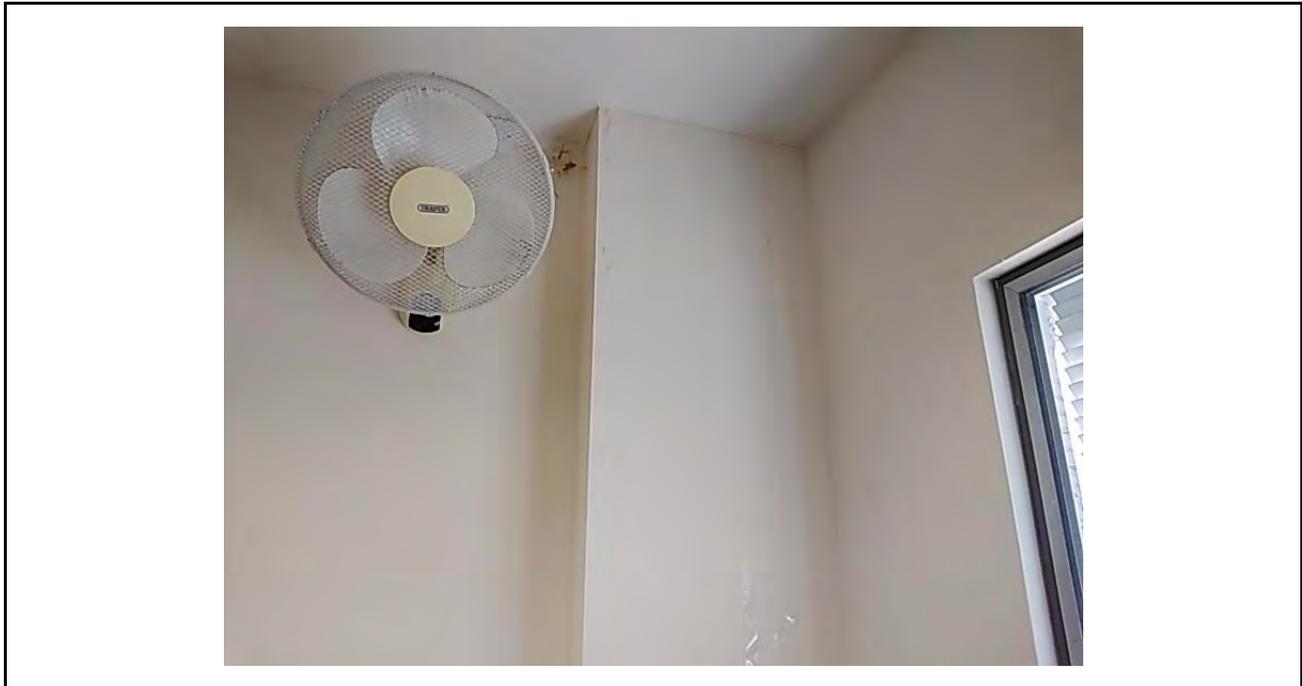
Surveyor	Luke Murphy	Building	Main Building
Survey Type	Re-Inspection	Floor	1
Survey Date	07/10/2025	Location/ Room	022 - Office 022
Next Inspection	07/10/2026	Sample No	P022
Level of Identification	Presumed	Inspection Ref	1075659 Original Ref: 340421

Description Behind boxing.

Score
Asbestos Type	Presumed Asbestos	-
Product Type		-
Extent of Damage		-
Surface Treatment		-
Estimated Amount		
Accessibility		
Risk Score		12

Recommendation	Inspection Required
Notes	Unable to remove due to damage limitation. The building/area is in use on a daily basis. No change.
