Asbestos Reinspection Survey

Mole Street Housing Office, B11 1XA

Report No	R-11330	Report Issue Date	19 November 2025
Client Name & Address	Asset Management & Maintenance Division Mole Street Centre Mole Street Sparkbrook Birmingham B11 1XA	Site Address	Mole Street Housing Office, Mole Street, Birmingham, B11 1XA
Order Placed By	Claire Lennon	Instruction Date	1 September 2025
Order Number	B1-AV0N4-2Z09-EH1-JZZZZZ-TV5EB- JZZZ-JXXX	Project Reference	IPBL001924
Reinspection Report Date	07/10/2026	Lead Surveyor	Luke Murphy

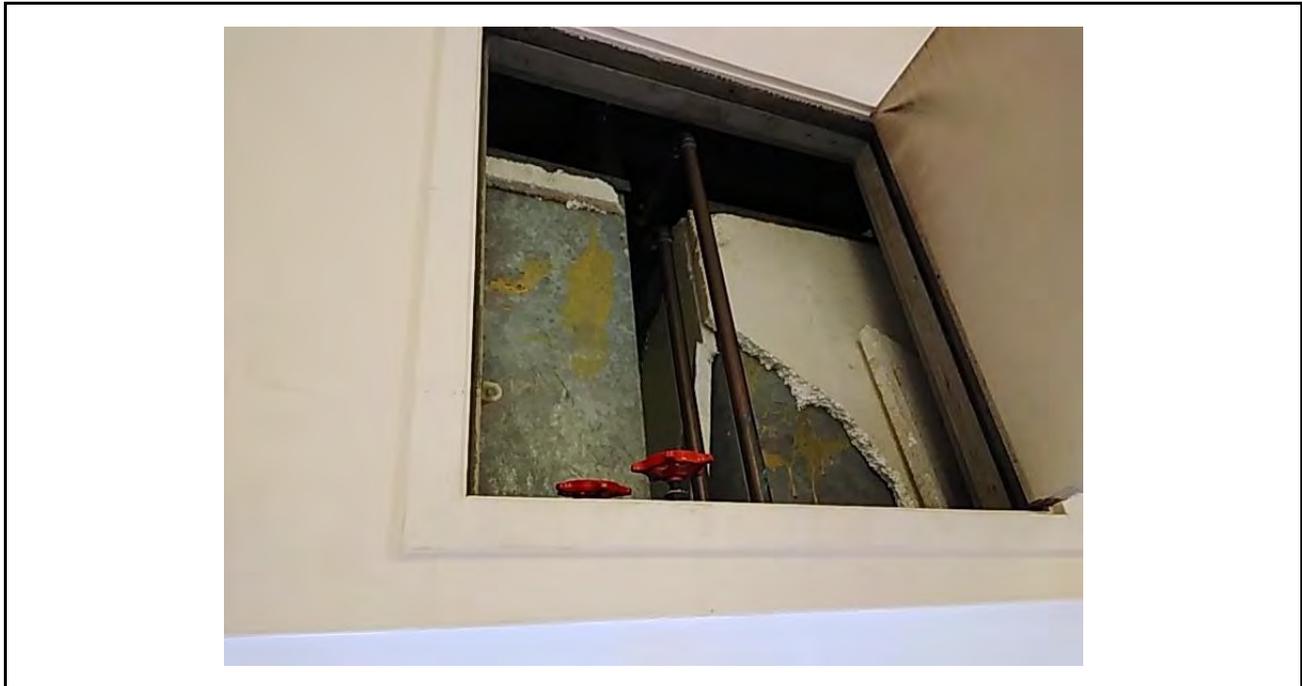
Surveyor	Luke Murphy	Building	Main Building
Survey Type	Re-Inspection	Floor	1
Survey Date	07/10/2025	Location/ Room	031 - Tank cupboard 031
Next Inspection	07/10/2026	Sample No	P021
Level of Identification	Presumed	Inspection Ref	1075657 Original Ref: 340387

Description No Access.

Score
Asbestos Type	Presumed Asbestos	-
Product Type		-
Extent of Damage		-
Surface Treatment		-
Estimated Amount		
Accessibility		
Risk Score		12

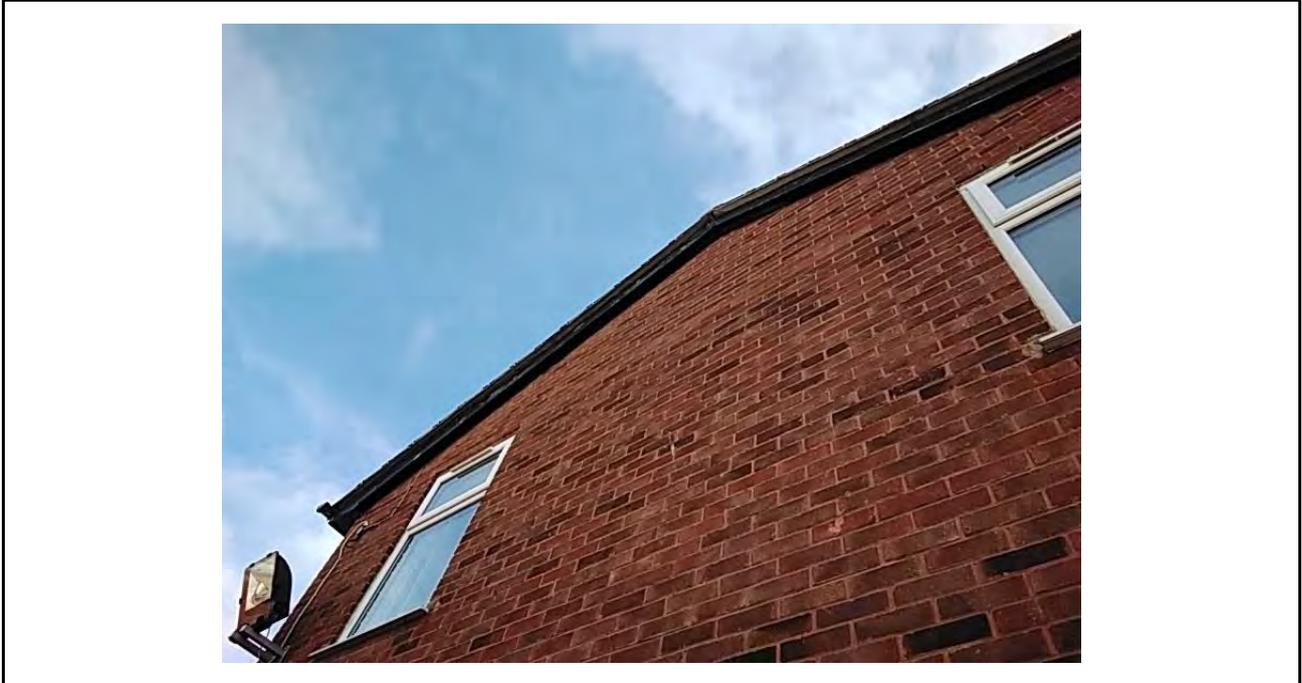
Surveyor	Luke Murphy	Building	Main Building
Survey Type	Re-Inspection	Floor	External
Survey Date	07/10/2025	Location/ Room	033 - External
Next Inspection	07/10/2026	Sample No	P024
Level of Identification	Presumed	Inspection Ref	1075662 Original Ref: 340451

Description Under cloak.

Score
Asbestos Type	Presumed Asbestos	-
Product Type		-
Extent of Damage		-
Surface Treatment		-
Estimated Amount		
Accessibility		
Risk Score		12

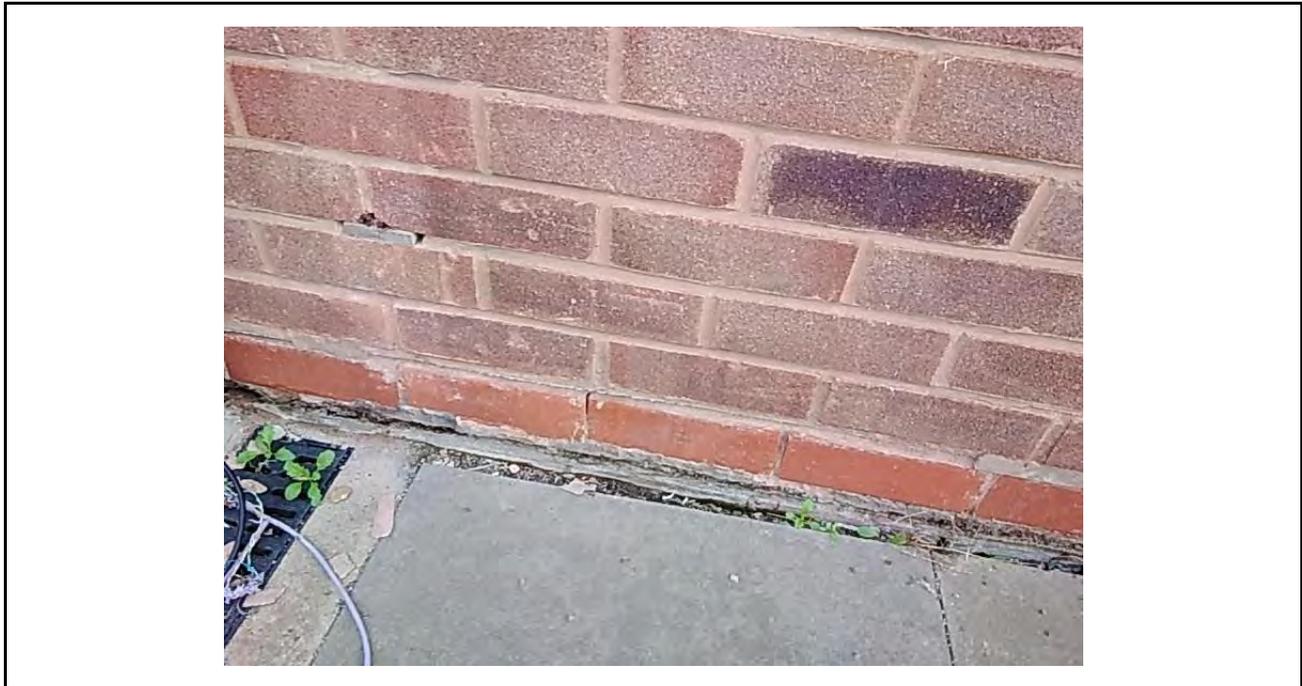
Surveyor	Luke Murphy	Building	Main Building
Survey Type	Re-Inspection	Floor	External
Survey Date	07/10/2025	Location/ Room	033 - External
Next Inspection	07/10/2026	Sample No	PS025
Level of Identification	Previously Sampled	Inspection Ref	1075664 Original Ref: 340446

Description Damp Proof Course.

Score
Asbestos Type	CHRYBOTILE	1
Product Type	Bitumen Products	1
Extent of Damage	Good Condition	0
Surface Treatment	Composite, reinforced or bonded	0
Estimated Amount	120 L/M	
Accessibility	Occasional Disturbance	
Risk Score		2

Recommendation	Manage & Re-inspect
Notes	No change.
