Asbestos Management Survey

College Road Depot, B44 0AY

Report No	D-05899	Report Issue Date	22 October 2020
Client Name & Address	Asset Management & Maintenance Division Mole Street Centre Mole Street Sparkbrook Birmingham B11 1XA	Site Address	College Road Depot, 599-603 College Road, Kingstanding, Birmingham, B44 0AY
Order Placed By	John Flaherty	Instruction Date	17 January 2020
Order Number	RHM01 JRRR A00	Project Reference	-
Survey Date(s)	22 September 2020	Lead Surveyor	Nazir Korimbocus

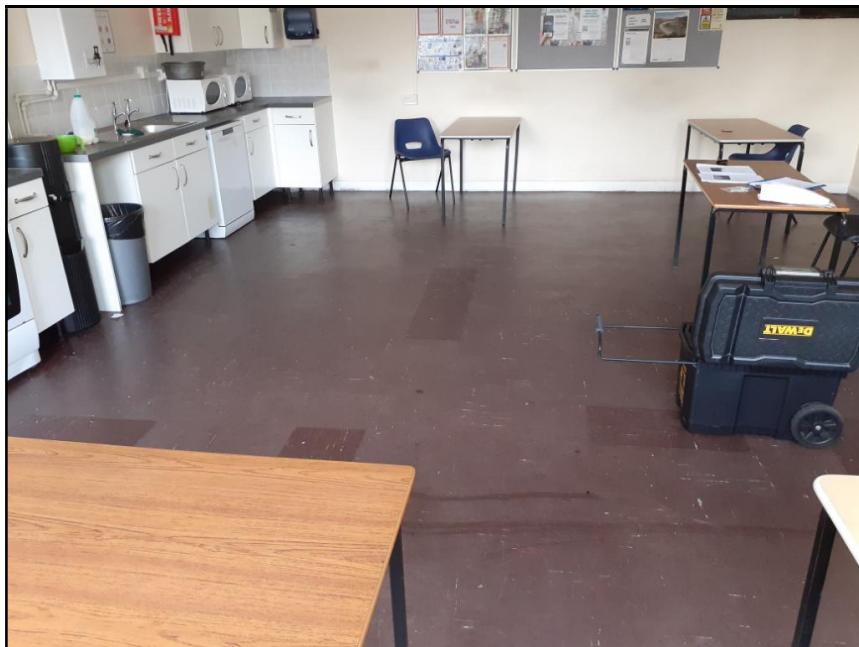
Surveyor	Nazir Korimbocus	Building	Main Building
Survey Type	Management	Floor	0
Survey Date	22/09/2020	Location/ Room	027 - Kitchen/diner 048
Next Inspection	22/09/2021	Sample No	S024
Level of Identification	Sample Analysed	Inspection Ref	556952

Description Floor tiles and adhesive .

Score
Asbestos Type	CHRYSTALITE (CHRYSTALITE IN ADHESIVE ONLY)	1
Product Type	Floor Tiles & Adhesive	1
Extent of Damage	Low Damage	1
Surface Treatment	Composite, reinforced or bonded	0
Estimated Amount	50 m ²	
Accessibility	Routinely Disturbed	
Risk Score		3

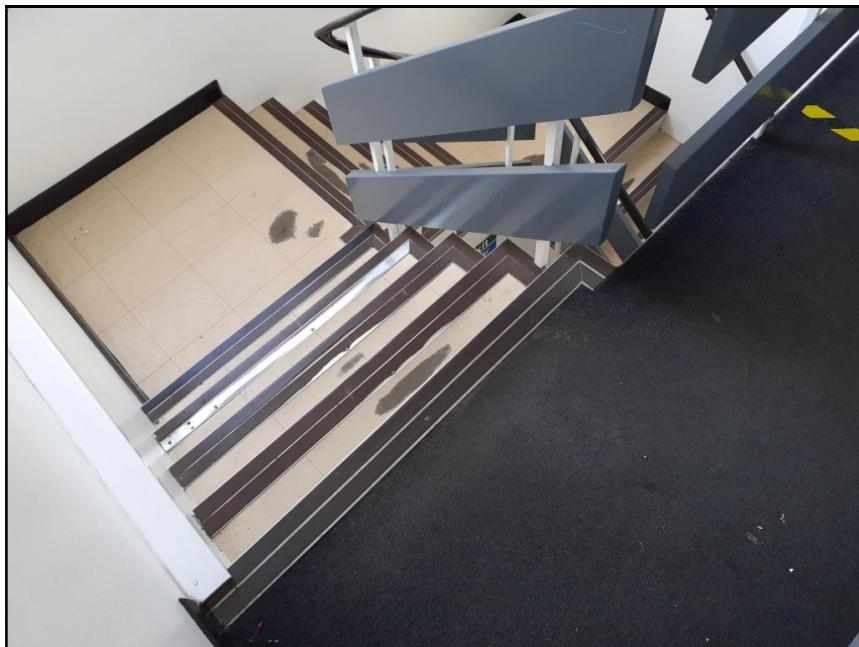
Surveyor	Nazir Korimbocus	Building	Main Building
Survey Type	Management		1
Survey Date	22/09/2020		028 - Stairwell and landing 024
Next Inspection	22/09/2021		X008
Level of Identification	Strongly Presumed		556962

Description Floor tiles and adhesive . Visually consistent with Sample 8.

Score
Asbestos Type	CHRYSTALITE (CHRYSTALITE IN TILE AND ADHESIVE)	1
Product Type	Floor Tiles & Adhesive	1
Extent of Damage	Medium Damage	2
Surface Treatment	Composite, reinforced or bonded	0
Estimated Amount	10 m ²	
Accessibility	Easily Disturbed	
Risk Score		4

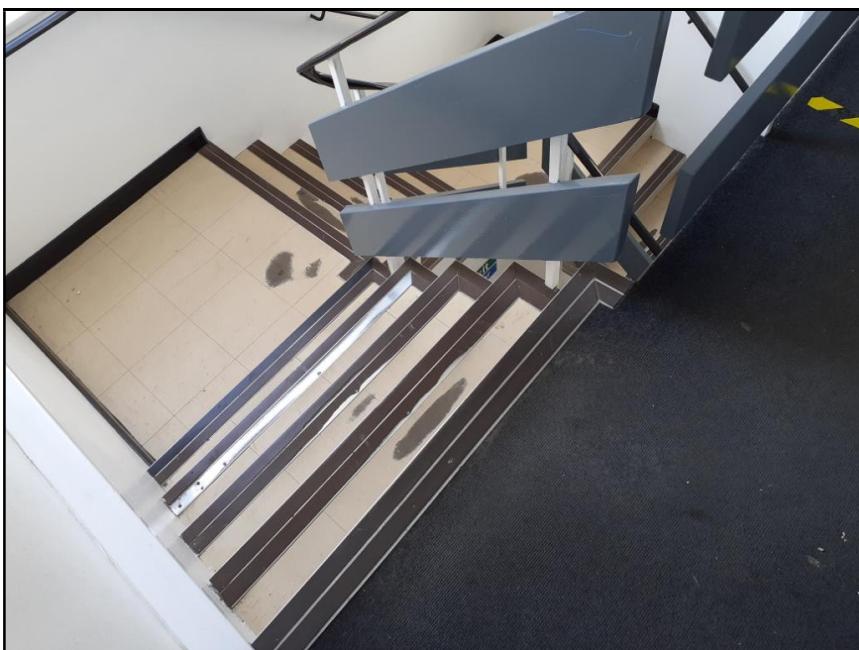
Surveyor	Nazir Korimbocus		Building	Main Building
Survey Type	Management		Floor	1
Survey Date	22/09/2020		Location/ Room	028 - Entrance and stairs 024
Next Inspection	22/09/2021		Sample No	X012
Level of Identification	Strongly Presumed		Inspection Ref	556963

Description Stair nosing strips . Visually consistent with Sample 12.

Score
Asbestos Type	NO ASBESTOS DETECTED	-
Product Type	Reinforced composites	-
Extent of Damage	Low Damage	-
Surface Treatment	Composite, reinforced or bonded	-
Estimated Amount	20 Items	
Accessibility	Routinely Disturbed	
Risk Score		0

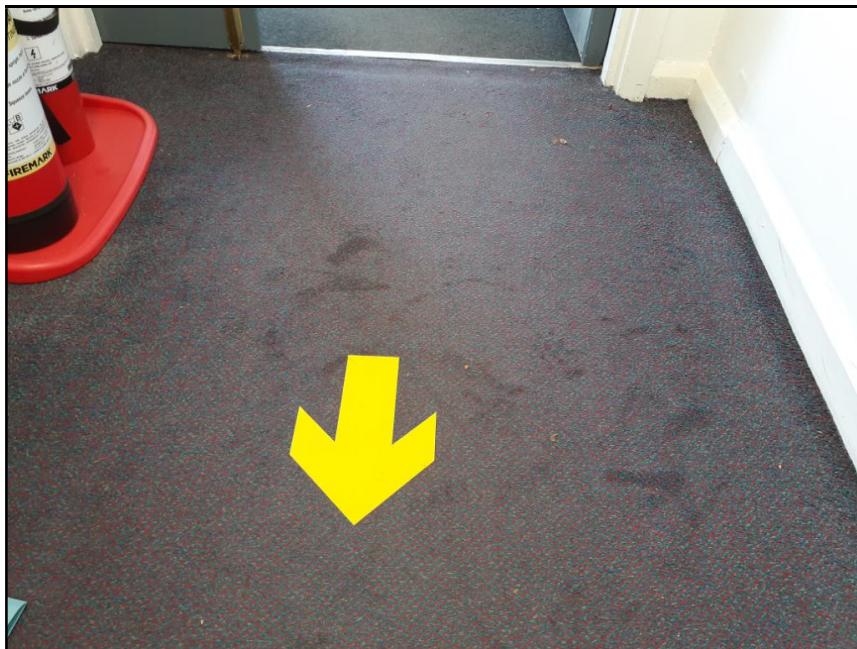
Surveyor	Nazir Korimbocus	Building	Main Building
Survey Type	Management	Floor	1
Survey Date	22/09/2020	Location/ Room	029 - Circulation 025
Next Inspection	22/09/2021	Sample No	X008
Level of Identification	Strongly Presumed	Inspection Ref	556971

Description Floor tiles and adhesive . Visually consistent with Sample 8.

Score
Asbestos Type	CHRYSTALITE (CHRYSTALITE IN TILE AND ADHESIVE)	1
Product Type	Floor Tiles & Adhesive	1
Extent of Damage	Low Damage	1
Surface Treatment	Composite, reinforced or bonded	0
Estimated Amount	5 m ²	
Accessibility	Usually Inaccessible	
Risk Score		3

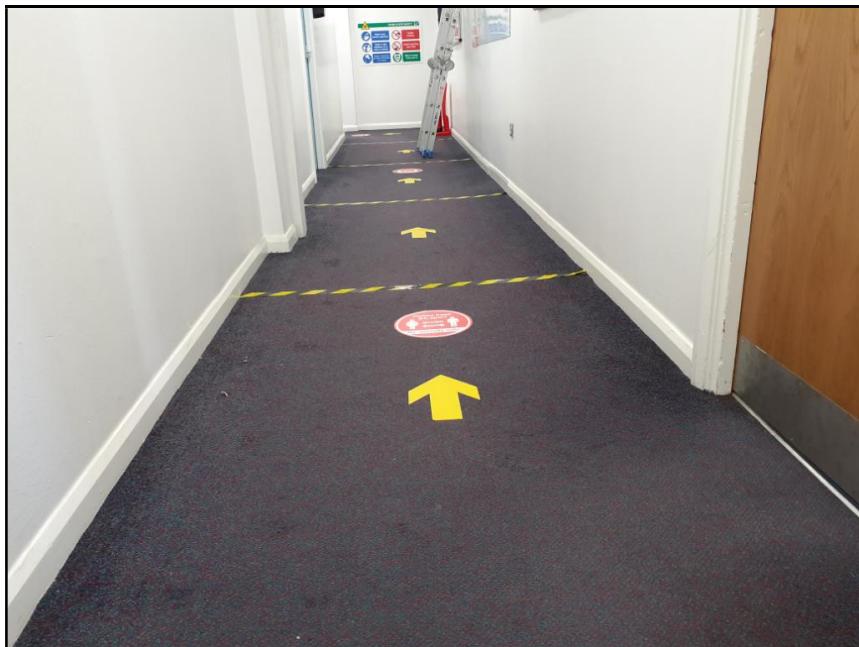
Surveyor	Nazir Korimbocus	Building	Main Building
Survey Type	Management	Floor	1
Survey Date	22/09/2020	Location/ Room	030 - Circulation 026
Next Inspection	22/09/2021	Sample No	X008
Level of Identification	Strongly Presumed	Inspection Ref	556979

Description Floor tiles and adhesive . Visually consistent with Sample 8.

Score
Asbestos Type	CHRYSTAL (CHRYSTAL IN TILE AND ADHESIVE)	1
Product Type	Floor Tiles & Adhesive	1
Extent of Damage	Low Damage	1
Surface Treatment	Composite, reinforced or bonded	0
Estimated Amount	30 m ²	
Accessibility	Usually Inaccessible	
Risk Score		3

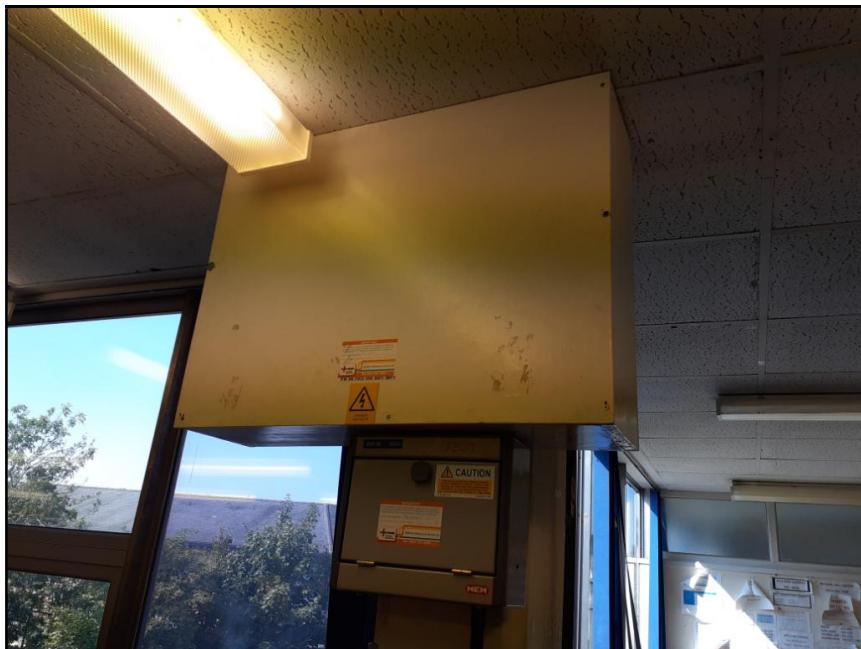
Surveyor	Nazir Korimbocus	Building	Main Building
Survey Type	Management	Floor	1
Survey Date	22/09/2020	Location/ Room	031 - Office 031
Next Inspection	22/09/2021	Sample No	P025
Level of Identification	Presumed	Inspection Ref	556990

Description Electrical distribution equipment .

Score
Asbestos Type	Presumed Asbestos	-
Product Type		-
Extent of Damage		-
Surface Treatment		-
Estimated Amount		
Accessibility		
Risk Score		12

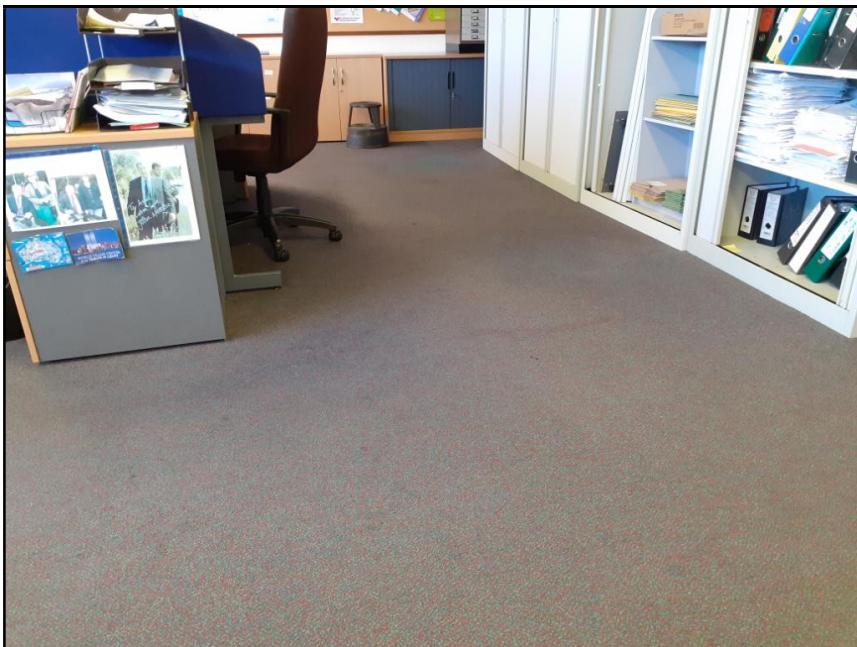
Surveyor	Nazir Korimbocus		Building	Main Building
Survey Type	Management		Floor	1
Survey Date	22/09/2020		Location/ Room	031 - Office 031
Next Inspection	22/09/2021		Sample No	X008
Level of Identification	Strongly Presumed		Inspection Ref	556989

Description Floor tiles and adhesive . Visually consistent with Sample 8.

Score
Asbestos Type	CHRYSTALITE (CHRYSTALITE IN TILE AND ADHESIVE)	1
Product Type	Floor Tiles & Adhesive	1
Extent of Damage	Low Damage	1
Surface Treatment	Composite, reinforced or bonded	0
Estimated Amount	200 m ²	
Accessibility	Usually Inaccessible	
Risk Score		3

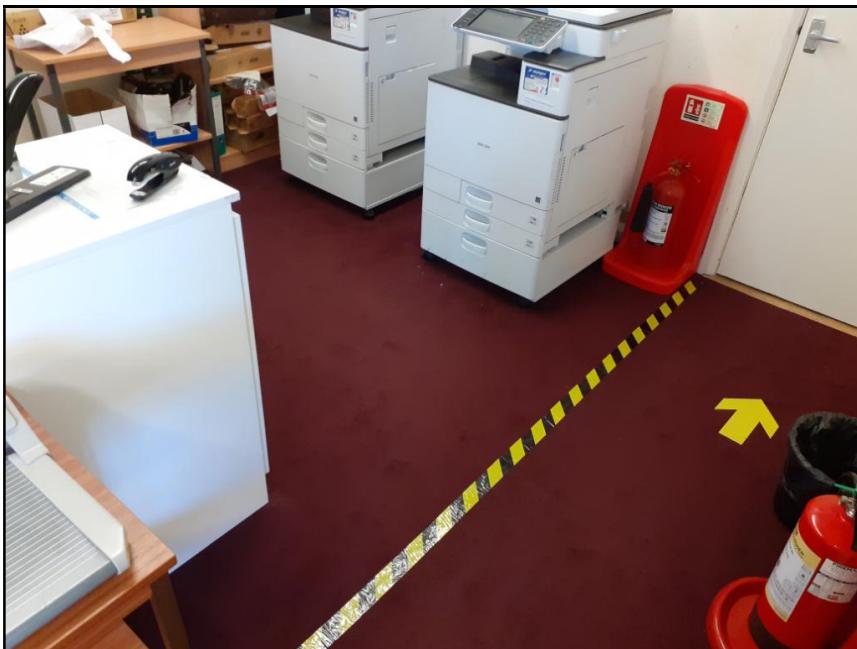
Surveyor	Nazir Korimbocus	Building	Main Building
Survey Type	Management	Floor	1
Survey Date	22/09/2020	Location/ Room	032 - Office 032
Next Inspection	22/09/2021	Sample No	X008
Level of Identification	Strongly Presumed	Inspection Ref	557000

Description Floor tiles and adhesive . Visually consistent with Sample 8.

Score
Asbestos Type	CHRYSTALITE (CHRYSTALITE IN TILE AND ADHESIVE)	1
Product Type	Floor Tiles & Adhesive	1
Extent of Damage	Low Damage	1
Surface Treatment	Composite, reinforced or bonded	0
Estimated Amount	30 m ²	
Accessibility	Usually Inaccessible	
Risk Score		3

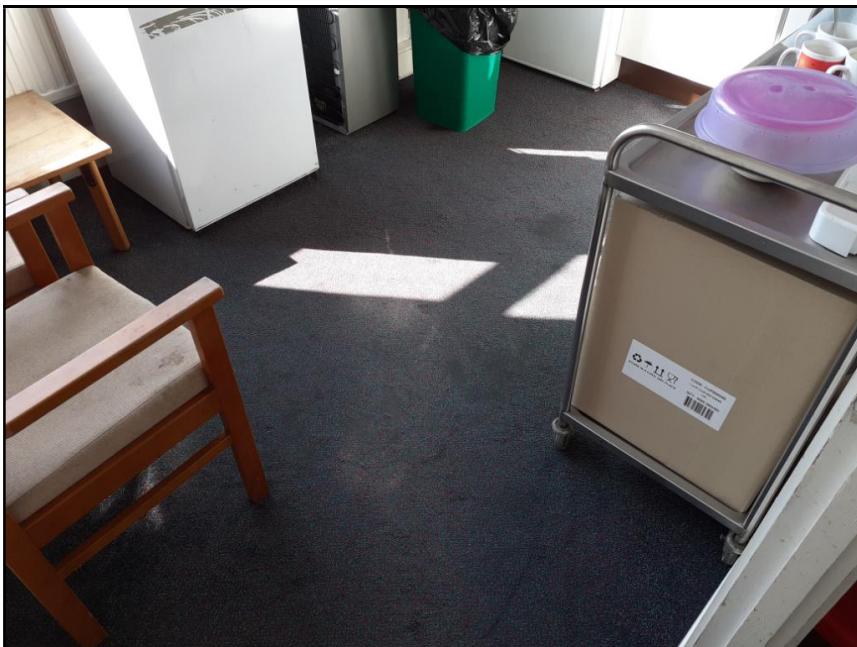
Surveyor	Nazir Korimbocus	Building	Main Building
Survey Type	Management	Floor	1
Survey Date	22/09/2020	Location/ Room	033 - Office 033
Next Inspection	22/09/2021	Sample No	X008
Level of Identification	Strongly Presumed	Inspection Ref	557010

Description Floor tiles and adhesive . Visually consistent with Sample 8.

Score
Asbestos Type	CHRYSTALITE (CHRYSTALITE IN TILE AND ADHESIVE)	1
Product Type	Floor Tiles & Adhesive	1
Extent of Damage	Low Damage	1
Surface Treatment	Composite, reinforced or bonded	0
Estimated Amount	30 m ²	
Accessibility	Usually Inaccessible	
Risk Score		3

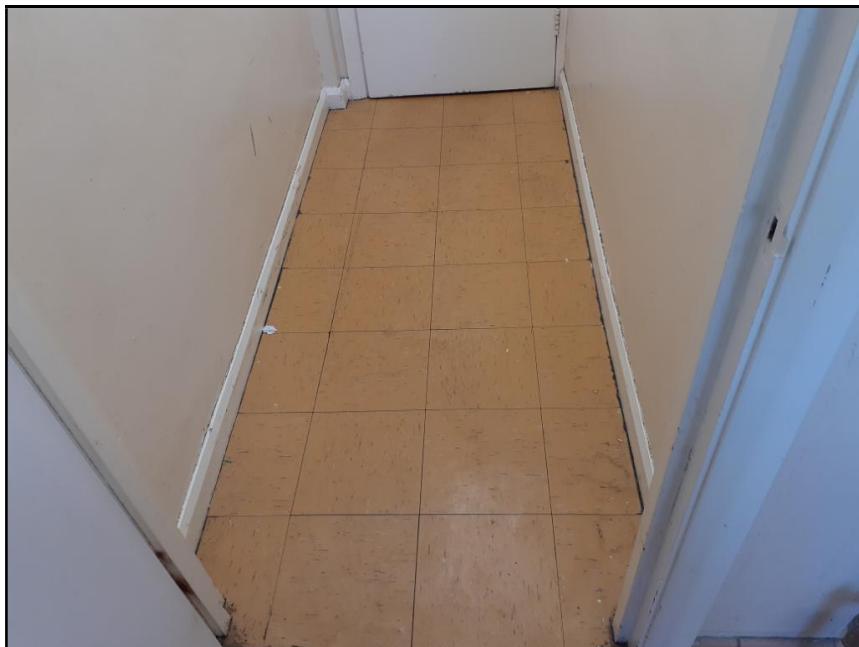
Surveyor	Nazir Korimbocus	Building	Main Building
Survey Type	Management	Floor	1
Survey Date	22/09/2020	Location/ Room	034 - Male toilets 034
Next Inspection	22/09/2021	Sample No	X008
Level of Identification	Strongly Presumed	Inspection Ref	557024

Description Floor tiles and adhesive . Visually consistent with Sample 8.

Score
Asbestos Type	CHRYSTALITE (CHRYSTALITE IN TILE AND ADHESIVE)	1
Product Type	Floor Tiles & Adhesive	1
Extent of Damage	Low Damage	1
Surface Treatment	Composite, reinforced or bonded	0
Estimated Amount	3 m ²	
Accessibility	Routinely Disturbed	
Risk Score		3

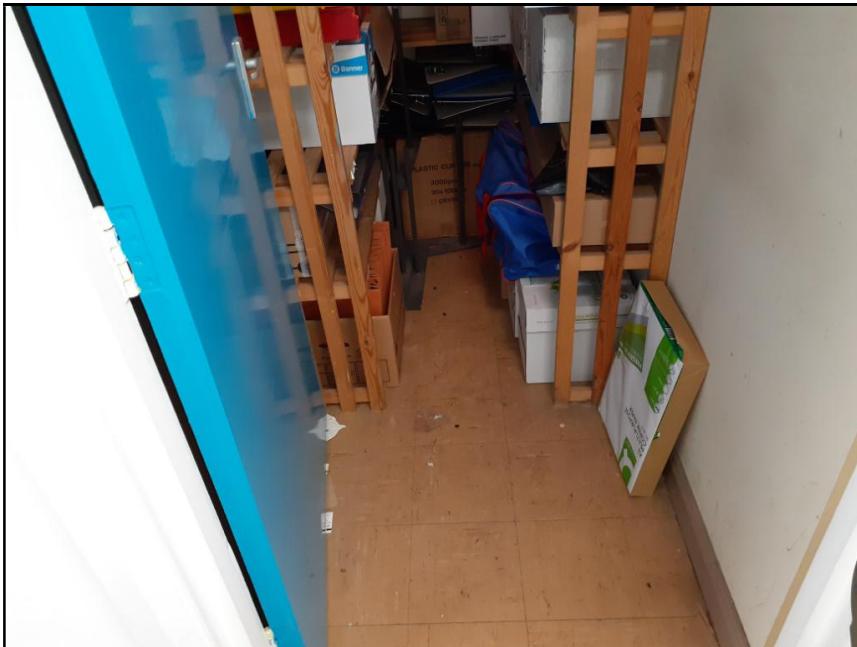
Surveyor	Nazir Korimbocus	Building	Main Building
Survey Type	Management	Floor	1
Survey Date	22/09/2020	Location/ Room	035 - Storage 035
Next Inspection	22/09/2021	Sample No	X008
Level of Identification	Strongly Presumed	Inspection Ref	557031

Description Floor tiles and adhesive . Visually consistent with Sample 8.

Score
Asbestos Type	CHRYSTALITE (CHRYSTALITE IN TILE AND ADHESIVE)	1
Product Type	Floor Tiles & Adhesive	1
Extent of Damage	Low Damage	1
Surface Treatment	Composite, reinforced or bonded	0
Estimated Amount	5 m ²	
Accessibility	Routinely Disturbed	
Risk Score		3

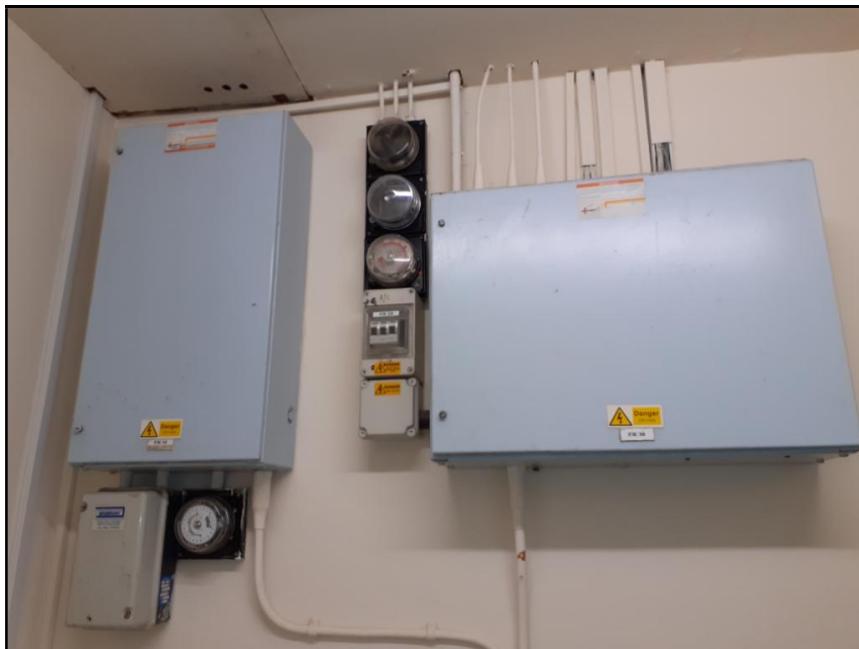
Surveyor	Nazir Korimbocus	Building	Main Building
Survey Type	Management	Floor	1
Survey Date	22/09/2020	Location/ Room	036 - Kitchen 036
Next Inspection	22/09/2021	Sample No	P027
Level of Identification	Presumed	Inspection Ref	557038

Description Electrical distribution equipment .

Score
Asbestos Type	Presumed Asbestos	-
Product Type		-
Extent of Damage		-
Surface Treatment		-
Estimated Amount		
Accessibility		
Risk Score		12

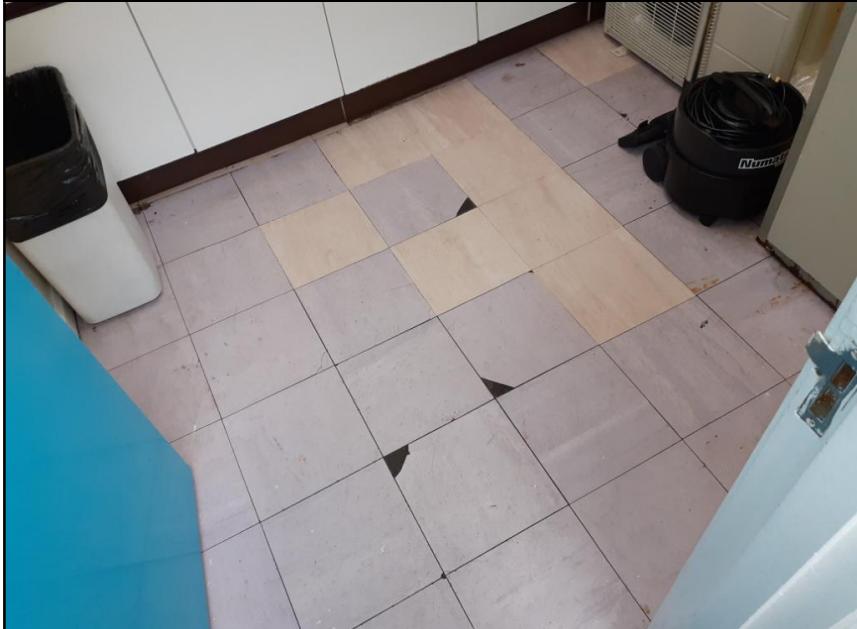
Building	Main Building
Survey Type	Management		Floor	1
Survey Date	22/09/2020		Location/ Room	036 - Kitchen 036
Next Inspection	22/09/2021		Sample No	S028
Level of Identification	Sample Analysed		Inspection Ref	557039

Description Floor tiles and adhesive .

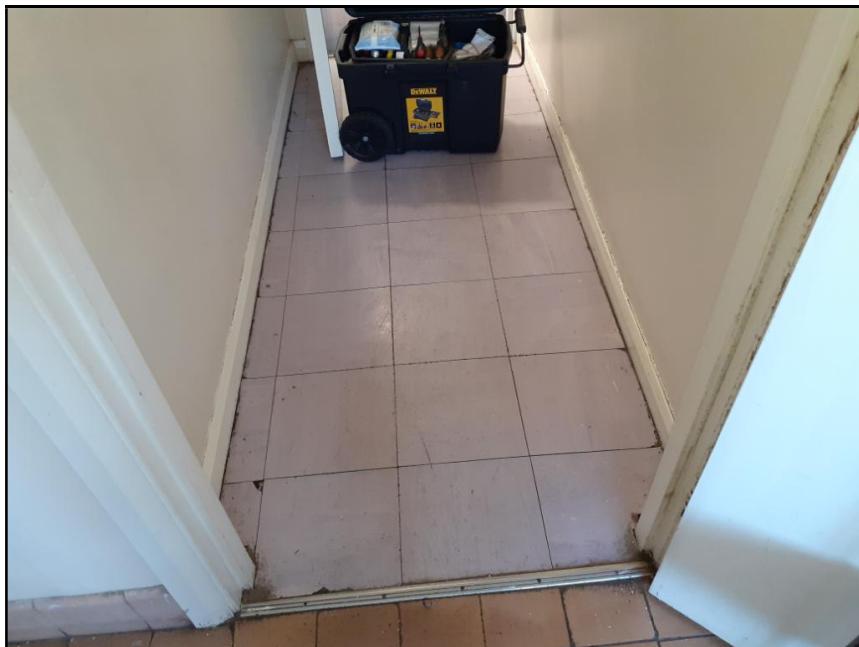
Surveyor	Nazir Korimbocus		Building	Main Building
Survey Type	Management		Floor	1
Survey Date	22/09/2020		Location/ Room	037 - Female toilets 037
Next Inspection	22/09/2021		Sample No	X028
Level of Identification	Strongly Presumed		Inspection Ref	557056

Description Floor tiles and adhesive . Visually consistent with Sample 28.

Score
Asbestos Type	CHRYSTAL (CHRYSTAL IN TILE AND ADHESIVE)	1
Product Type	Floor Tiles & Adhesive	1
Extent of Damage	Low Damage	1
Surface Treatment	Composite, reinforced or bonded	0
Estimated Amount	3 m ²	
Accessibility	Routinely Disturbed	
Risk Score		3

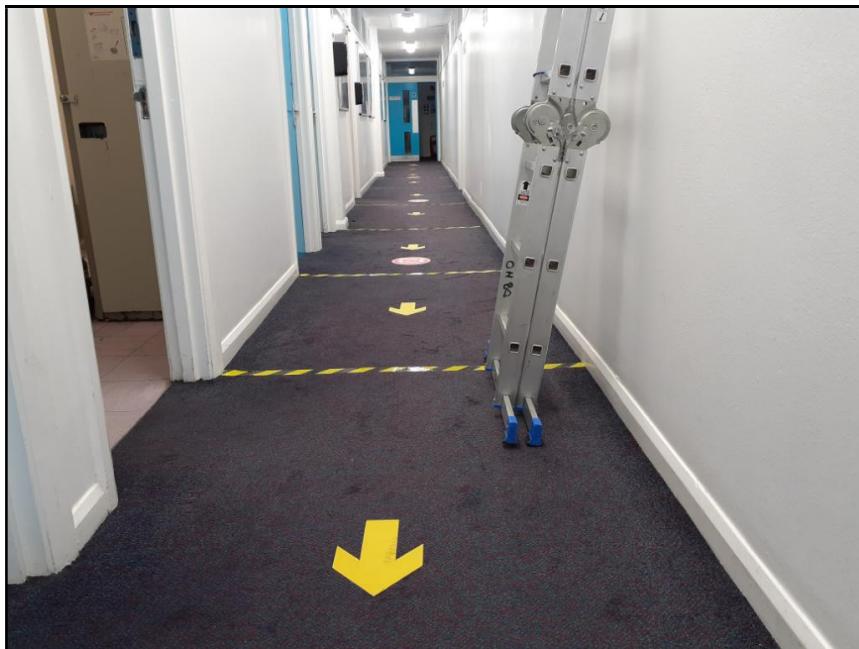
Surveyor	Nazir Korimbocus	Building	Main Building
Survey Type	Management	Floor	1
Survey Date	22/09/2020	Location/ Room	038 - Circulation 038
Next Inspection	22/09/2021	Sample No	X008
Level of Identification	Strongly Presumed	Inspection Ref	556546

Description Floor tiles and adhesive . Visually consistent with Sample 8.

Score
Asbestos Type	CHRYSTOILE (CHRYSTOILE IN TILE AND ADHESIVE)	1
Product Type	Floor Tiles & Adhesive	1
Extent of Damage	Low Damage	1
Surface Treatment	Composite, reinforced or bonded	0
Estimated Amount	30 m ²	
Accessibility	Usually Inaccessible	
Risk Score		3

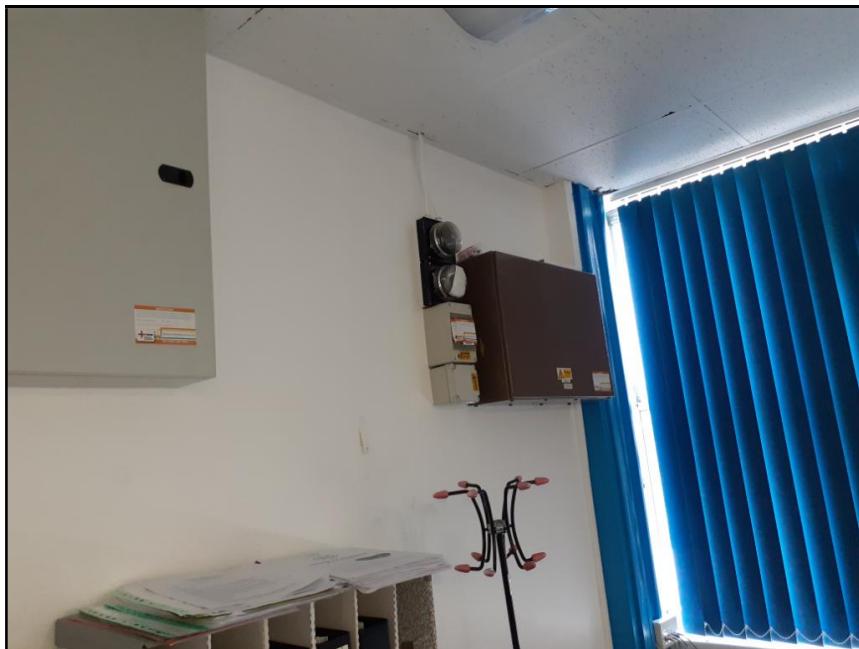
Surveyor	Nazir Korimbocus	Building	Main Building
Survey Type	Management	Floor	1
Survey Date	22/09/2020	Location/ Room	039 - Office 027
Next Inspection	22/09/2021	Sample No	P029
Level of Identification	Presumed	Inspection Ref	557074

Description Electrical distribution equipment .

Score
Asbestos Type	Presumed Asbestos	-
Product Type		-
Extent of Damage		-
Surface Treatment		-
Estimated Amount		
Accessibility		
Risk Score		12

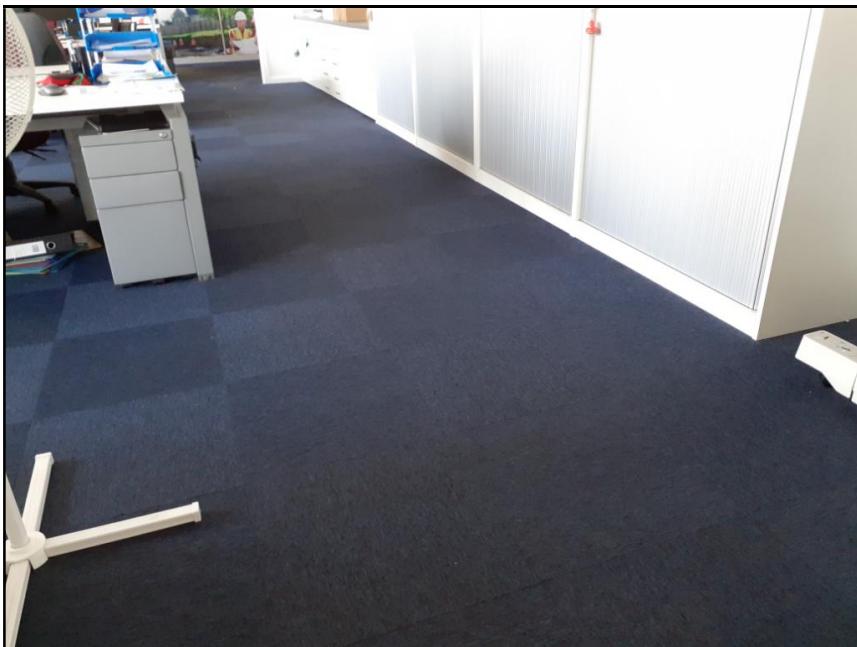
Surveyor	Nazir Korimbocus		Building	Main Building
Survey Type	Management		Floor	1
Survey Date	22/09/2020		Location/ Room	039 - Office 027
Next Inspection	22/09/2021		Sample No	X008
Level of Identification	Strongly Presumed		Inspection Ref	557073

Description Floor tiles and adhesive . Visually consistent with Sample 8.

Score
Asbestos Type	CHRYSTAL (CHRYSTAL IN TILE AND ADHESIVE)	1
Product Type	Floor Tiles & Adhesive	1
Extent of Damage	Low Damage	1
Surface Treatment	Composite, reinforced or bonded	0
Estimated Amount	200 m ²	
Accessibility	Usually Inaccessible	
Risk Score		3

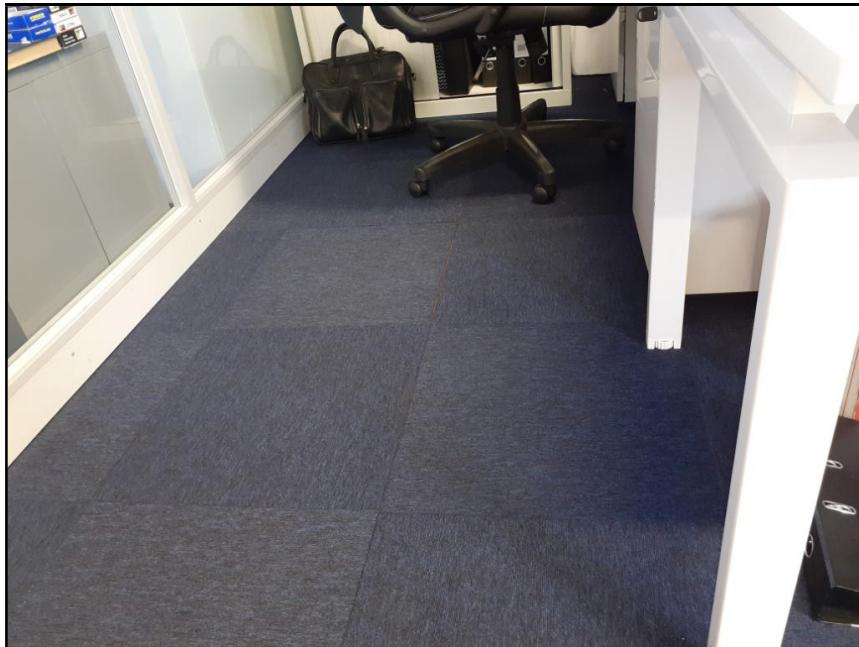
Surveyor	Nazir Korimbocus	Building	Main Building
Survey Type	Management	Floor	1
Survey Date	22/09/2020	Location/ Room	040 - Office 028
Next Inspection	22/09/2021	Sample No	X008
Level of Identification	Strongly Presumed	Inspection Ref	556547

Description Floor tiles and adhesive . Visually consistent with Sample 8.

Score
Asbestos Type	CHRYSTAL (CHRYSTAL IN TILE AND ADHESIVE)	1
Product Type	Floor Tiles & Adhesive	1
Extent of Damage	Low Damage	1
Surface Treatment	Composite, reinforced or bonded	0
Estimated Amount	30 m ²	
Accessibility	Usually Inaccessible	
Risk Score		3

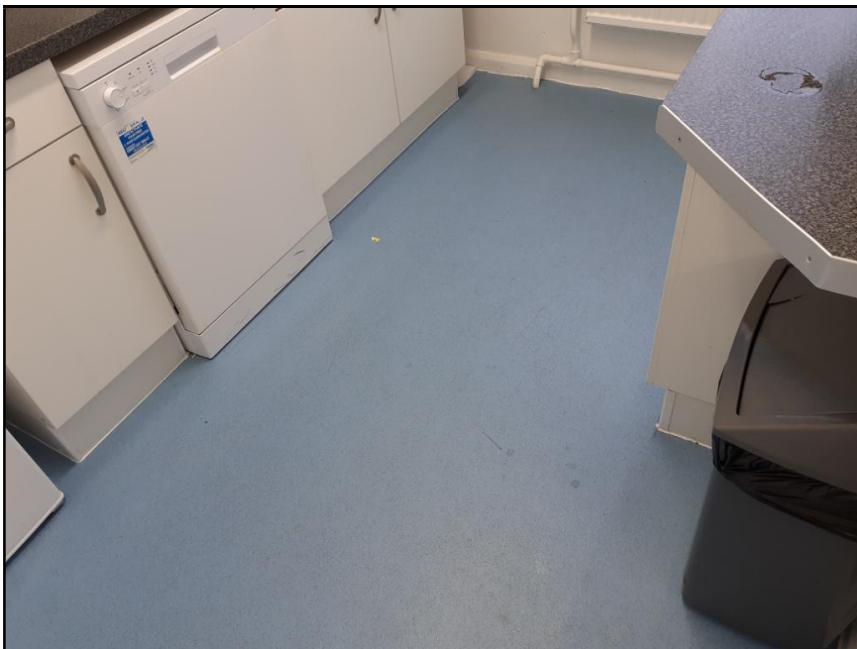
Surveyor	Nazir Korimbocus	Building	Main Building
Survey Type	Management	Floor	1
Survey Date	23/09/2020	Location/ Room	041 - Kitchen 027a
Next Inspection	23/09/2021	Sample No	S030
Level of Identification	Sample Analysed	Inspection Ref	556548

Description Floor tiles and adhesive beneath carpet .

Score
Asbestos Type	NO ASBESTOS DETECTED	-
Product Type	Floor Tiles & Adhesive	-
Extent of Damage	Low Damage	-
Surface Treatment	Composite, reinforced or bonded	-
Estimated Amount	10 m ²	
Accessibility	Usually Inaccessible	
Risk Score		0

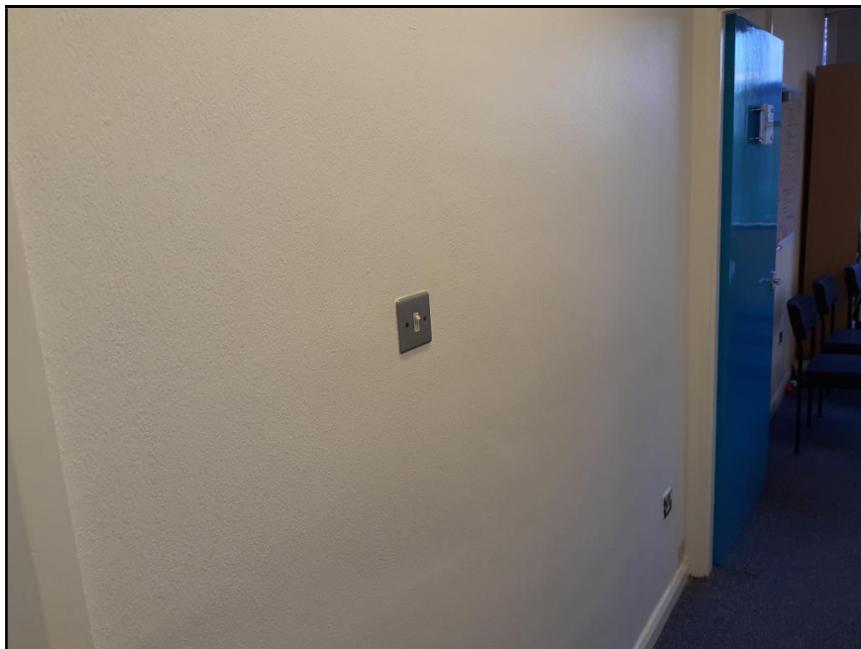
Surveyor	Nazir Korimbocus	Building	Main Building
Survey Type	Management	Floor	1
Survey Date	23/09/2020	Location/ Room	042 - Circulation 042
Next Inspection	23/09/2021	Sample No	S031
Level of Identification	Sample Analysed	Inspection Ref	556550

Description Textured coating to walls .

Score
Asbestos Type	NO ASBESTOS DETECTED	-
Product Type	Textured Coating	-
Extent of Damage	Low Damage	-
Surface Treatment	Composite, reinforced or bonded	-
Estimated Amount	30 m ²	
Accessibility	Easily Disturbed	
Risk Score		0

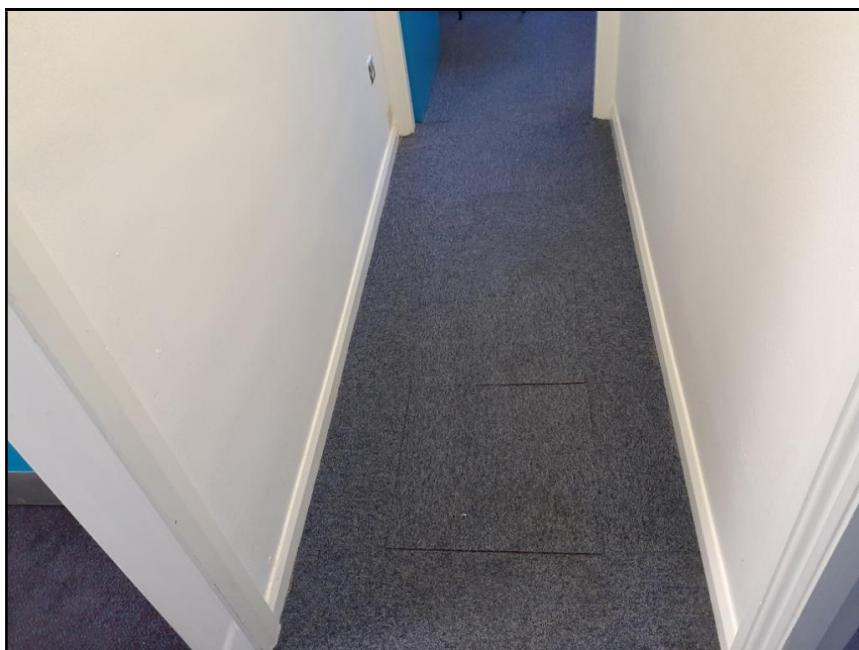
Surveyor	Nazir Korimbocus	Building	Main Building
Survey Type	Management	Floor	1
Survey Date	23/09/2020	Location/ Room	042 - Circulation 042
Next Inspection	23/09/2021	Sample No	X008
Level of Identification	Strongly Presumed	Inspection Ref	556549

Description Floor tiles and adhesive . Visually consistent with Sample 8.

Score
Asbestos Type	CHRYSTAL (CHRYSTAL IN TILE AND ADHESIVE)	1
Product Type	Floor Tiles & Adhesive	1
Extent of Damage	Low Damage	1
Surface Treatment	Composite, reinforced or bonded	0
Estimated Amount	5 m ²	
Accessibility	Usually Inaccessible	
Risk Score		3

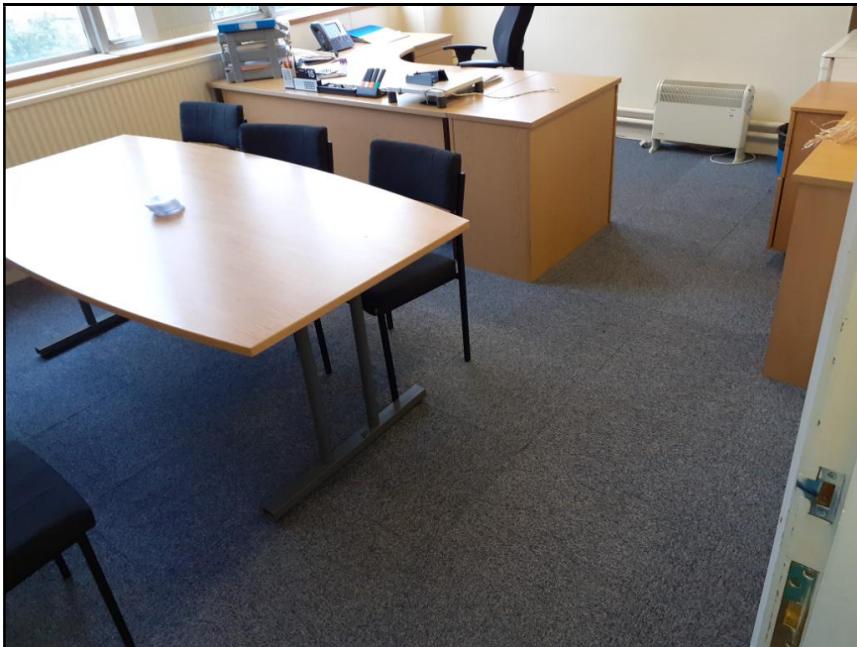
Surveyor	Nazir Korimbocus		Building	Main Building
Survey Type	Management		Floor	1
Survey Date	23/09/2020		Location/ Room	043 - Office 043
Next Inspection	23/09/2021		Sample No	X008
Level of Identification	Strongly Presumed		Inspection Ref	556551

Description Floor tiles and adhesive . Visually consistent with Sample 8.

Score
Asbestos Type	CHRYSTALITE (CHRYSTALITE IN TILE AND ADHESIVE)	1
Product Type	Floor Tiles & Adhesive	1
Extent of Damage	Low Damage	1
Surface Treatment	Composite, reinforced or bonded	0
Estimated Amount	30 m ²	
Accessibility	Usually Inaccessible	
Risk Score		3

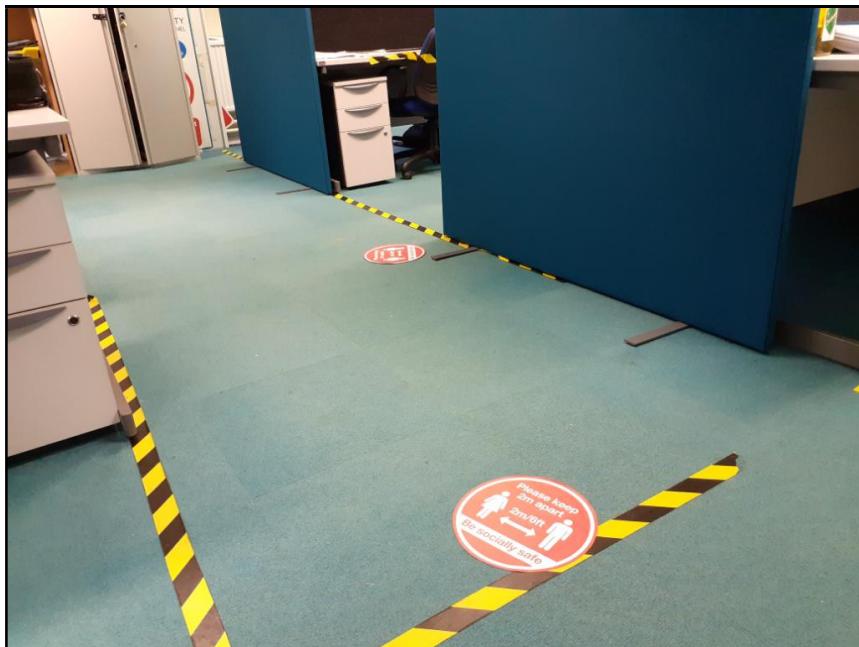
Surveyor	Nazir Korimbocus	Building	Main Building
Survey Type	Management	Floor	1
Survey Date	23/09/2020	Location/ Room	044 - Office 044
Next Inspection	23/09/2021	Sample No	X008
Level of Identification	Strongly Presumed	Inspection Ref	556552

Description Floor tiles and adhesive . Visually consistent with Sample 8.

Score
Asbestos Type	CHRYSTALITE (CHRYSTALITE IN TILE AND ADHESIVE)	1
Product Type	Floor Tiles & Adhesive	1
Extent of Damage	Low Damage	1
Surface Treatment	Composite, reinforced or bonded	0
Estimated Amount	100 m ²	
Accessibility	Usually Inaccessible	
Risk Score		3

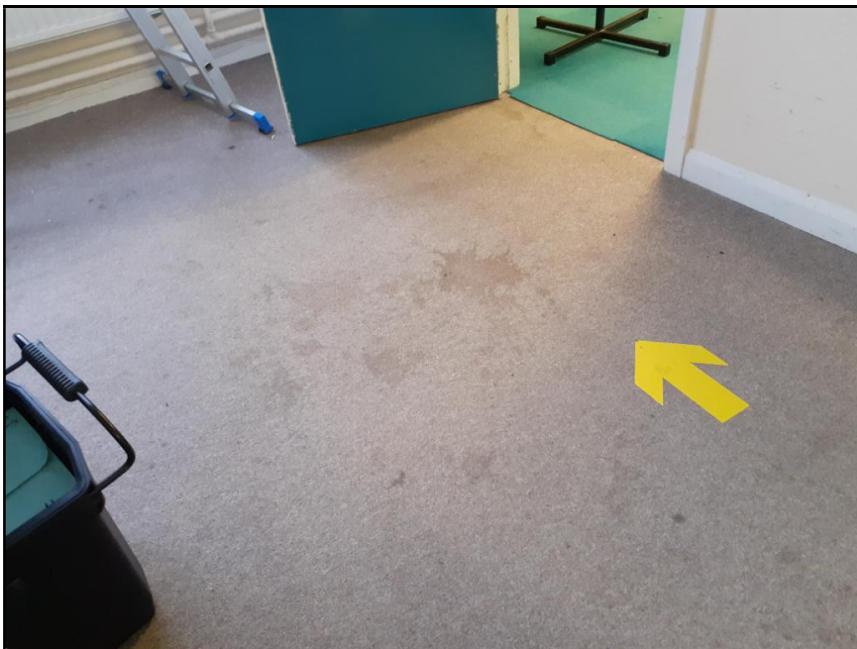
Surveyor	Nazir Korimbocus	Building	Main Building
Survey Type	Management	Floor	1
Survey Date	23/09/2020	Location/ Room	045 - Office 045
Next Inspection	23/09/2021	Sample No	X008
Level of Identification	Strongly Presumed	Inspection Ref	556553

Description Floor tiles and adhesive . Visually consistent with Sample 8.

Score
Asbestos Type	CHRYSTALITE (CHRYSTALITE IN TILE AND ADHESIVE)	1
Product Type	Floor Tiles & Adhesive	1
Extent of Damage	Low Damage	1
Surface Treatment	Composite, reinforced or bonded	0
Estimated Amount	30 m ²	
Accessibility	Usually Inaccessible	
Risk Score		3

Recommendation	Manage & Re-inspect
Notes	Floor tiles and adhesive beneath carpet.

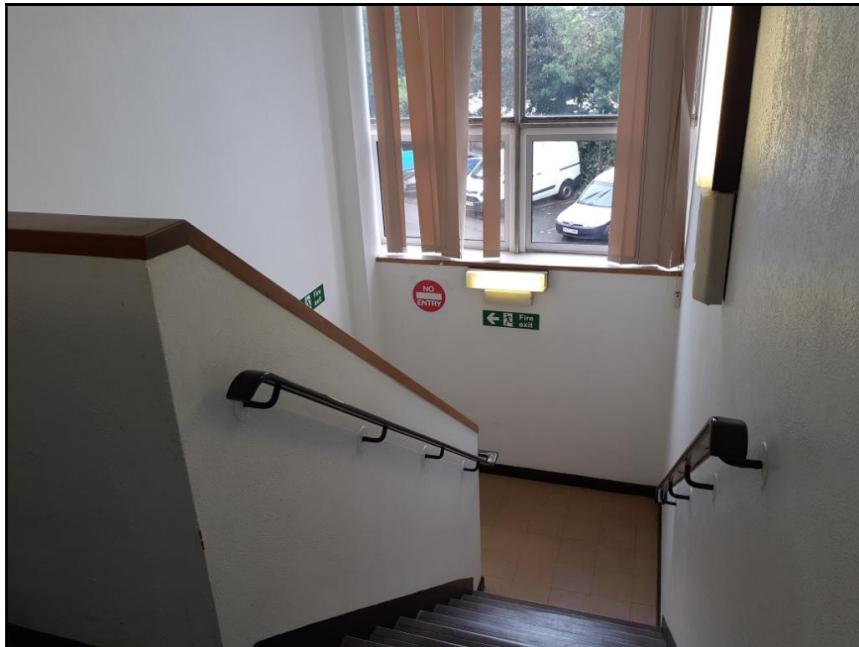
Surveyor	Nazir Korimbocus	Building	Main Building
Survey Type	Management		1
Survey Date	23/09/2020		046 - Stairwell and landing 041
Next Inspection	23/09/2021		S032
Level of Identification	Sample Analysed		556562

Description Textured coating to walls .

Score
Asbestos Type	NO ASBESTOS DETECTED	-
Product Type	Textured Coating	-
Extent of Damage	Low Damage	-
Surface Treatment	Composite, reinforced or bonded	-
Estimated Amount	200 m ²	
Accessibility	Easily Disturbed	
Risk Score		0

Recommendation	No Recommendation Required
Notes

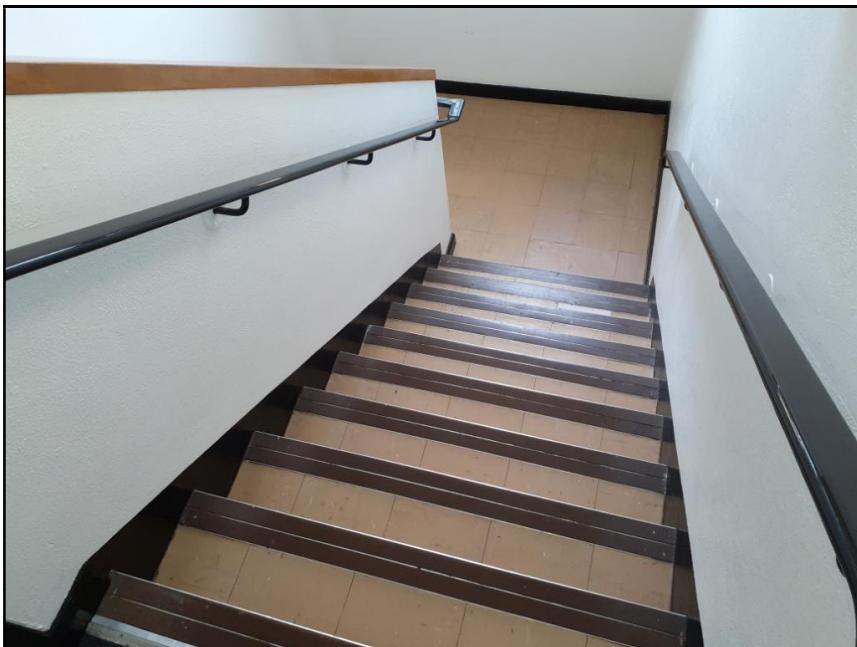
Surveyor	Nazir Korimbocus	Building	Main Building
Survey Type	Management	Floor	1
Survey Date	23/09/2020	Location/ Room	046 - Stairwell and landing 041
Next Inspection	23/09/2021	Sample No	X011
Level of Identification	Strongly Presumed	Inspection Ref	556563

Description Floor tiles and adhesive . Visually consistent with Sample 11.

Score
Asbestos Type	CHRYSTAL (CHRYSTAL IN TILE ONLY)	1
Product Type	Floor Tiles & Adhesive	1
Extent of Damage	Low Damage	1
Surface Treatment	Composite, reinforced or bonded	0
Estimated Amount	20 m ²	
Accessibility	Routinely Disturbed	
Risk Score		3

Recommendation	Manage & Re-inspect
Notes

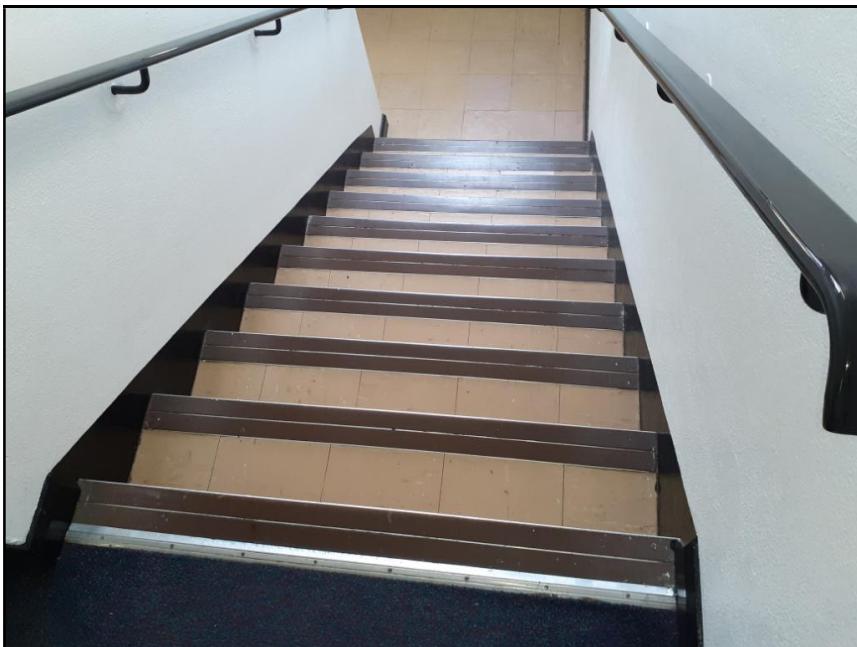
Surveyor	Nazir Korimbocus	Building	Main Building
Survey Type	Management	Floor	1
Survey Date	23/09/2020	Location/ Room	046 - Stairwell and landing 041
Next Inspection	23/09/2021	Sample No	X012
Level of Identification	Strongly Presumed	Inspection Ref	556564

Description Stair nosing strips . Visually consistent with Sample 12.

Score
Asbestos Type	NO ASBESTOS DETECTED	-
Product Type	Reinforced composites	-
Extent of Damage	Low Damage	-
Surface Treatment	Composite, reinforced or bonded	-
Estimated Amount	20 Items	
Accessibility	Routinely Disturbed	
Risk Score		0

Recommendation	No Recommendation Required
Notes	Stair nosing strips.

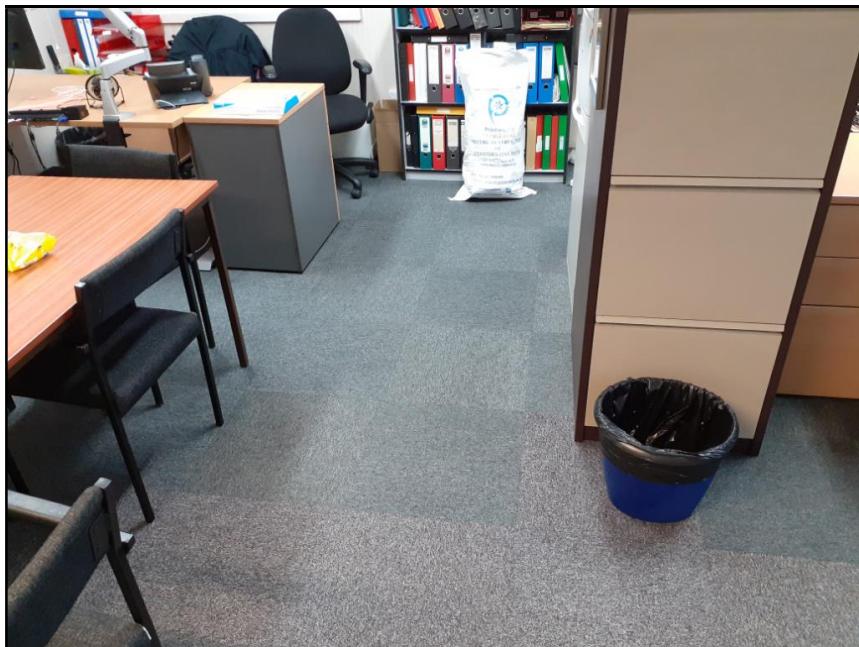
Surveyor	Nazir Korimbocus		Building	Main Building
Survey Type	Management		Floor	1
Survey Date	23/09/2020		Location/ Room	047 - Office 040
Next Inspection	23/09/2021		Sample No	X008
Level of Identification	Strongly Presumed		Inspection Ref	556565

Description Floor tiles and adhesive . Visually consistent with Sample 8.

Score
Asbestos Type	CHRYSTAL (CHRYSTAL IN TILE AND ADHESIVE)	1
Product Type	Floor Tiles & Adhesive	1
Extent of Damage	Low Damage	1
Surface Treatment	Composite, reinforced or bonded	0
Estimated Amount	100 m ²	
Accessibility	Usually Inaccessible	
Risk Score		3

Recommendation	Manage & Re-inspect
Notes	Floor tiles and adhesive beneath carpet.

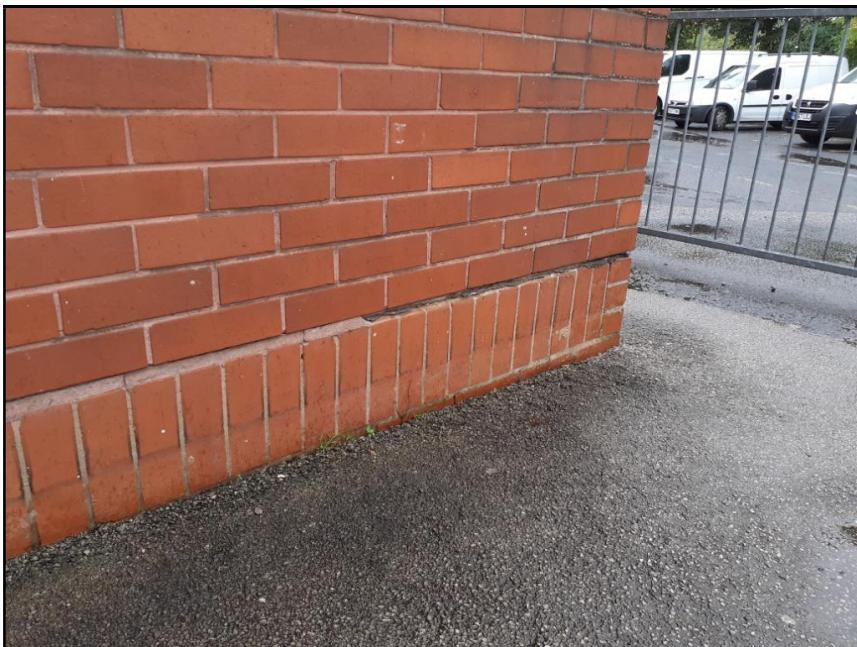
Surveyor	Nazir Korimbocus		Building	Main Building
Survey Type	Management		Floor	External
Survey Date	23/09/2020		Location/ Room	050 - Perimeter
Next Inspection	23/09/2021		Sample No	S034
Level of Identification	Sample Analysed		Inspection Ref	556593

Description Damp proof membrane .

Score
Asbestos Type	CHRYSOTILE	1
Product Type	Bitumen Products	1
Extent of Damage	Low Damage	1
Surface Treatment	Composite, reinforced or bonded	0
Estimated Amount	200 L/M	
Accessibility	Usually Inaccessible	
Risk Score		3

Recommendation	Manage & Re-inspect
Notes	Damp proof membrane to external walls.

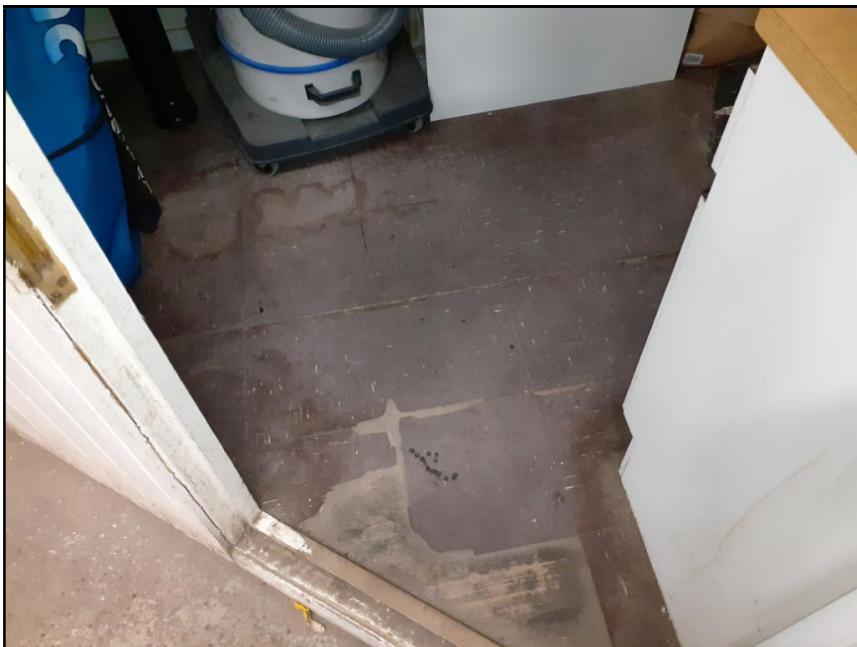
Surveyor	Nazir Korimbocus	Building	Store 1
Survey Type	Management	Floor	0
Survey Date	23/09/2020	Location/ Room	060 - Storage 013
Next Inspection	23/09/2021	Sample No	X036
Level of Identification	Strongly Presumed	Inspection Ref	557143

Description Floor tiles and adhesive . Visually consistent with Sample 36.

Score
Asbestos Type	CHRYSTAL (CHRYSTAL IN ADHESIVE ONLY)	1
Product Type	Floor Tiles & Adhesive	1
Extent of Damage	Medium Damage	2
Surface Treatment	Composite, reinforced or bonded	0
Estimated Amount	4 m ²	
Accessibility	Routinely Disturbed	
Risk Score		4

Recommendation	Manage & Re-inspect
Notes	Floor tiles and adhesive to the corner section of the floor.

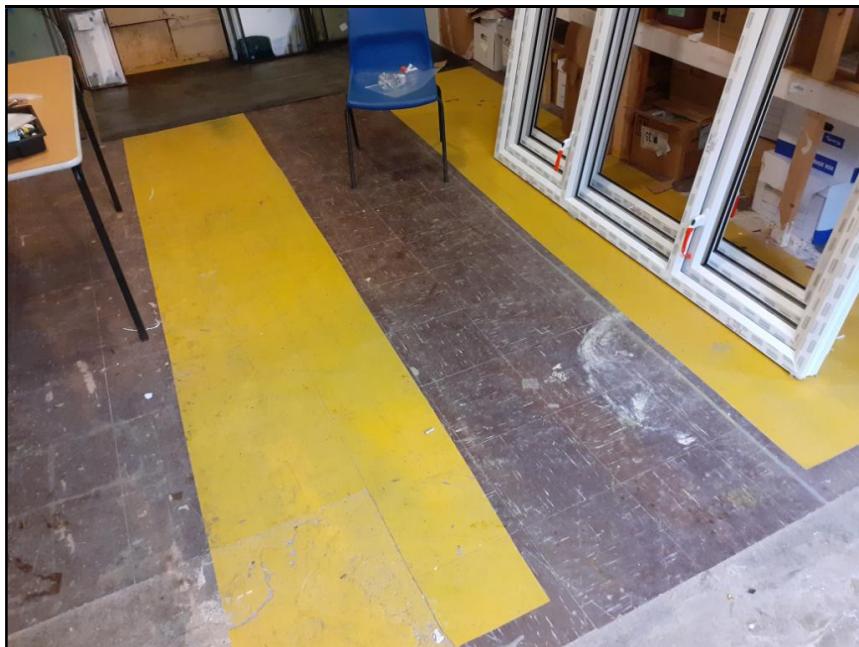
Surveyor	Nazir Korimbocus		Building	Store 2
Survey Type	Management		Floor	0
Survey Date	23/09/2020		Location/ Room	051 - Storage 008
Next Inspection	23/09/2021		Sample No	S036
Level of Identification	Sample Analysed		Inspection Ref	556595

Description Floor tiles and adhesive .

Score
Asbestos Type	CHRYSTAL (CHRYSTAL IN ADHESIVE ONLY)	1
Product Type	Floor Tiles & Adhesive	1
Extent of Damage	Low Damage	1
Surface Treatment	Composite, reinforced or bonded	0
Estimated Amount	30 m ²	
Accessibility	Routinely Disturbed	
Risk Score		3

Recommendation	Manage & Re-inspect
Notes	Floor tiles and adhesive to part section of the floor.
